September 4, 2008

Ref: DRAFT Preliminary 22nd Floor External Elevator Shaft Observations
Board of Equalization (BOE) Building, 450 N Street, Sacramento, CA 95814
LaCroix Davis LLC Project No. 2372-572

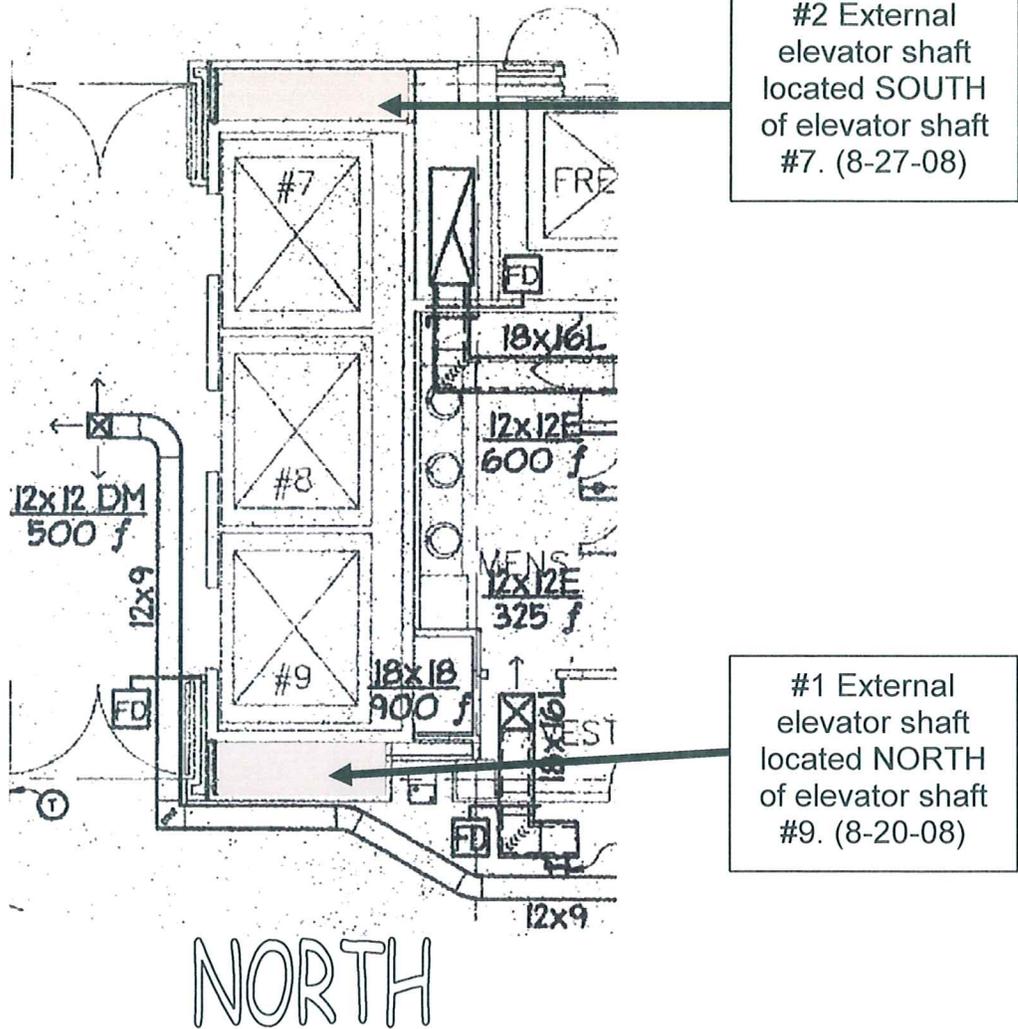
Figure 1.

As requested, LaCroix Davis LLC (LCD) is providing a summary of LCD's observations of the "open spaces" located to the south and north of elevator shafts 9 and 7, respectively, at the Board of Equalization (BOE) building located at 450 N Street, Sacramento, CA 95814. See Figure 1 below.
