**Post Inspection Clearance Assessment Report**  
**Department of General Services**  
**LaCroix Davis Investigative Areas – 23<sup>rd</sup> Floor Containments**  
**Board of Equalization Building, 450 N. Street**  
**Sacramento, California**

November 7<sup>th</sup>, 2008  
BOE 23<sup>rd</sup> Floor LCD Containment Clearances  
Sacramento, CA

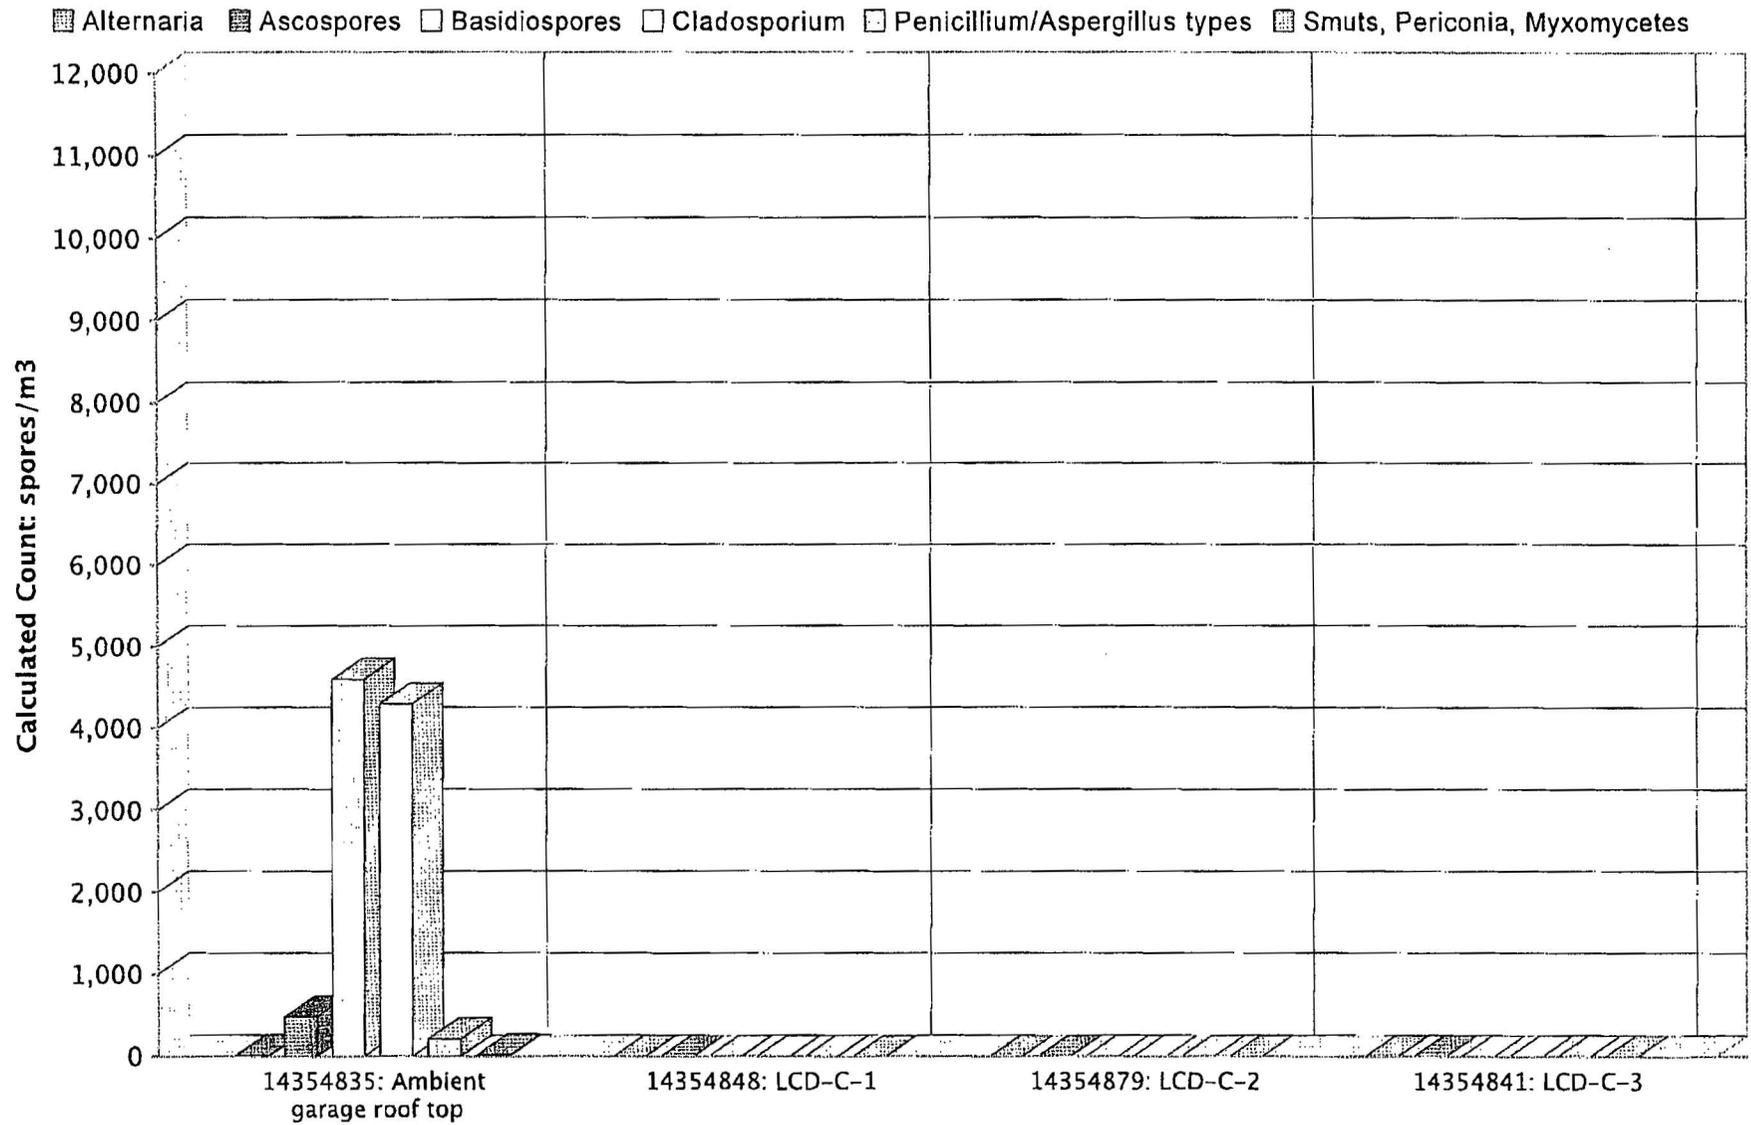
### SPORE TRAP REPORT: NON-VIABLE METHODOLOGY

Note: Graphical output may understate the importance of certain "marker" genera.  
TestAmerica Environmental Microbiology Laboratory, Inc.

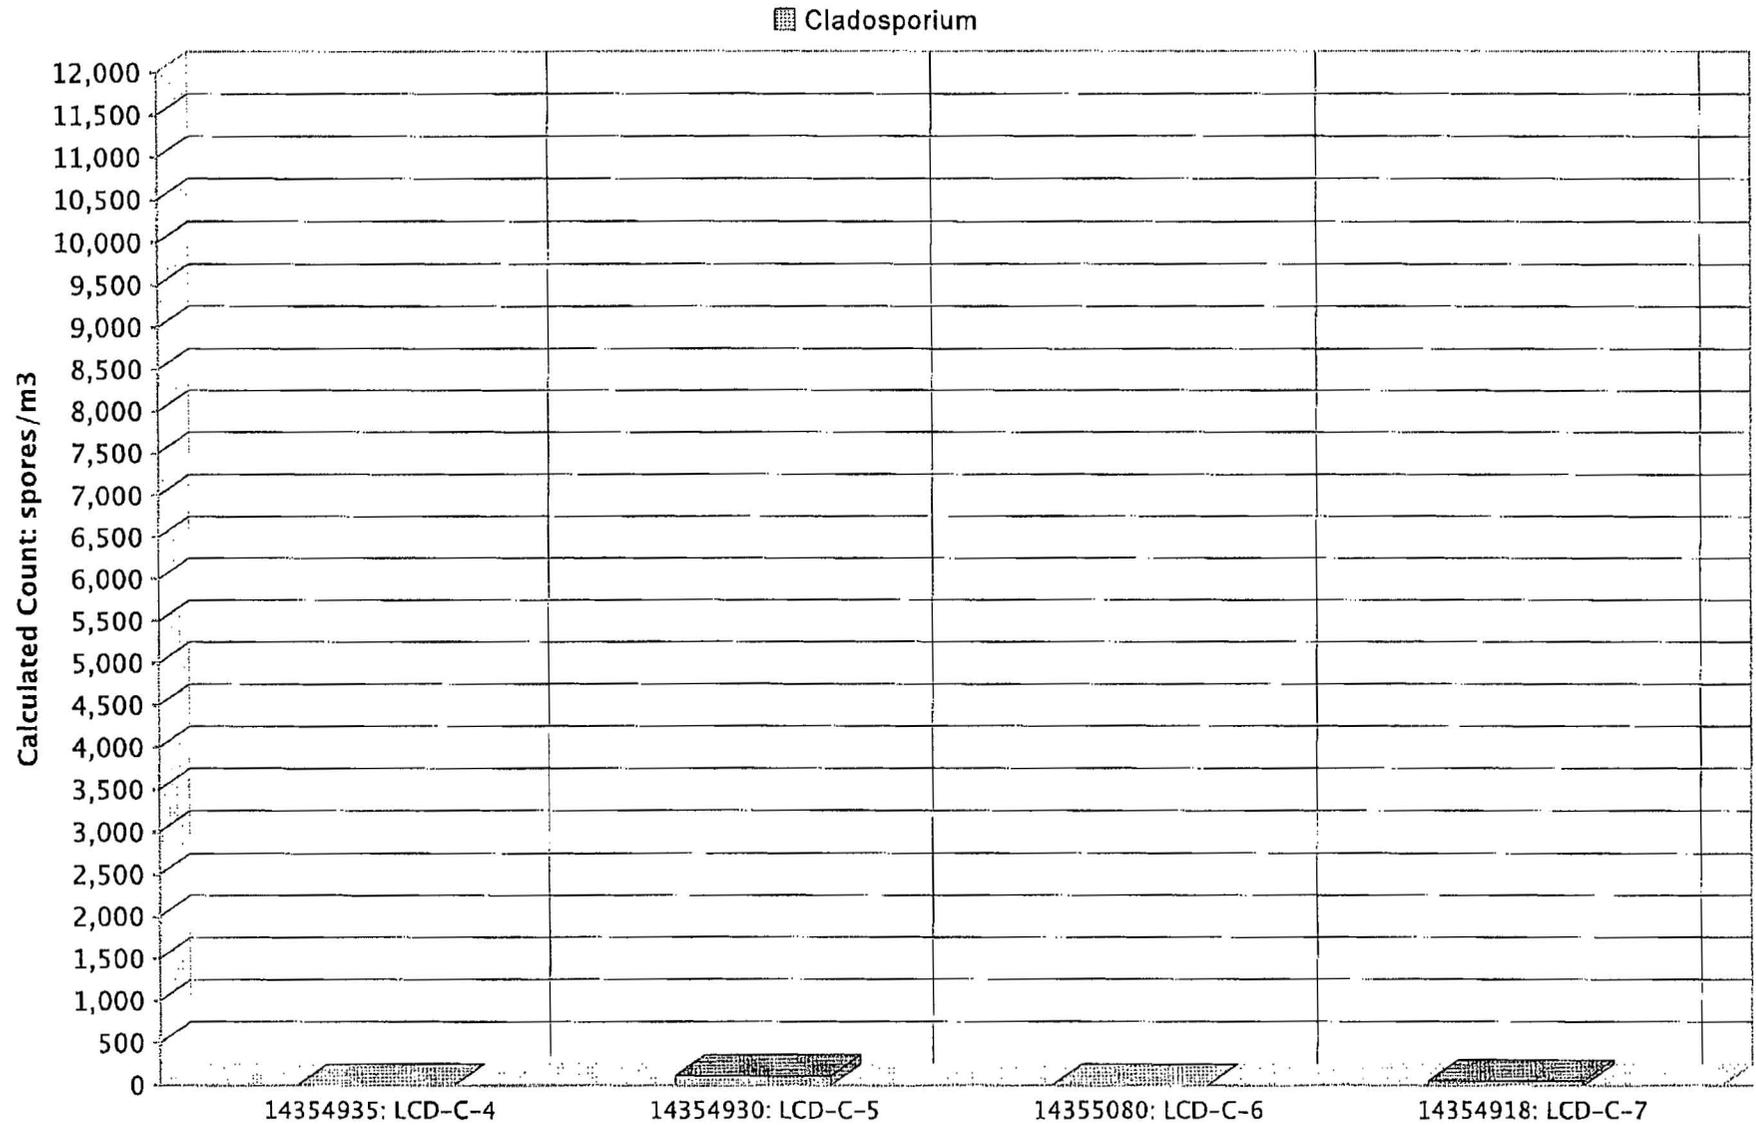
### SPORE TRAP REPORT: NON-VIABLE METHODOLOGY

Note: Graphical output may understate the importance of certain "marker" genera.  
TestAmerica Environmental Microbiology Laboratory, Inc.

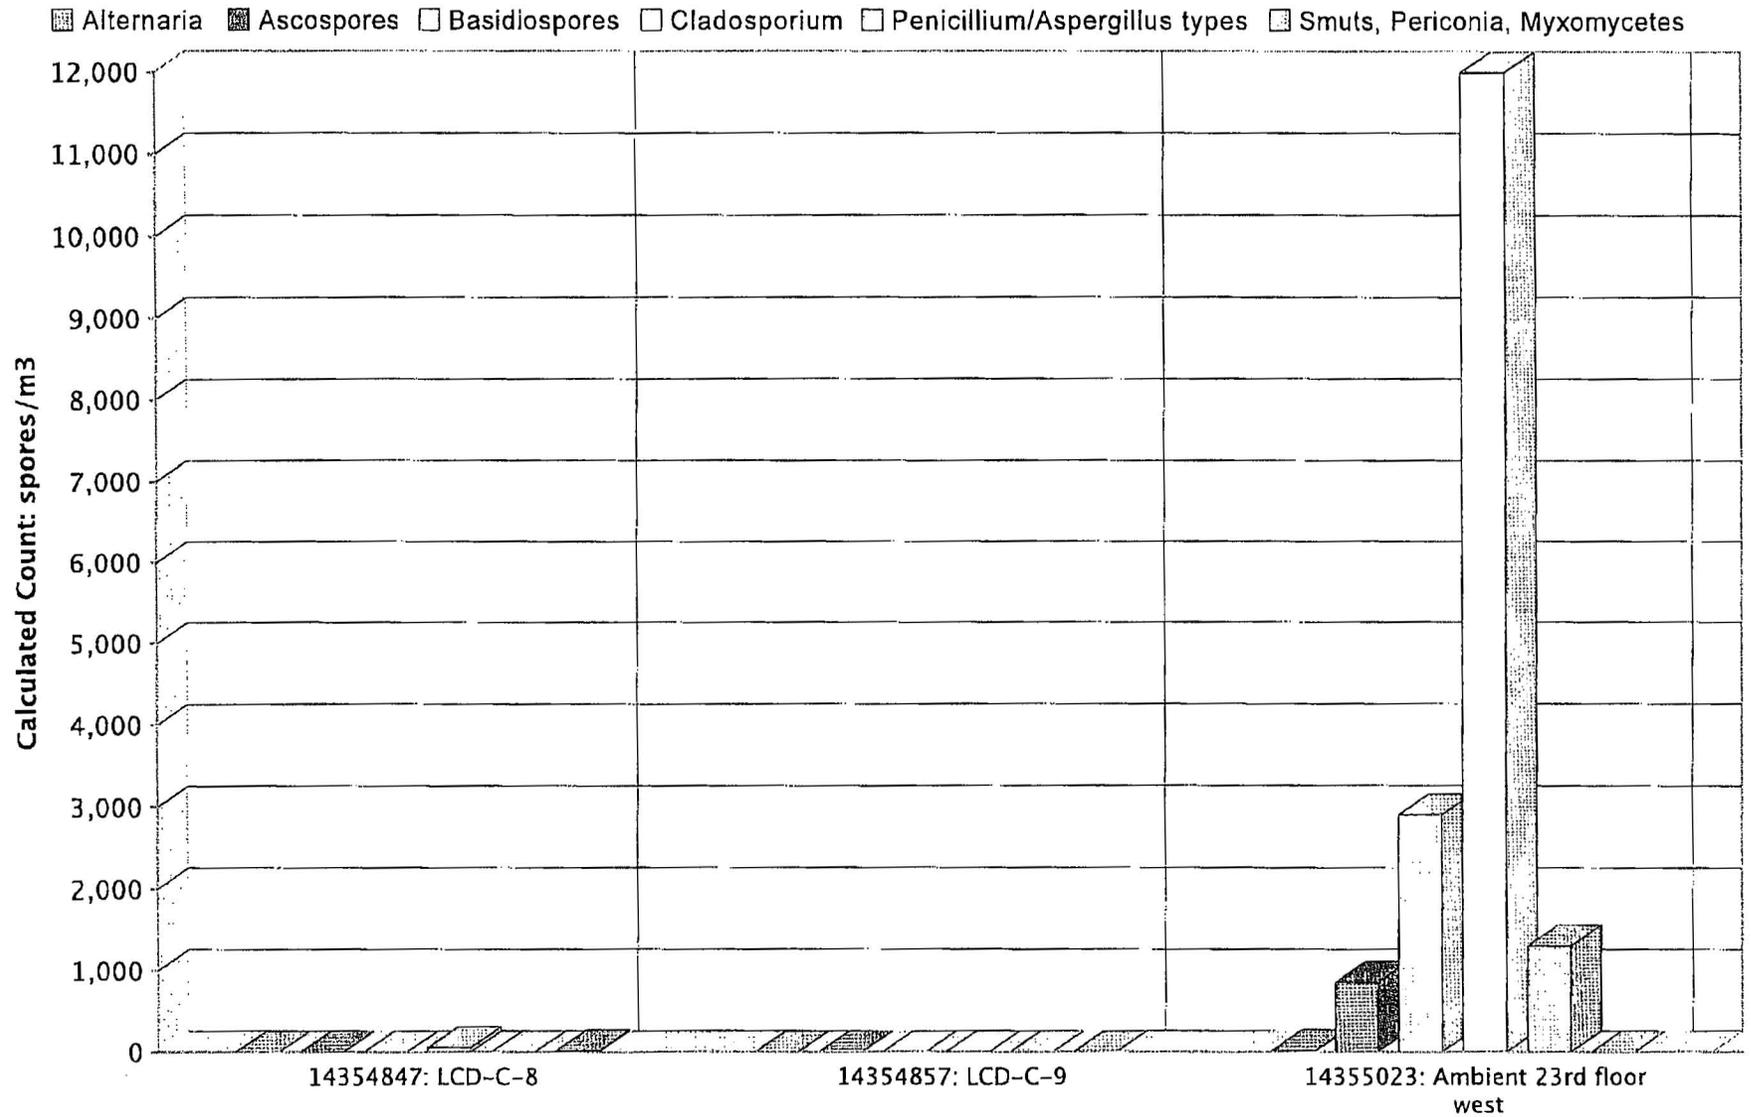
### SPORE TRAP REPORT: NON-VIABLE METHODOLOGY

Note: Graphical output may understate the importance of certain "marker" genera.  
TestAmerica Environmental Microbiology Laboratory, Inc.

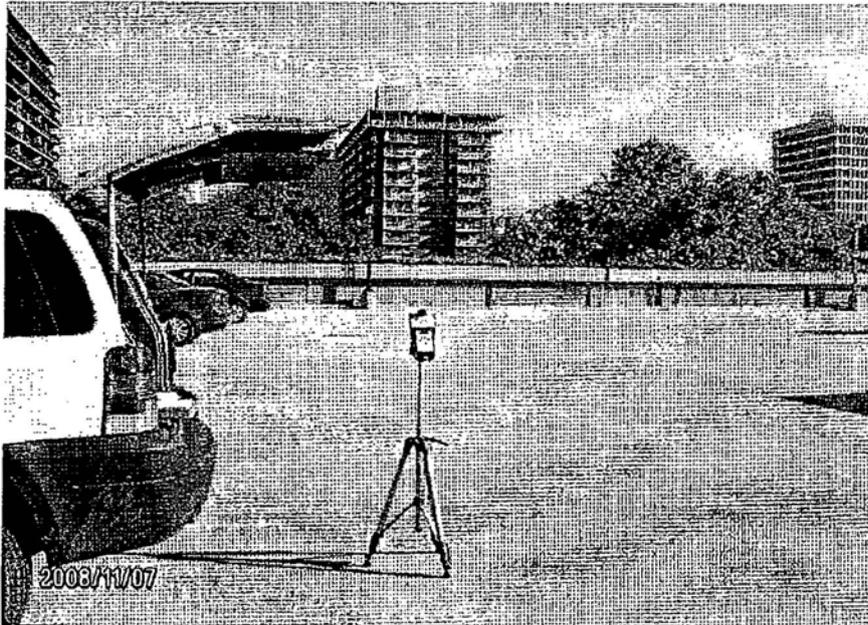
- 1) Image of ambient air sampling location at Garage Rooftop of BOE building (Subject Building) located at 450 N Street, Sacramento.

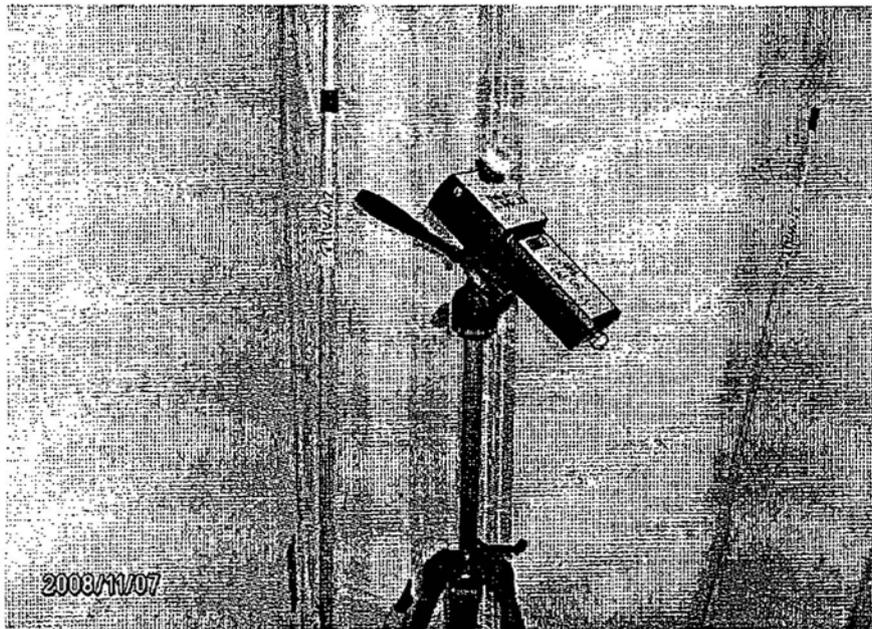
4) Image of interior entry chamber construction and air sampling activity performed within LCD-C-2 at time of assessment.

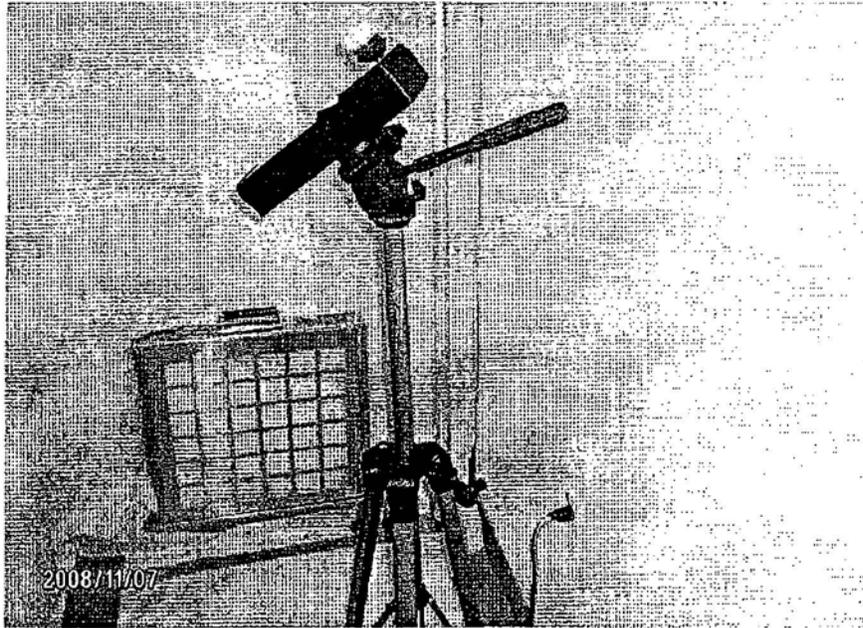
7) Image of air sampling equipment and HEPA filtered negative air machine as viewed from interior side of containment LCD-C-4 at time of assessment.

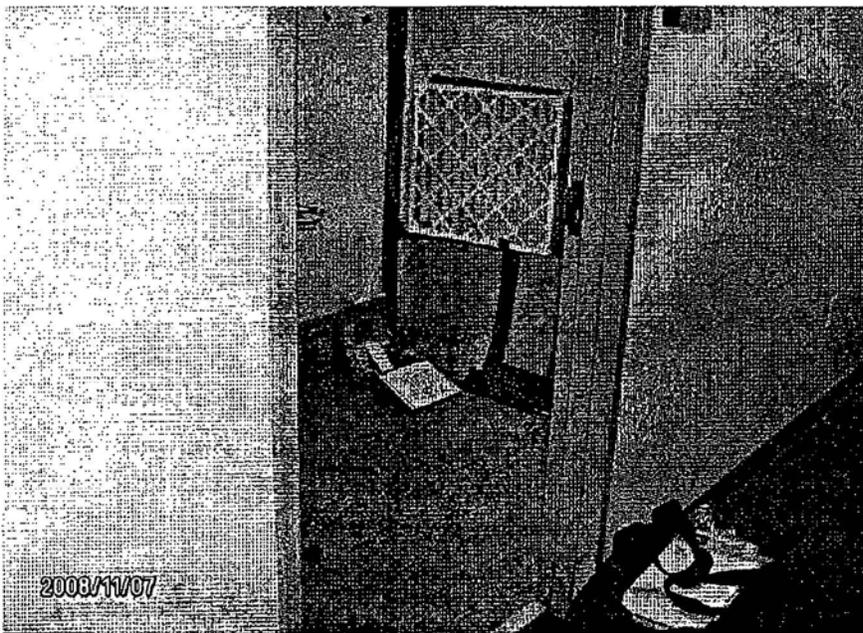
8) Image from hallway of LCD-C-5 containment area erected at restroom entry area.

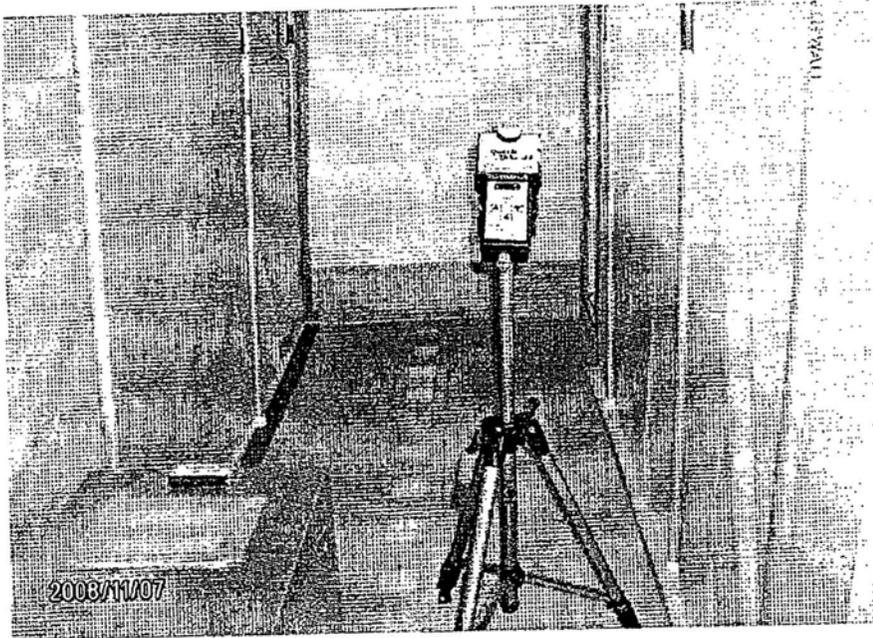
9) Image of air sampling equipment and critical barriers erected within LCD-C-5 containment system at time of assessment.

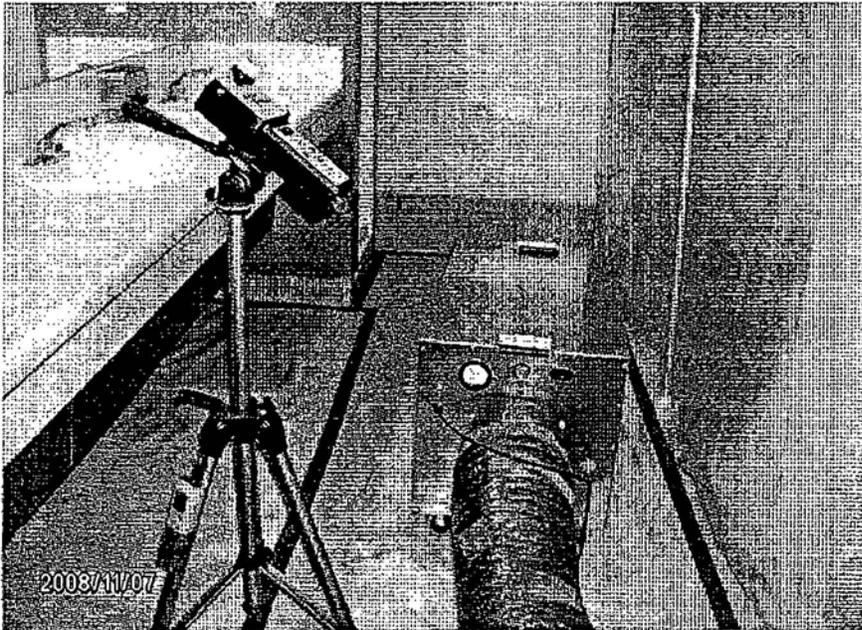
12) Image of air sampling and air handling equipment within men's restroom LCD-C-8 containment at time of assessment.

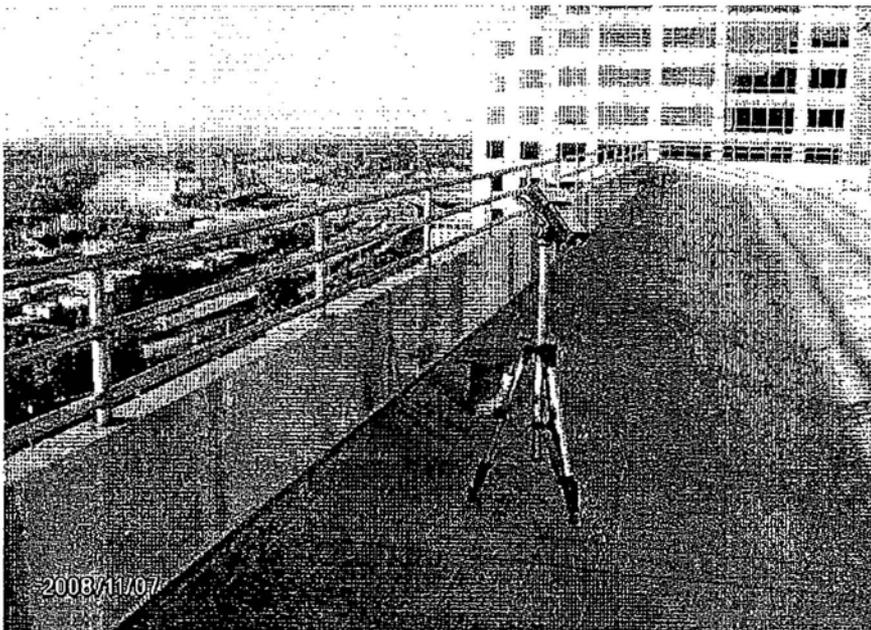
14) Image of ambient air sampling location on 23<sup>rd</sup> Floor Western Balcony of BOE building performed at conclusion of interior clearance inspection sampling.
