BioMax Environmental

March 31st, 2008

Post Mitigation Assessment Report
Department of General Services Board of Equalization Building
450 N. Street - 23rd Floor South and East Containment Areas
Sacramento, California

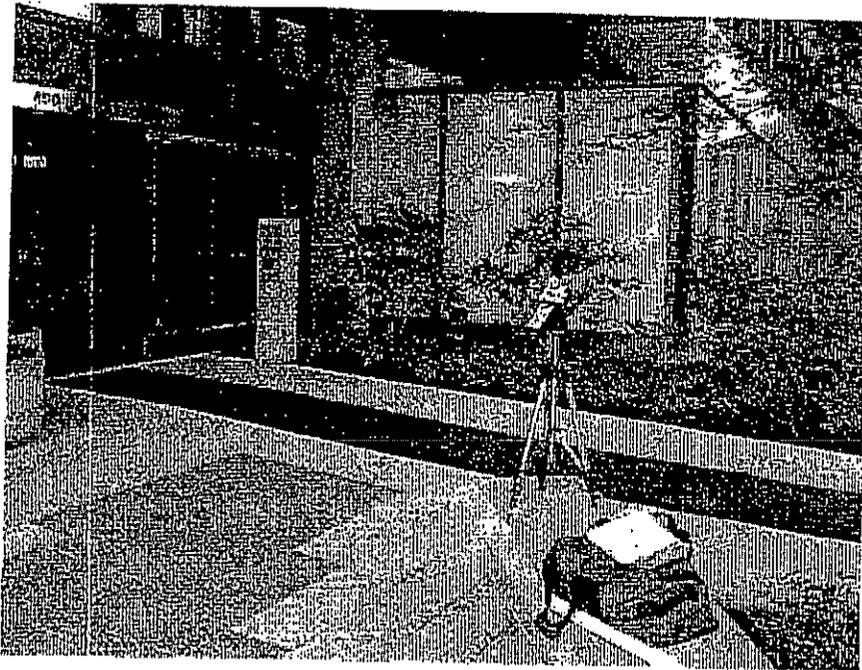
- 1) Image of ambient air sampling location at front entry of BOE Building (Subject Building) located at 450 N Street, Sacramento, California at time of assessment.

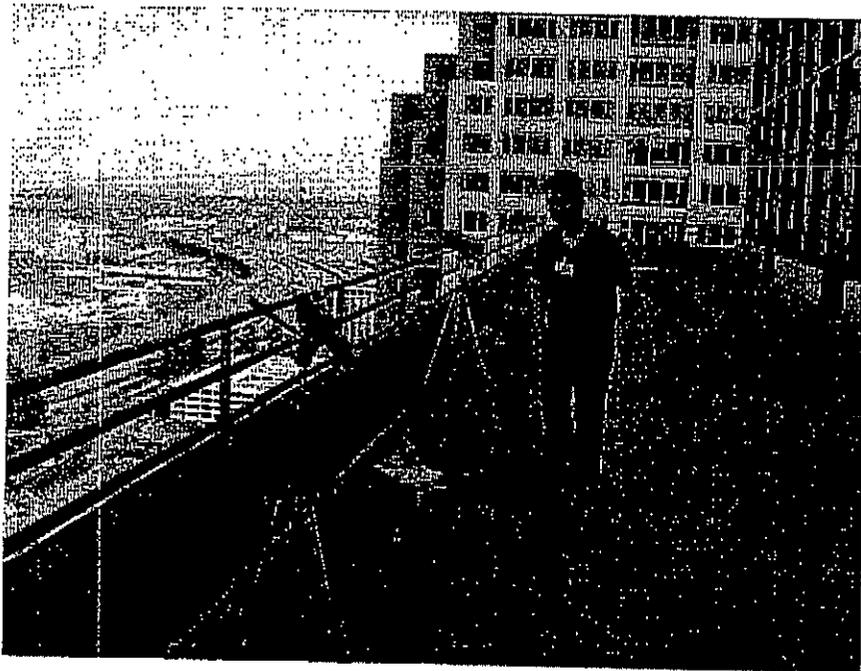
- 2) Image of Ambient air sampling location on balcony of 23 south with HTI technician collecting parallel samples.

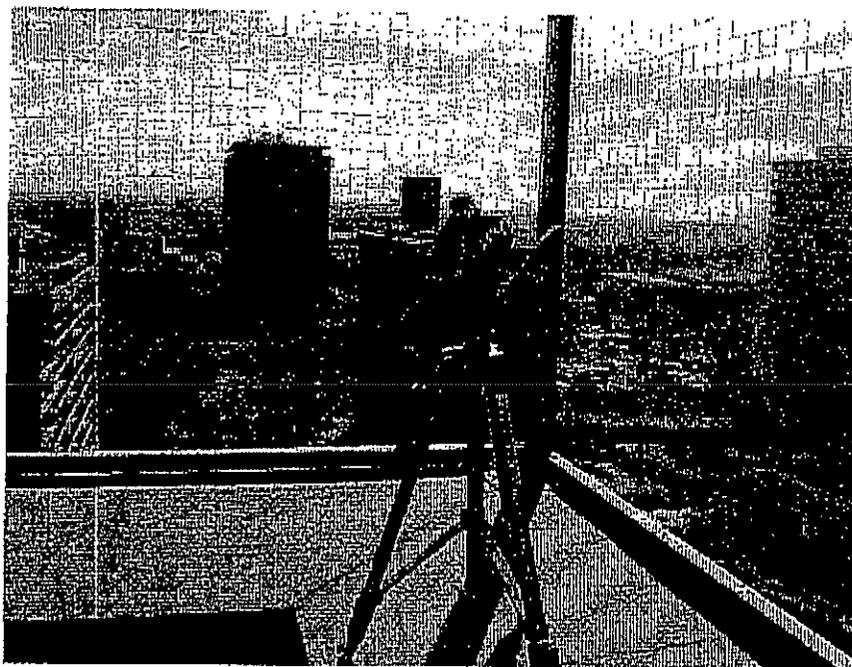
3) Image of 12 Floor southeastern balcony during ambient air collection procedures at time of assessment.

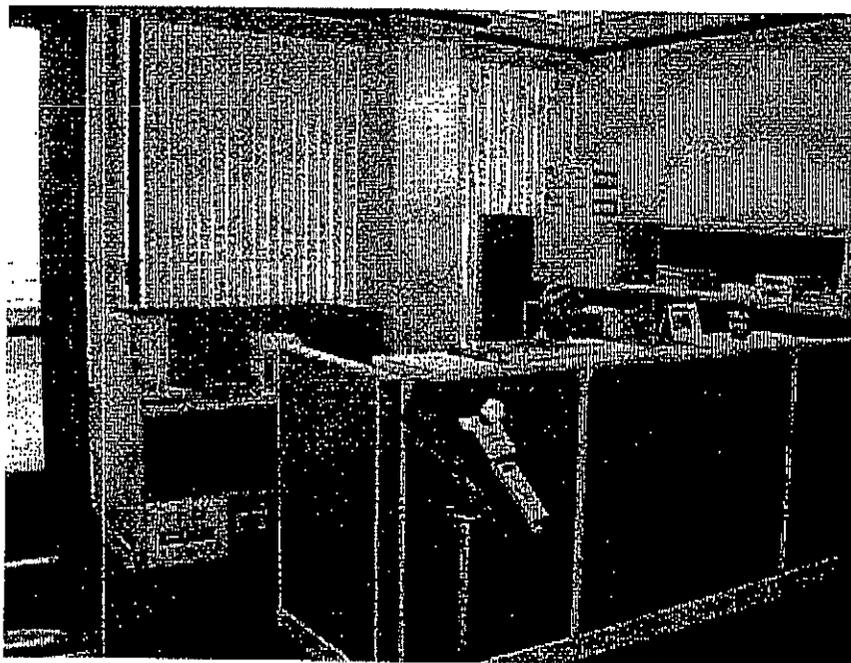
4) Image of hallway air sampling within construction offices location (outside containment) adjacent to 23 South containment area at time of assessment.

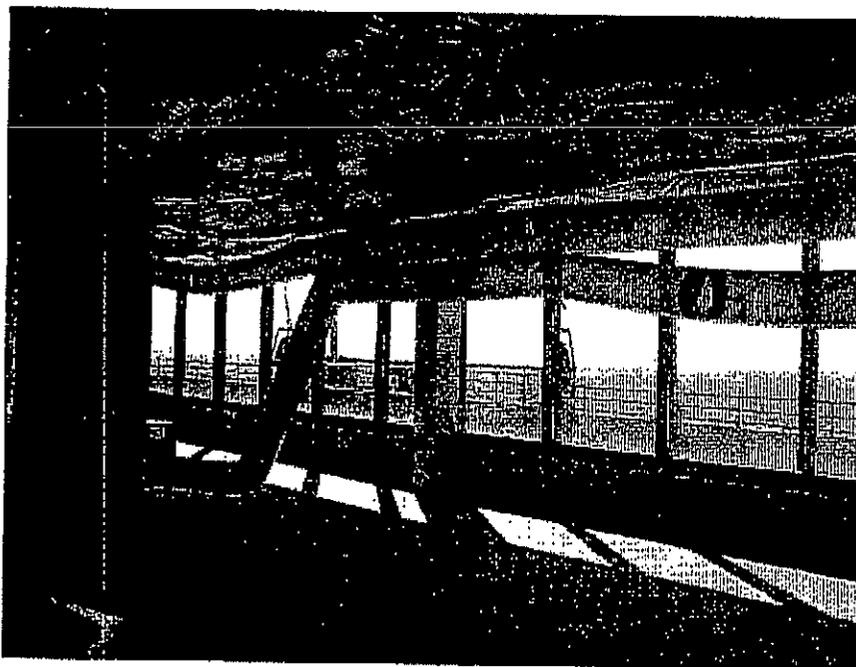
8) Wide angle image of 23South containment space indicating ventilation ducting and contained ceiling structures at time of assessment.

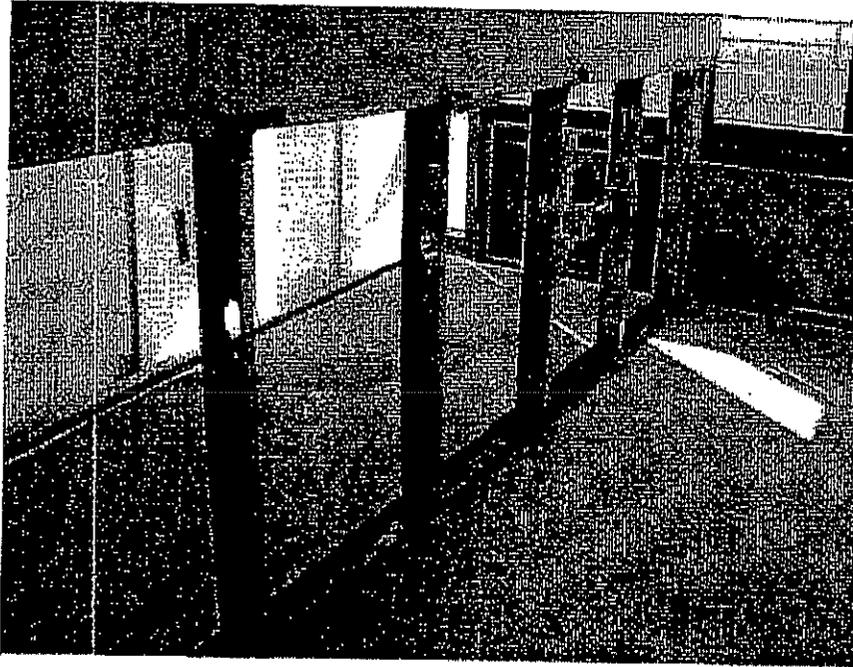
6. As prescribed, all identified affected interior wallboard building materials had been removed from each of the affected areas exposing interior wall cavity framing (metal) as well as underlayment wallboard siding materials once present within the impacted containment areas. Upon post mitigation inspection, all remaining exposed building materials associated with the interior wall systems exhibited no significant staining and/or elevated mold growth following the completion of prescribed physical mold removal and chemical decontamination procedures performed by the selected mitigation contractor on the surfaces of such exposed building materials.

11) Additional image of exposed wall metal framing located at eastern corner of 23 South containment area.

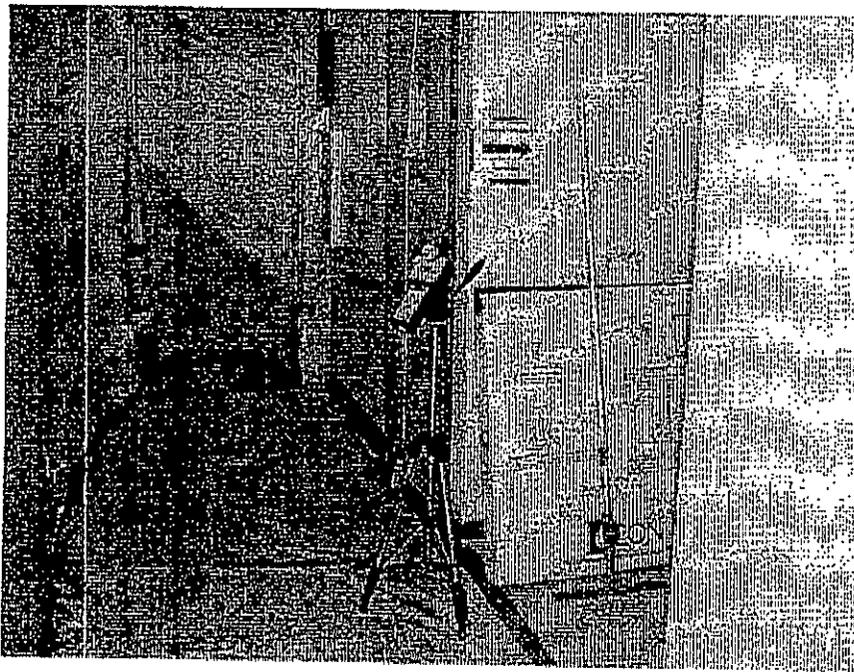
12) Image of air sampling equipment located at exterior hallway of 23 South containment. Sample collected outside containment structures.

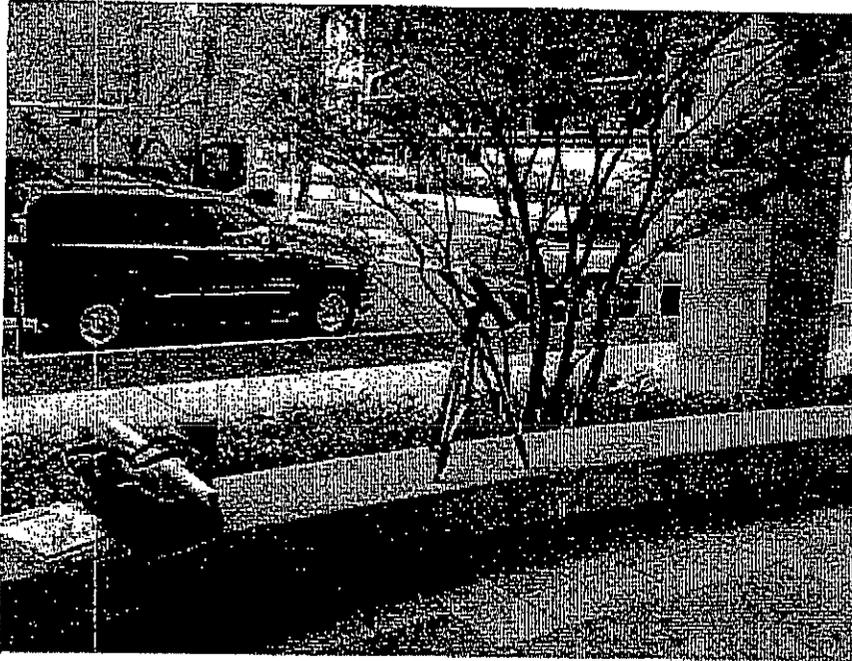
1) Image of ambient air sampling location at front entry of BOE Building (Subject Building) located at 450 N Street, Sacramento, California at time of assessment.

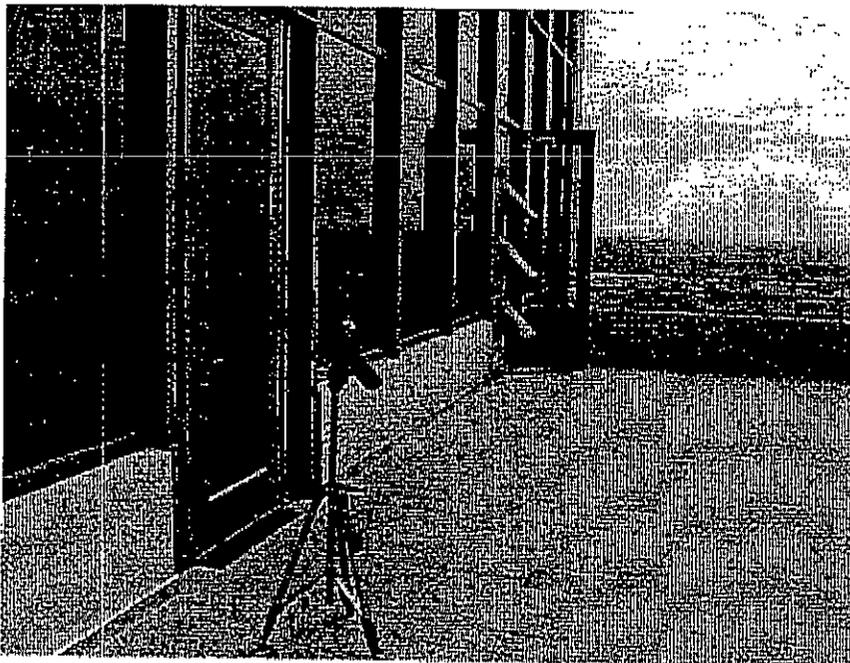
2) Image of Ambient air sampling location on balcony of 23 South at time of assessment.

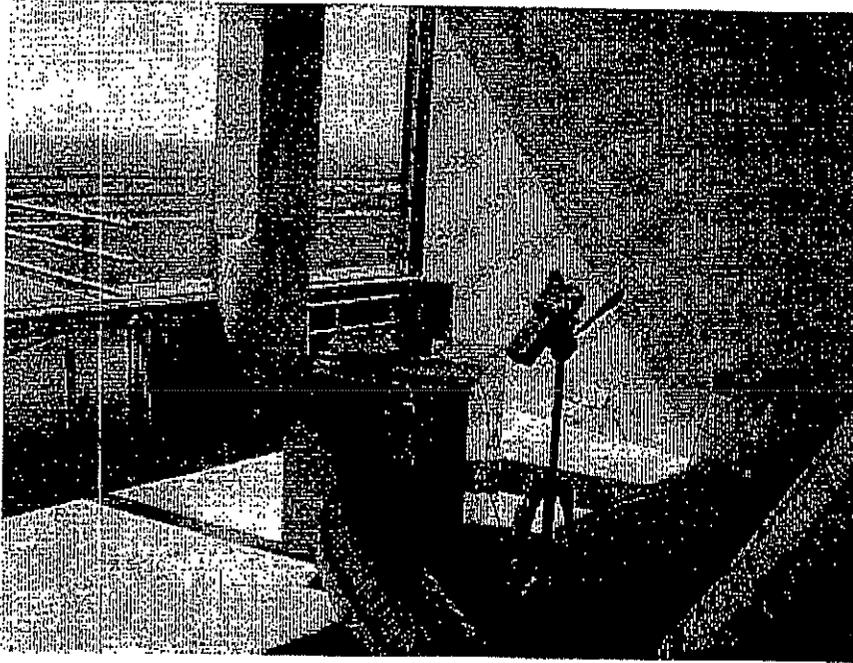
3) Image within 23 Eastern containment system indicating location of air sampling devices and air handling equipment at time of assessment.

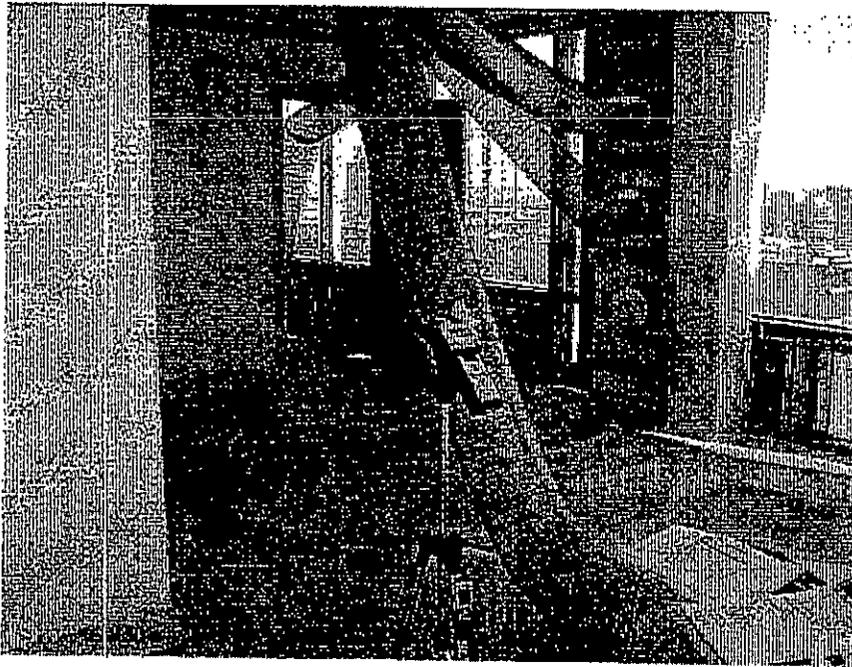
4) Additional image of air sampling and air handling equipment within 23 East containment area at time of assessment.

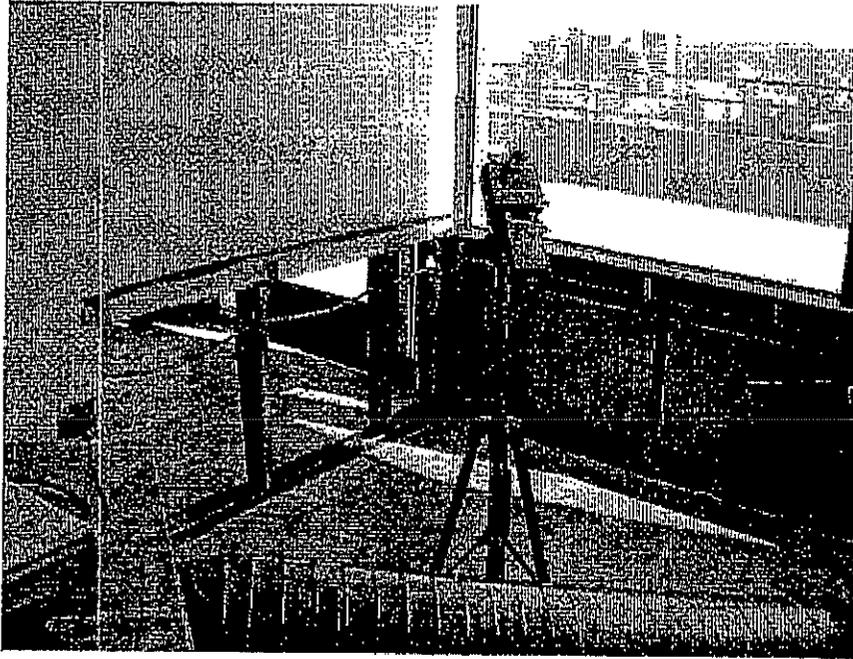
5) Image within 23rd Floor east containment area indicating location of air sampling equipment and extent of perimeter and interior wall removal.

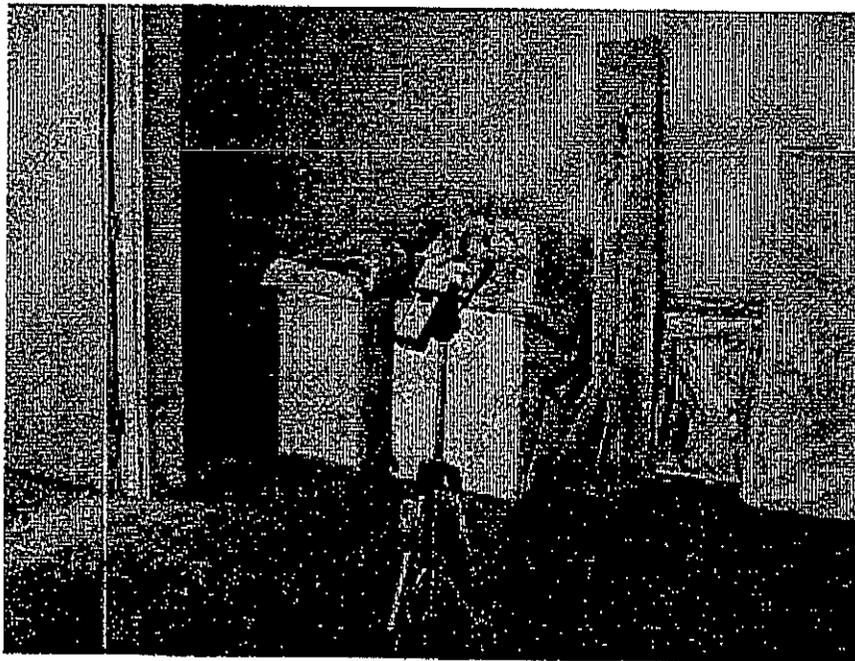
6) Image of protected office furnishings located within interior office where air sampling was performed as part of this assessment.

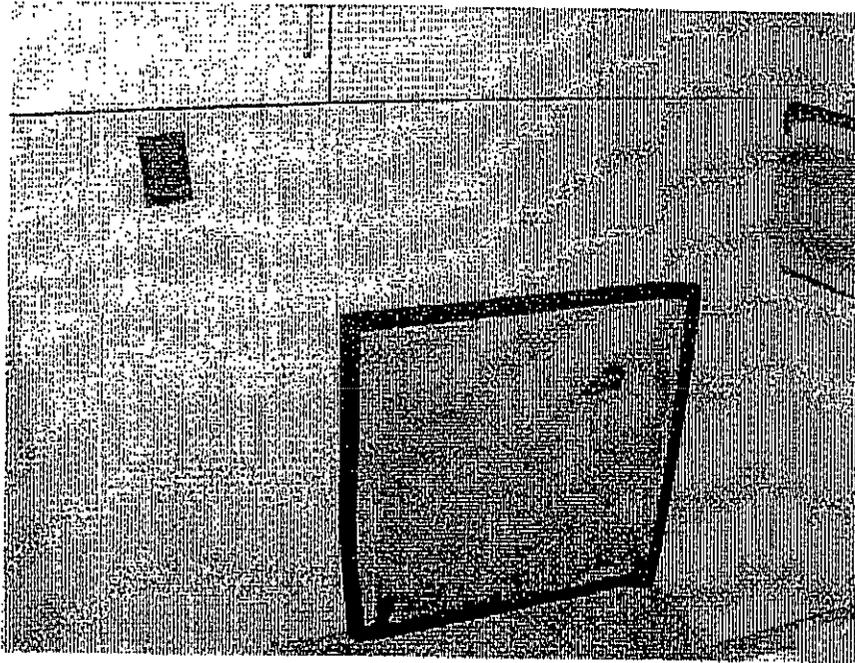
- 7) Close-up image of mini coffee bar cabinet location indicating wallboard and cabinet removal prior to clearance assessment within 23 East containment area.

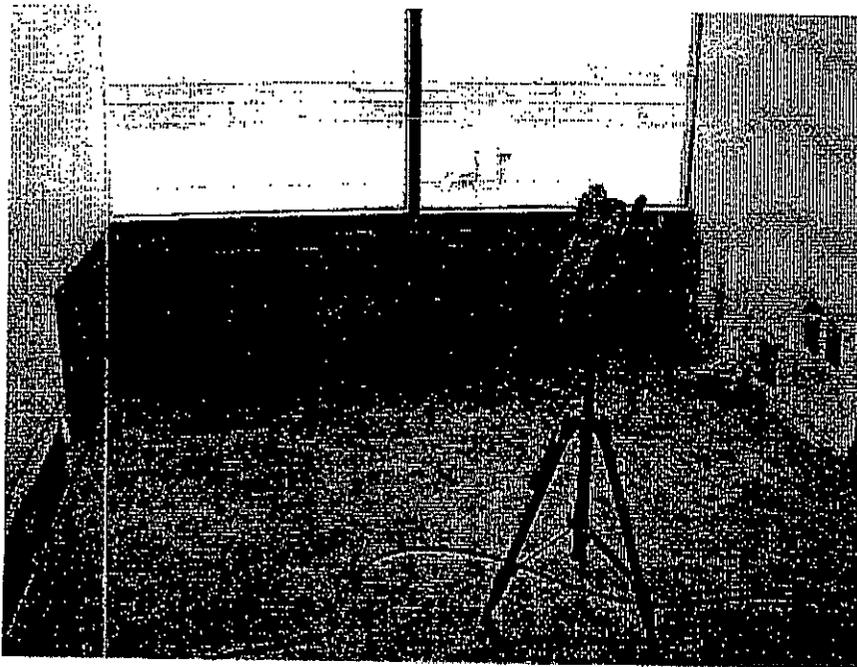
- 8) Air sampling within 23 East containment perimeter office space indicating extent of exterior and interior wallboard removal.

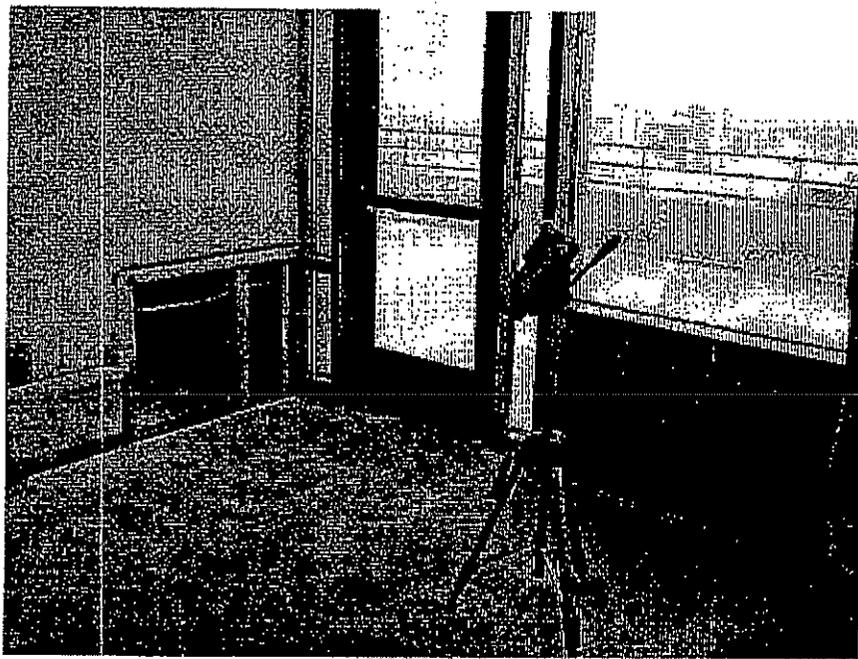
- 9) Additional image of air handling equipment location within 23 East perimeter office at doorway location.

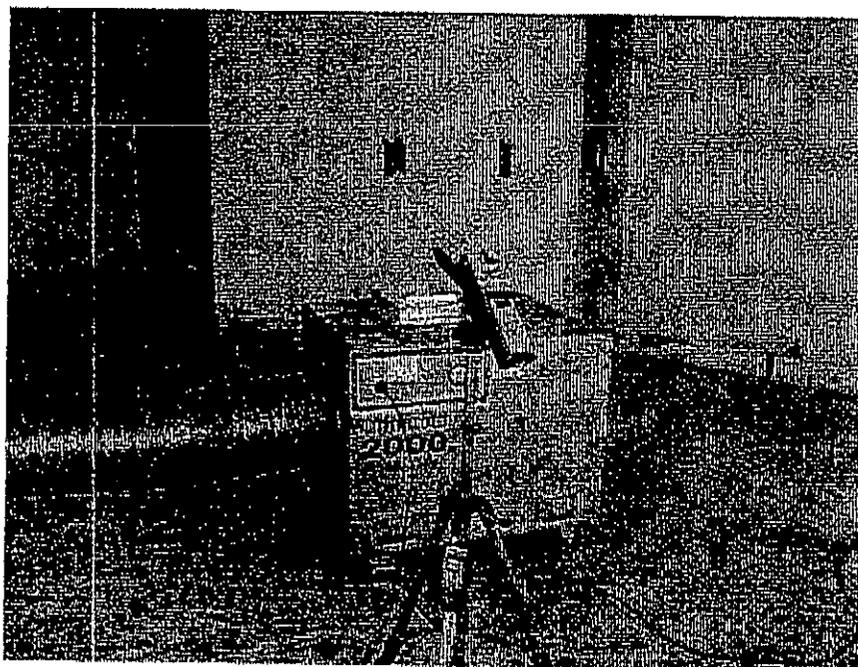
- 10) Image of air sampling equipment within 23 East containment area.
