BioMax Environmental

Post Mitigation Assessment
Department of General Services Board of Equalization Building
First Floor Conference Room Areas
450 N. Street
Sacramento, California

April 21st, 2008BOE Building 1st Floor Conference Rooms

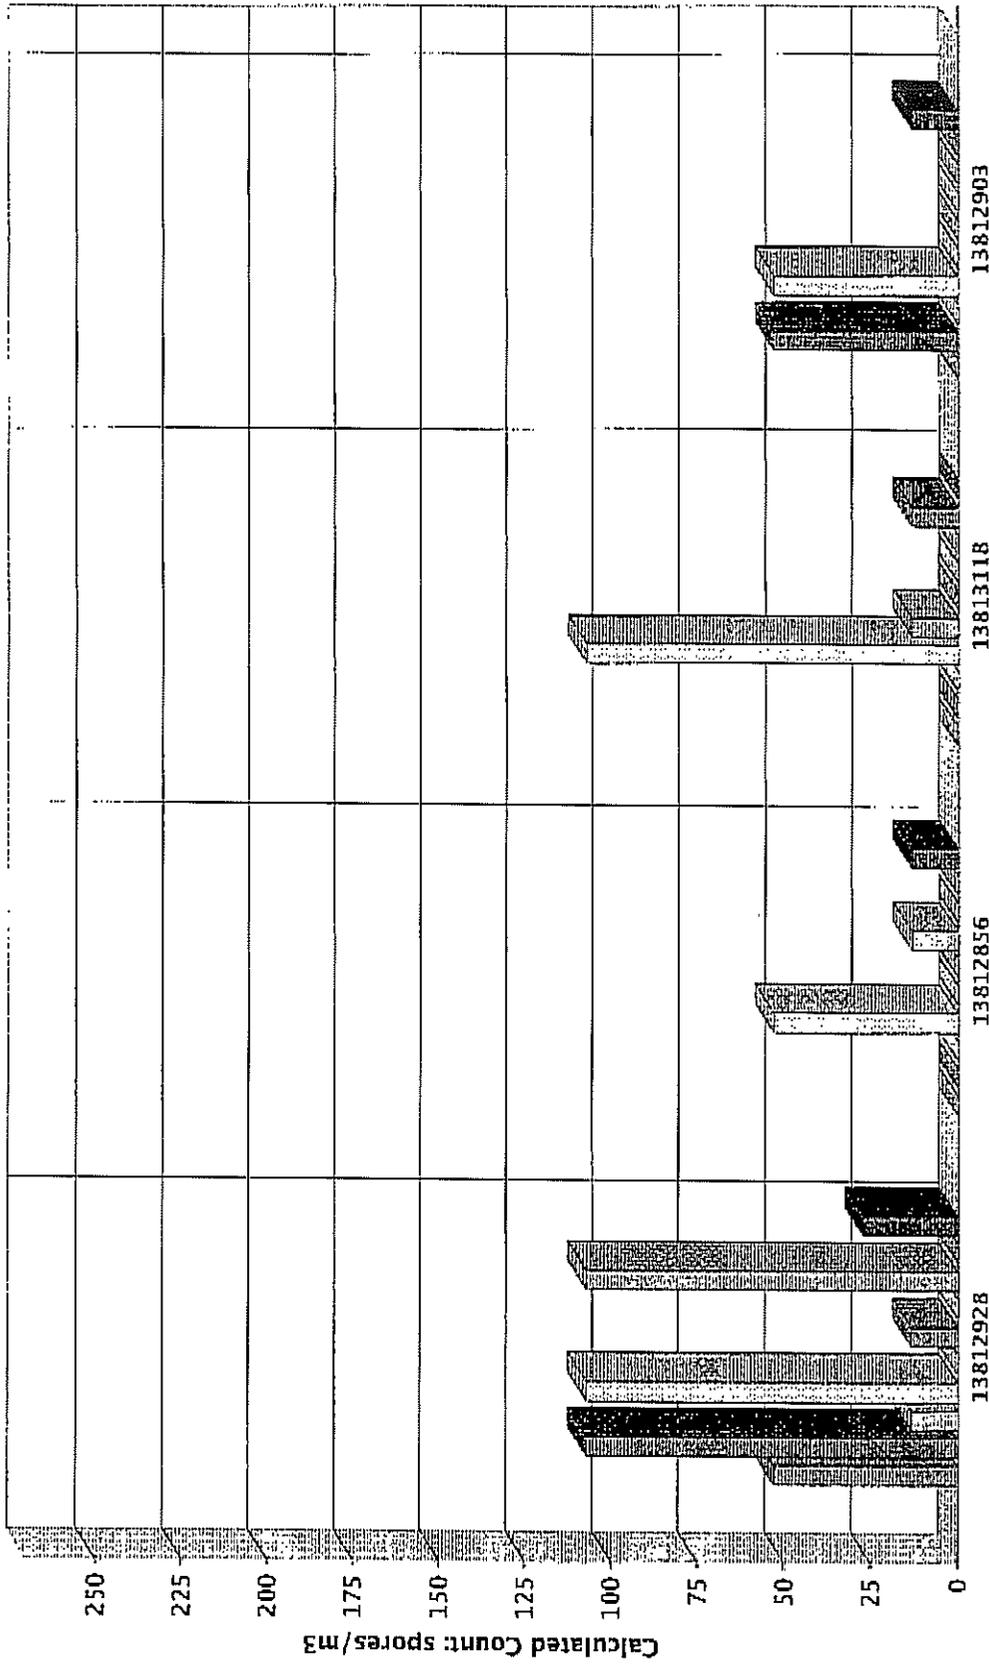
SPORE TRAP REPORT: NON-VIABLE METHODOLOGY

- Ascospores Basidiospores Chaetomium Cladosporium Nigrospora Oidium Other brown
- Penicillium/Aspergillus types Rusts Smuts, Periconia, Myxomycetes

Comments:
 Note: Graphical output may understate the importance of certain "marker" genera.

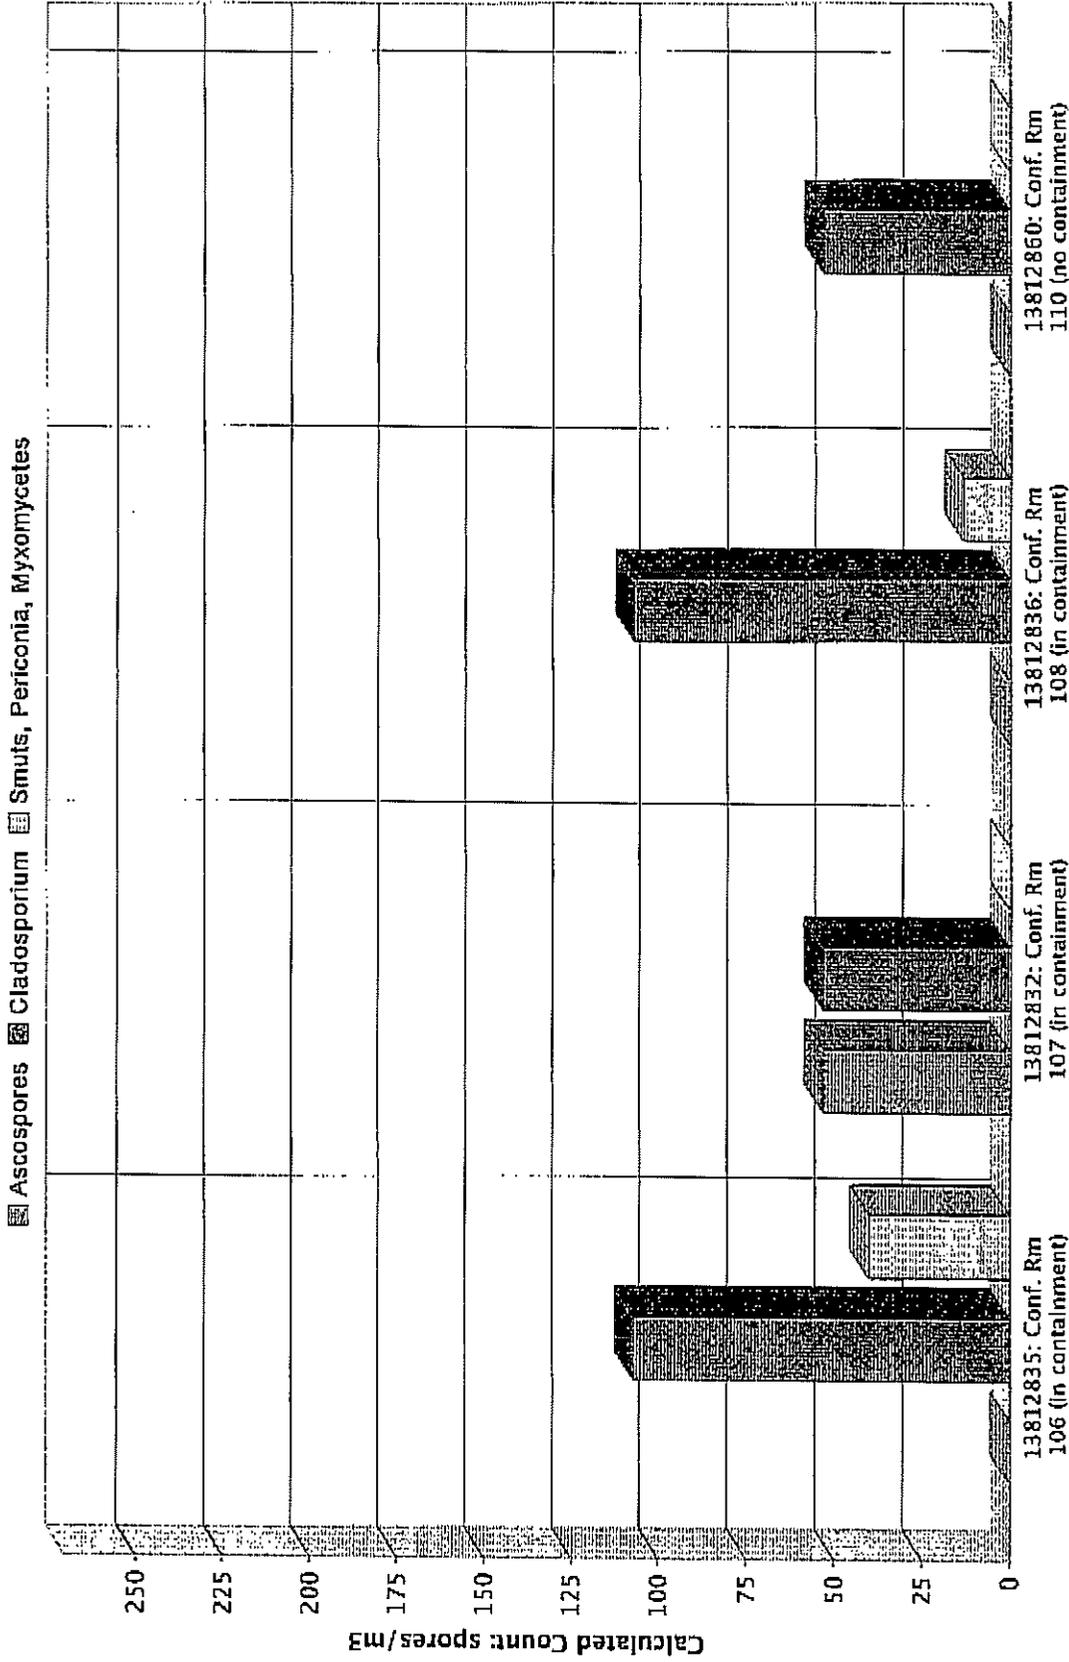
SPORE TRAP REPORT: NON-VIABLE METHODOLOGY

Comments:
 Note: Graphical output may understate the importance of certain "marker" genera.

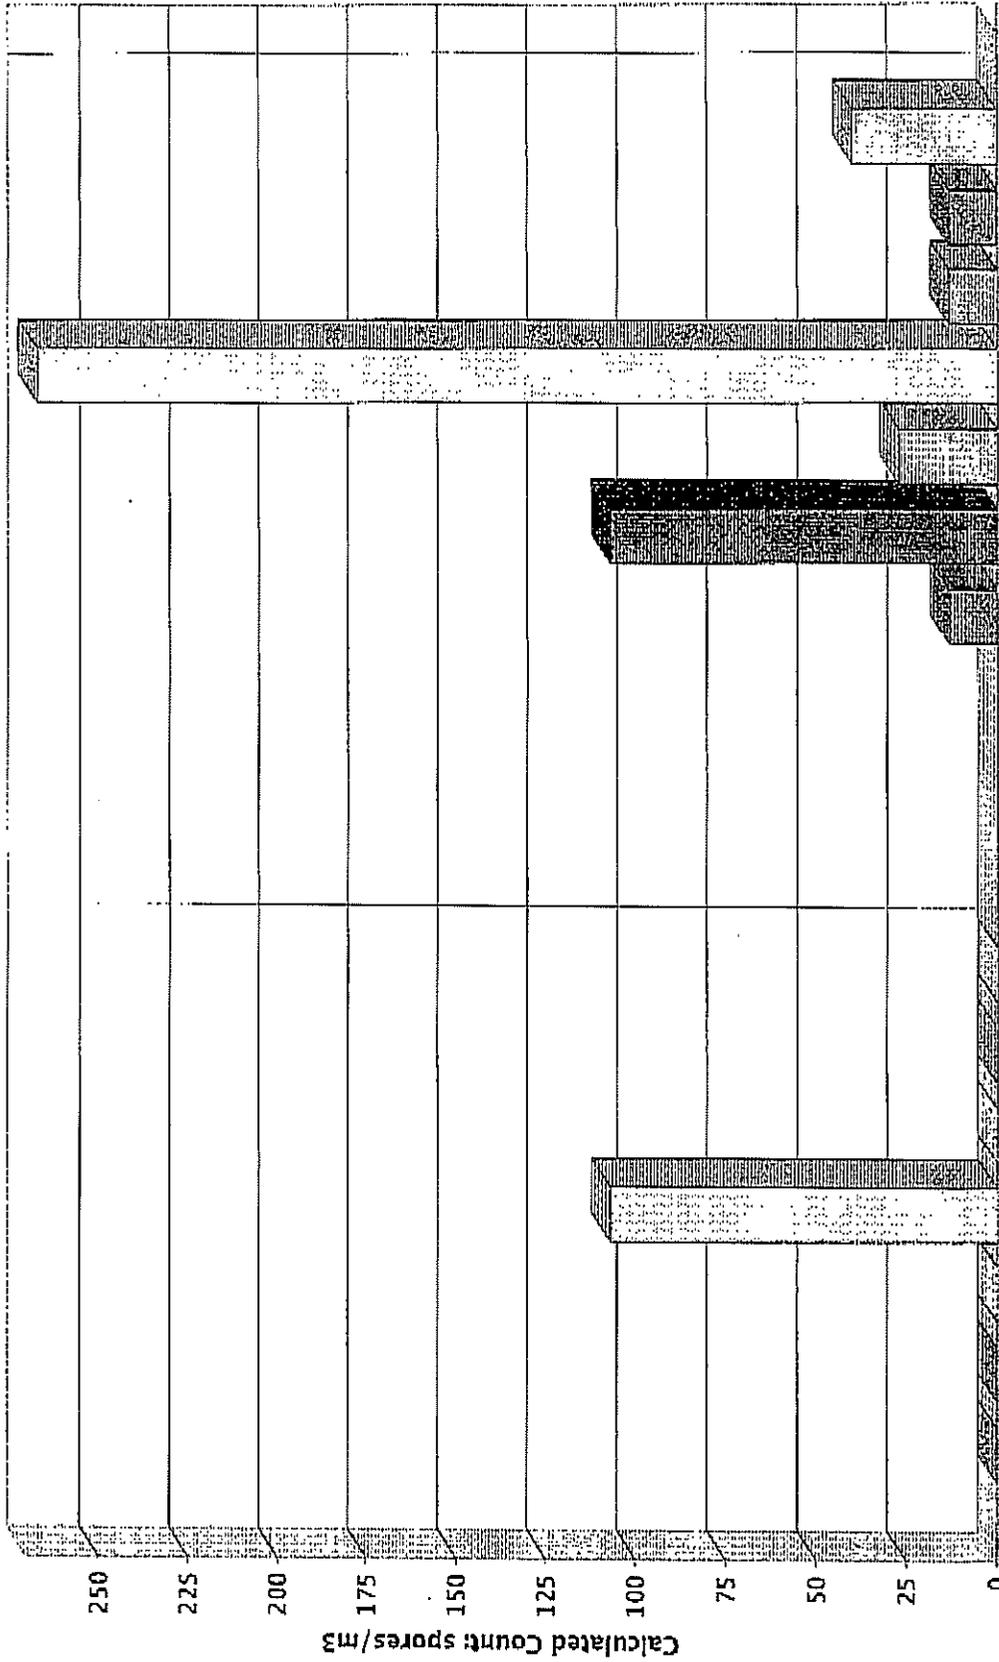
SPORE TRAP REPORT: NON-VIABLE METHODOLOGY

Alternaria Basidiospores Chaetomium Cladosporium Oidium Rusts Smuts, Periconia, Myxomycetes

13813073: Ambient post front entry

13812862: Conf. Rm 111 (no containment)

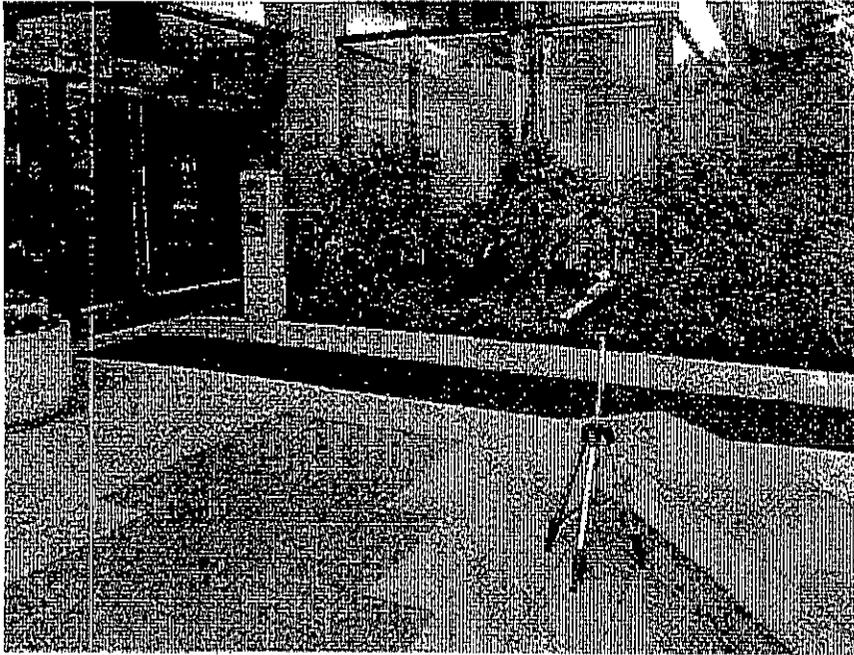
- 1) Image of ambient air sampling location at front entry of BOE Building (Subject Building) located at 450 N Street, Sacramento, California at time of assessment.

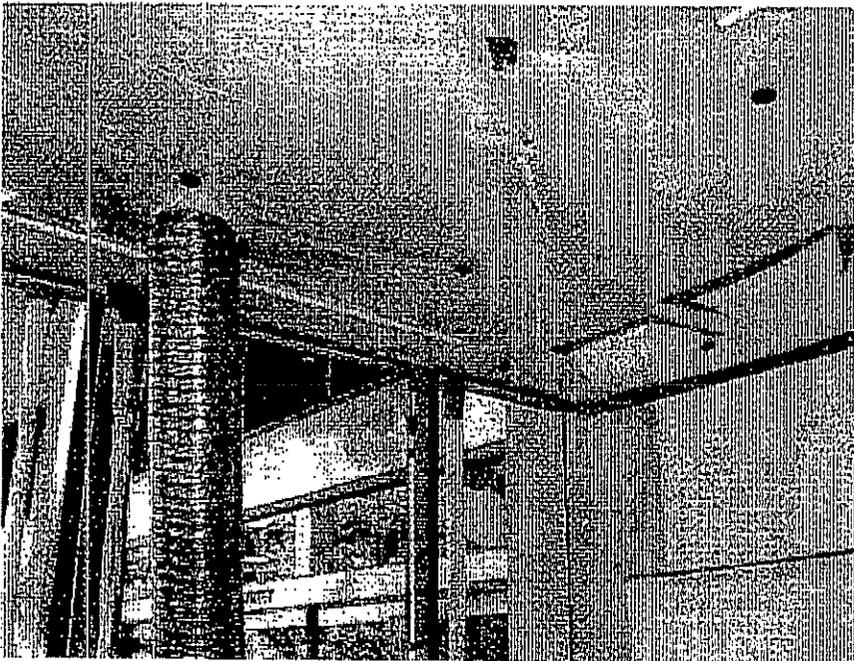
- 4) Image of representative ceiling barrier system (Room 105) utilized within each conference room as recommended by BioMax.

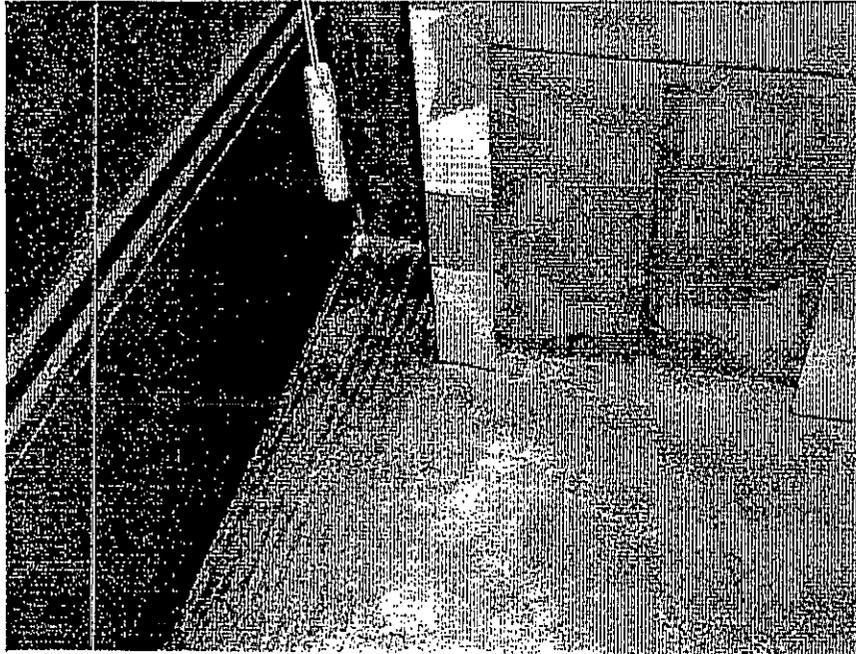
4. As noted within BioMax's previously referenced report, the primary affected areas of visible moisture damage previously identified included moisture and mold damaged flooring and wallboard materials located along the perimeter window conference room walls.

- 7) Image within 107 perimeter wall indicating residual stained concrete flooring at metal wall framing.

3. BioMax recommends that any reconstruction of interior structural building materials within these areas should only be undertaken utilizing high quality, visibly clean (hand selected) construction grade building materials obtained from reputable commercial sources and which are verified through visual assessment to be free from elevated microbial contamination and/or elevated moisture content. Building materials, which are notably moist and/or visibly stained, should not be used during the reconstruction undertaken within the subject building. BioMax recommends that all current plastic barriers (as established during this mitigation) should remain during any such reconstruction activity so as to minimize the potential transmission of associated construction dust and debris throughout the subject structure.

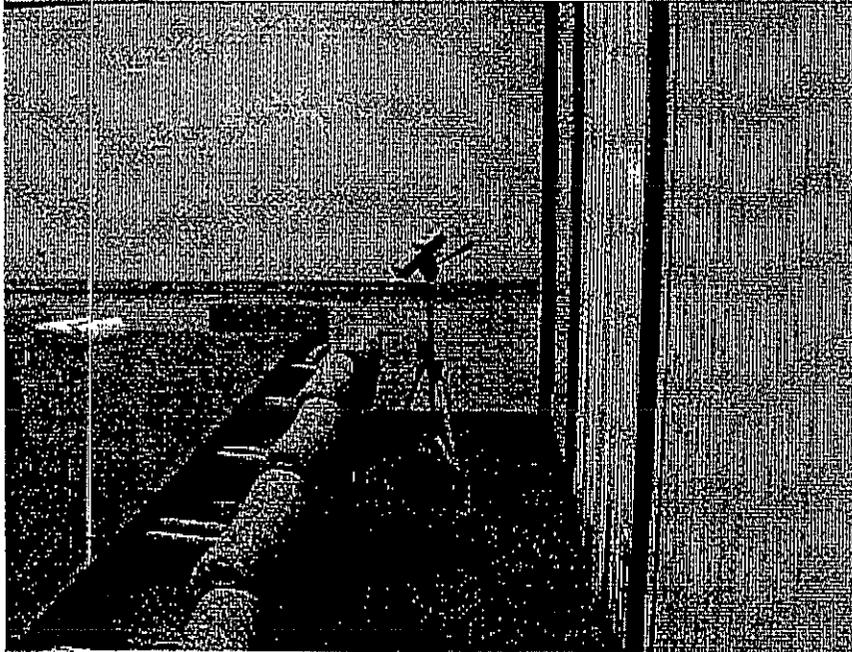
- 9) Image within conference room 110 where no mitigative carpet removal was performed. Air sampling for verification purposes only.

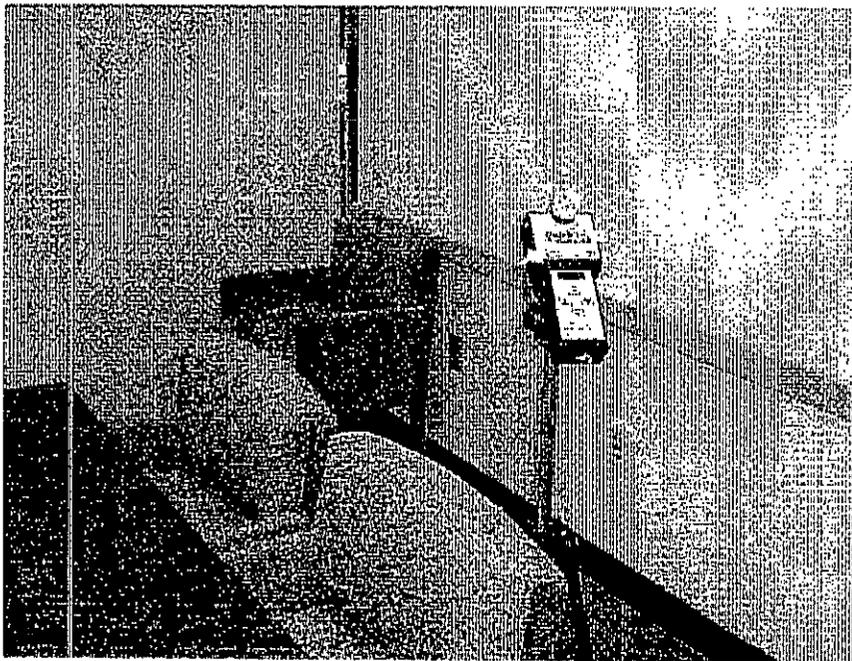
- 10) Image of air sampling equipment and location within conference room 111 at time of assessment.
