BioMax Environmental

March 31st, 2008

Post Mitigation Assessment Report
Department of General Services Board of Equalization Building
450 N. Street - 23rd Floor South and East Containment Areas
Sacramento, California

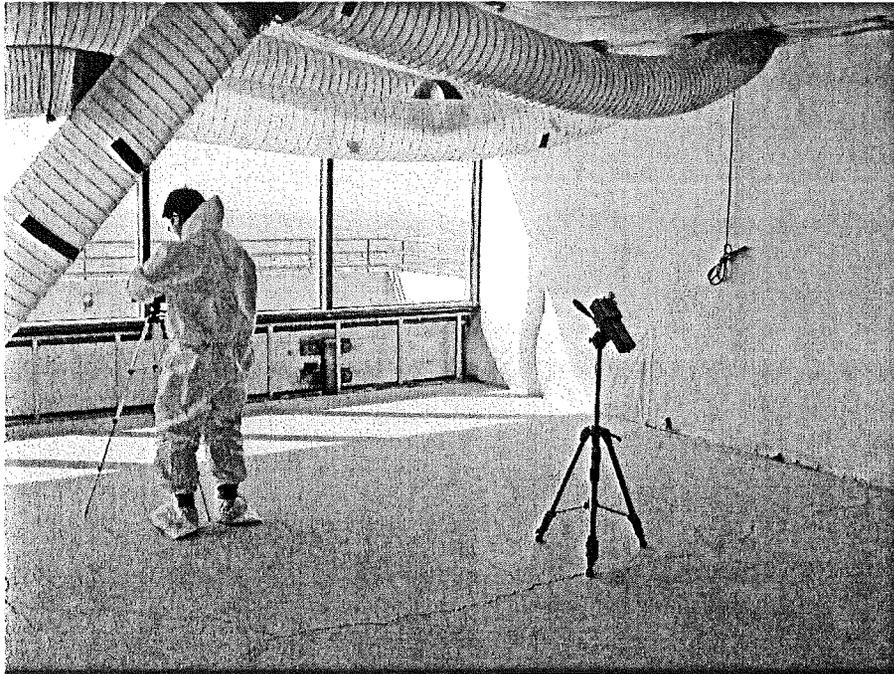
- 5) Image within 23rd Floor south containment area indicating location of air sampling equipment and “parallel” HTI technician activities.

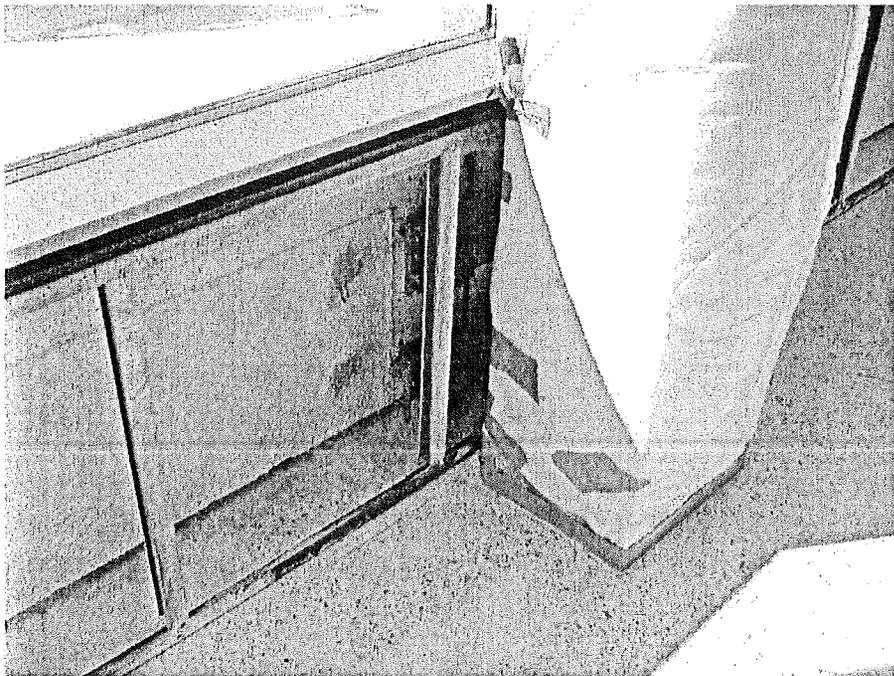
- 6) Image of encased column located at exterior perimeter wall within 23 South containment area following wallboard removal.

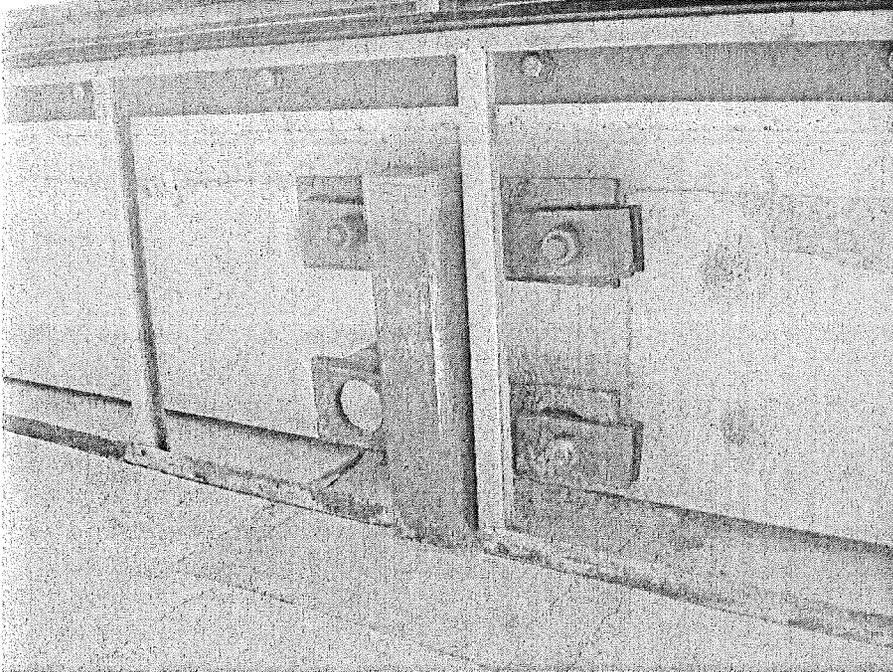
- 7) Close-up image of perimeter wall structures indicating evidence of prior water intrusion (corrosion on floor sill metal) following removal of damaged wallboard materials.

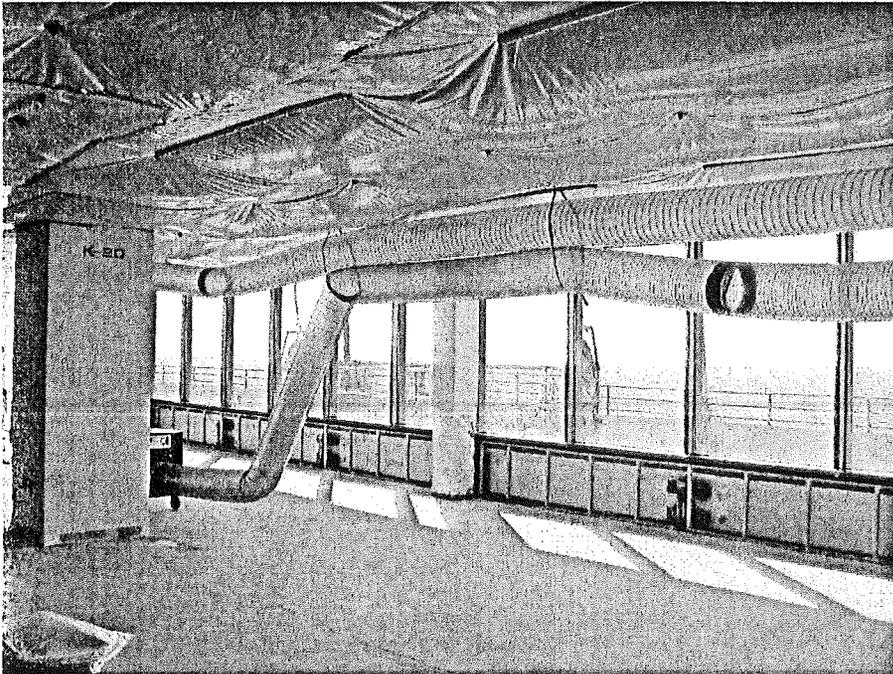
- 8) Wide angle image of 23South containment space indicating ventilation ducting and contained ceiling structures at time of assessment.

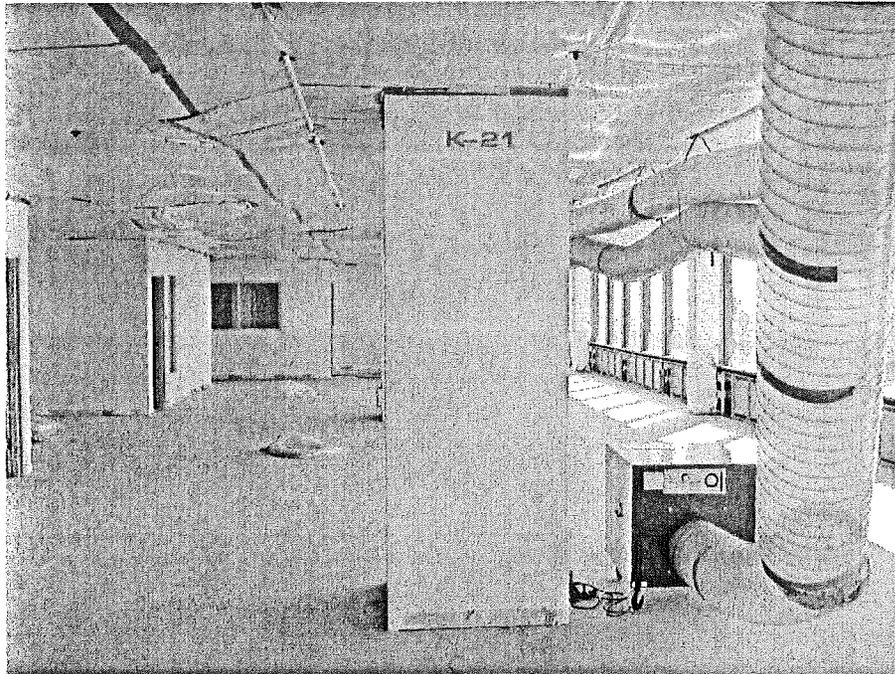
- 9) Additional image of air handling equipment location within 23 south containment area and exposed concrete subflooring present at time of assessment.

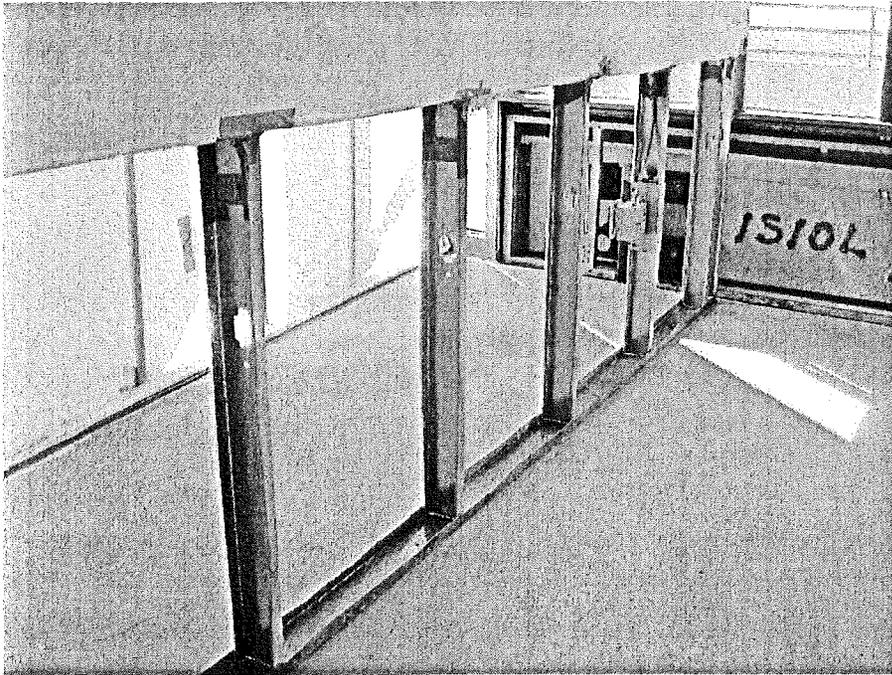
11) Additional image of exposed wall metal framing located at eastern corner of 23 South containment area.

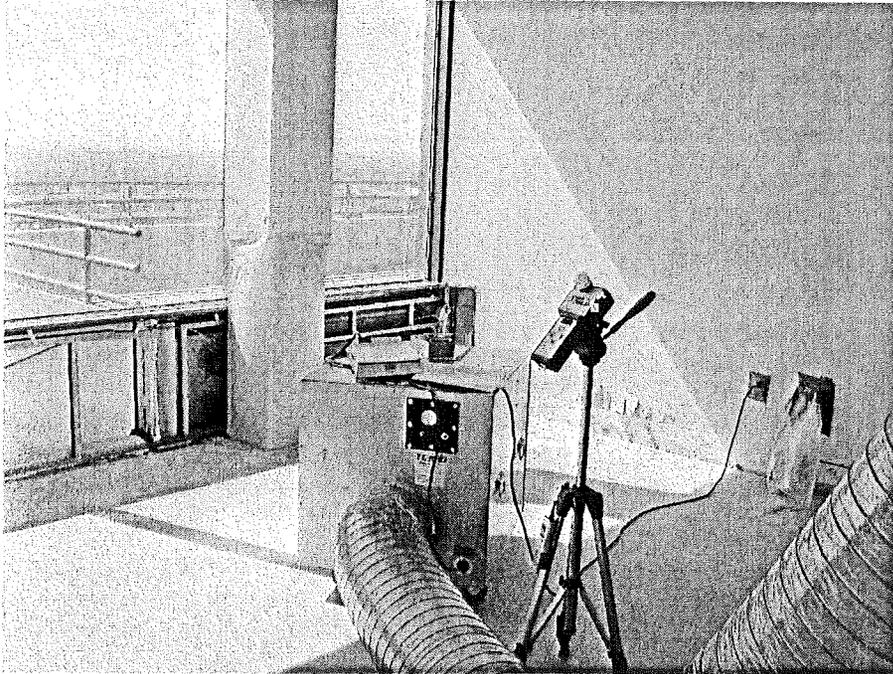
- 3) Image within 23 Eastern containment system indicating location of air sampling devices and air handling equipment at time of assessment.

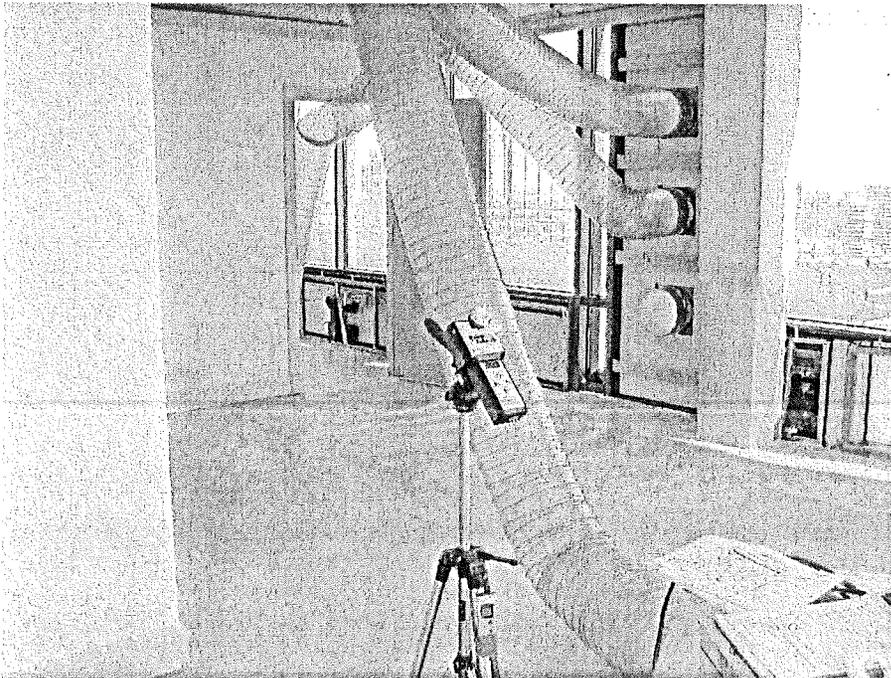
- 4) Additional image of air sampling and air handling equipment within 23 East containment area at time of assessment.

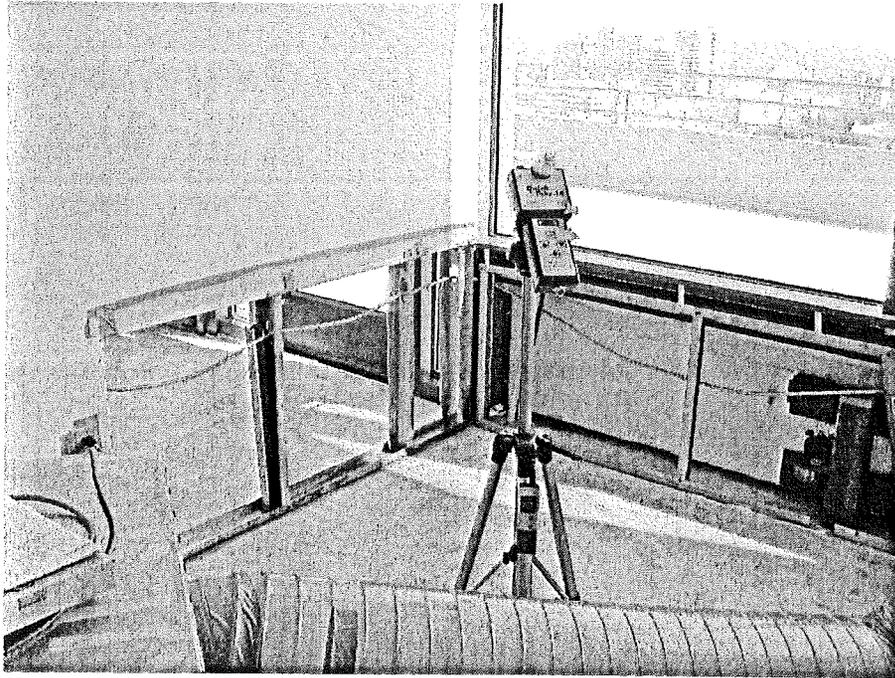
- 5) Image within 23rd Floor east containment area indicating location of air sampling equipment and extent of perimeter and interior wall removal.

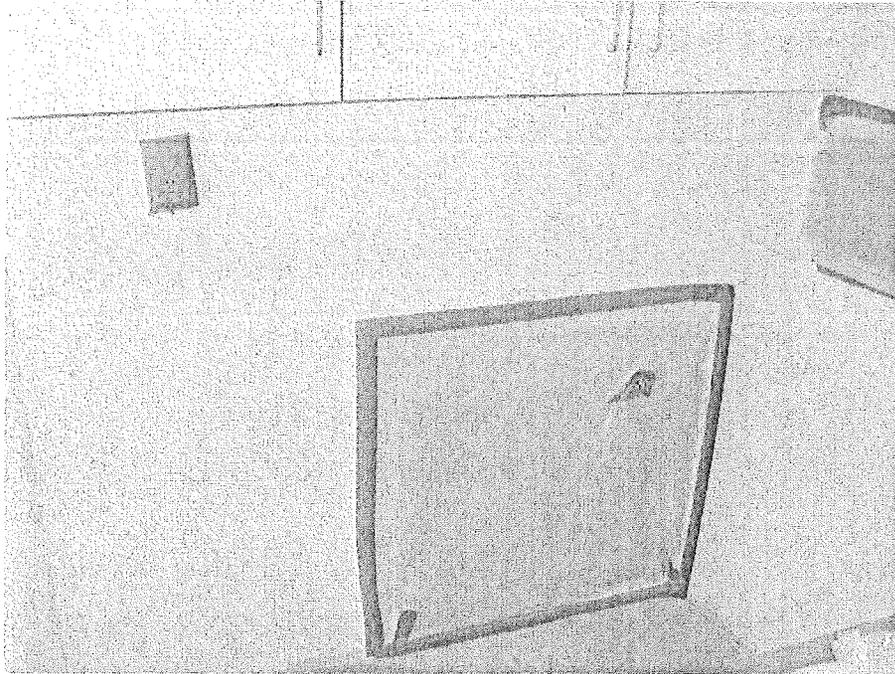
7) Close-up image of mini coffee bar cabinet location indicating wallboard and cabinet removal prior to clearance assessment within 23 East containment area.

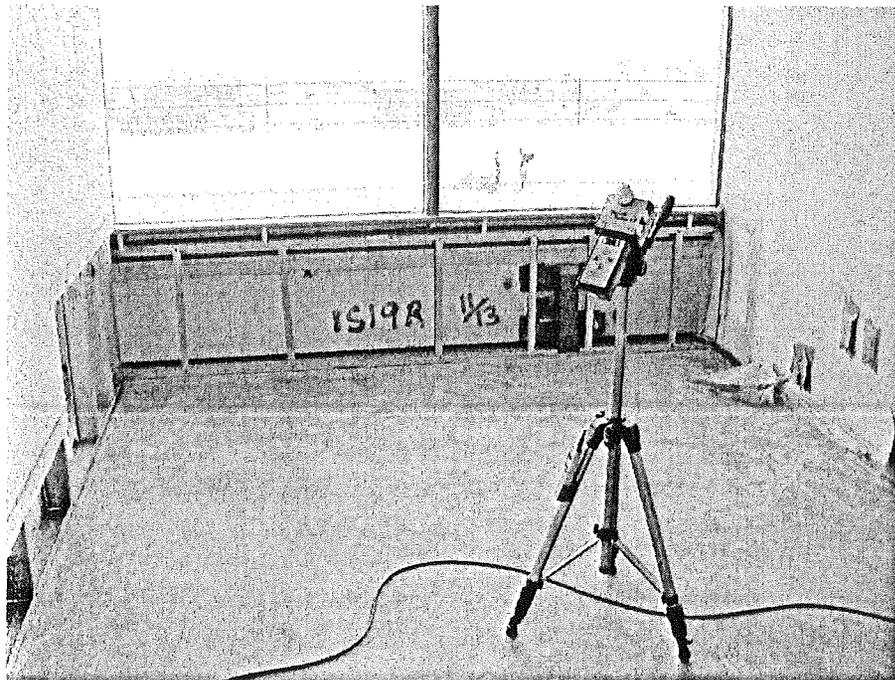
8) Air sampling within 23 East containment perimeter office space indicating extent of exterior and interior wallboard removal.

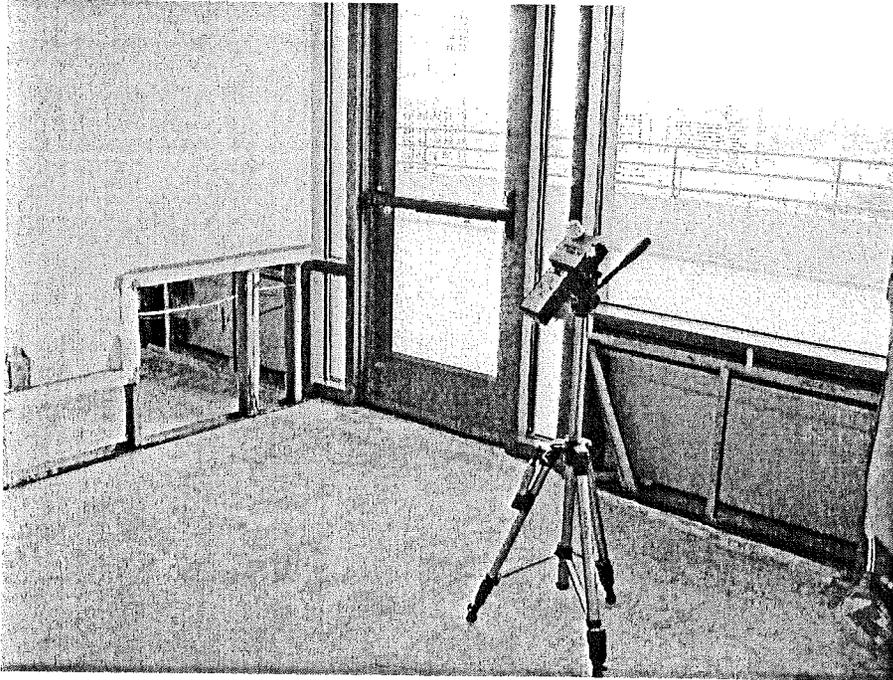
9) Additional image of air handling equipment location within 23 East perimeter office at doorway location.
