# **BioMax Environmental**

**Post Mitigation Assessment Report**  
**Department of General Services Board of Equalization Building**  
**450 N. Street – Break Rooms 704, 143 and Areas 2304 and 23Women’s Restroom**  
**Sacramento, California**

BOE Building Break Rooms 704, 143, Area 2304, and 23WRR Clearances  
Sacramento, CA

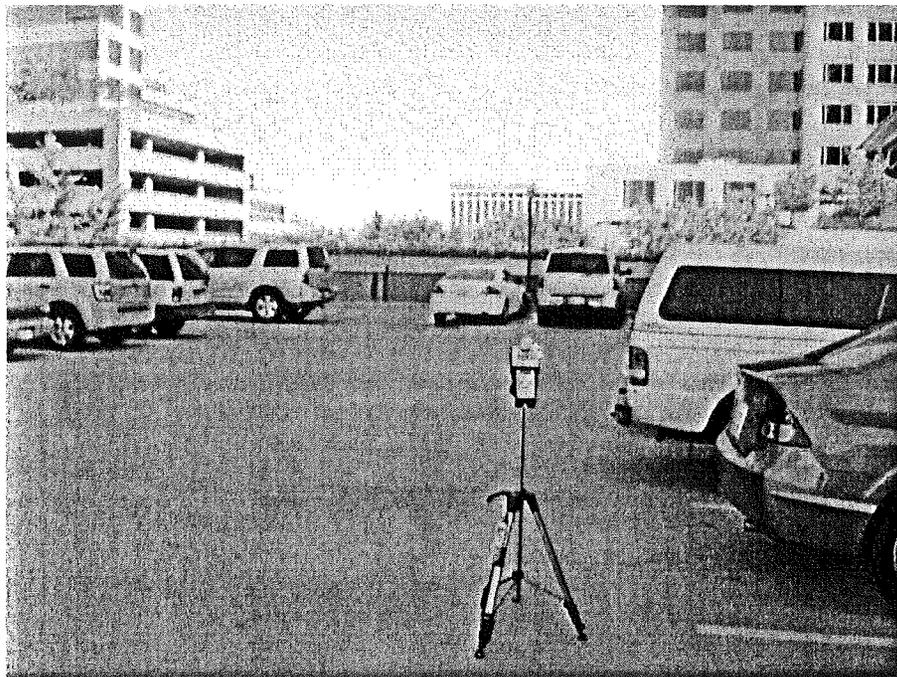
- 1) Image of ambient air sampling location at rooftop of garage structure adjacent to the BOE building (Subject Building) located at 450 N Street, Sacramento.

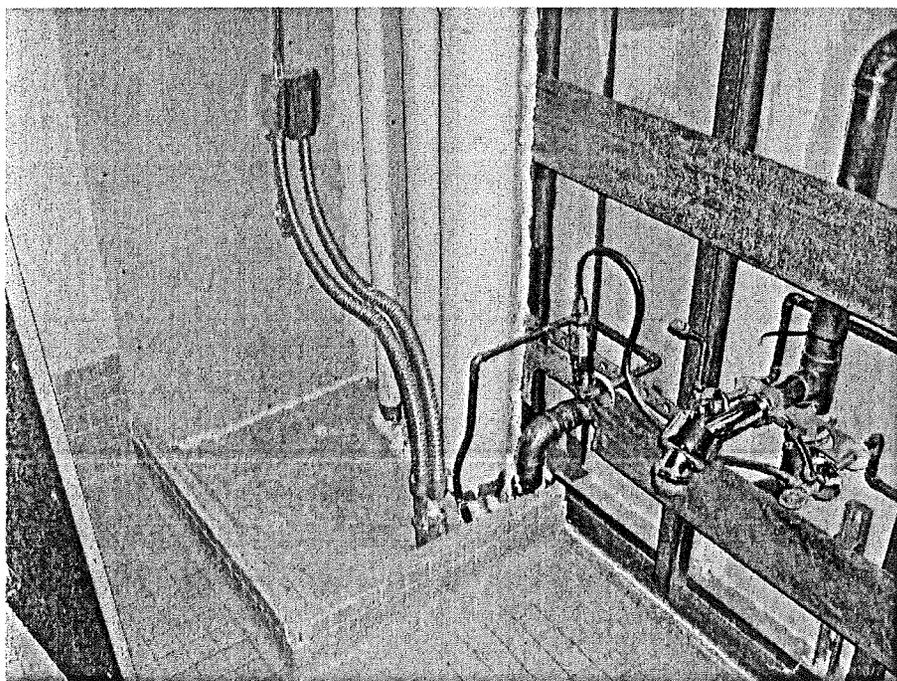
- 2) Image of interior of left side of women's restroom located on 23<sup>rd</sup> floor of subject building at time of assessment.

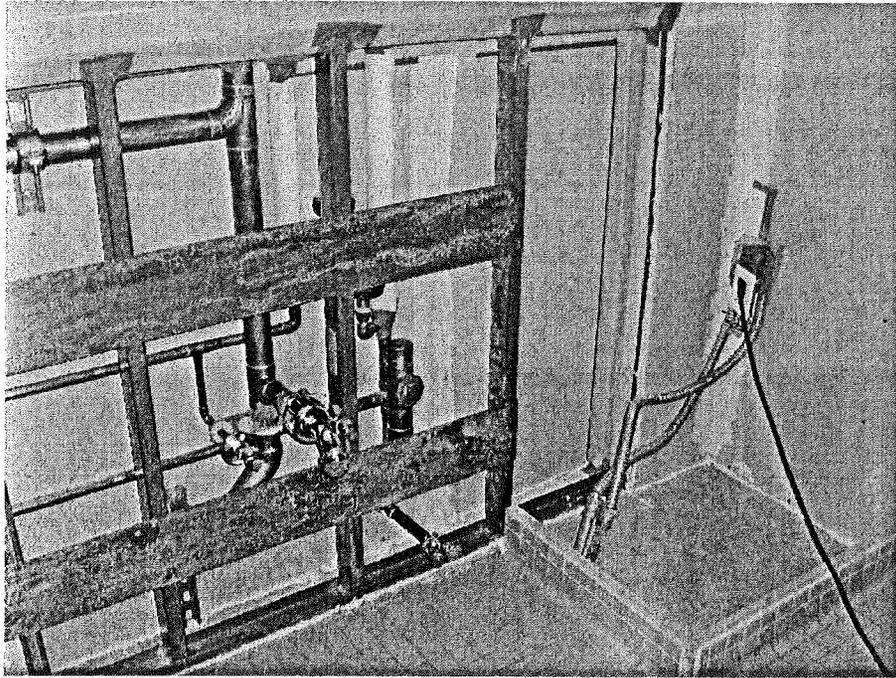
- 3) Image of right side of women's restroom located on 23<sup>rd</sup> floor of subject building at time of assessment.

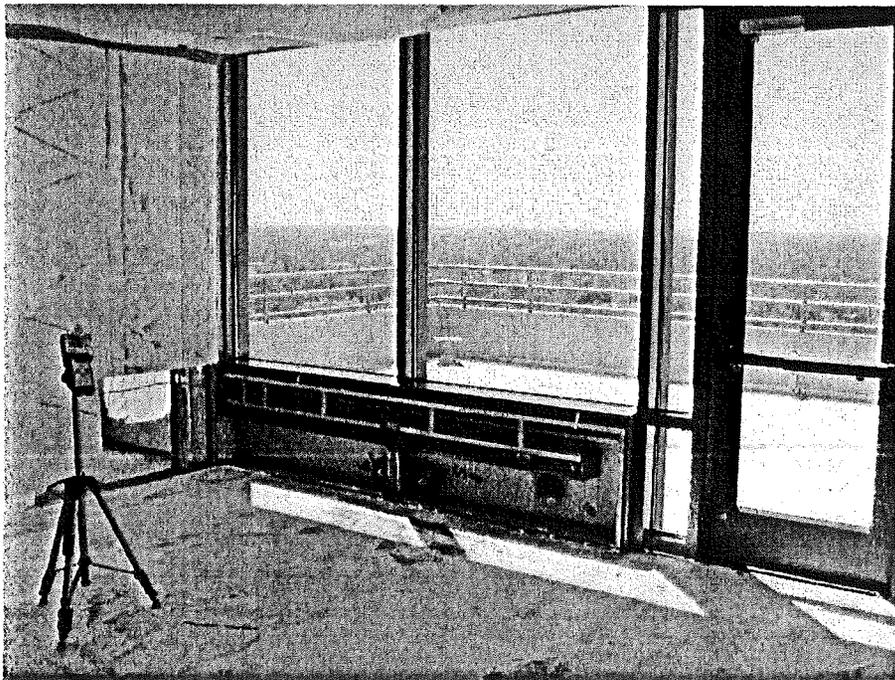
- 4) Image of interior of 2304 containment area ("Edwards Corridor") indicating extent of wall/floor removal and conditions at time of assessment.

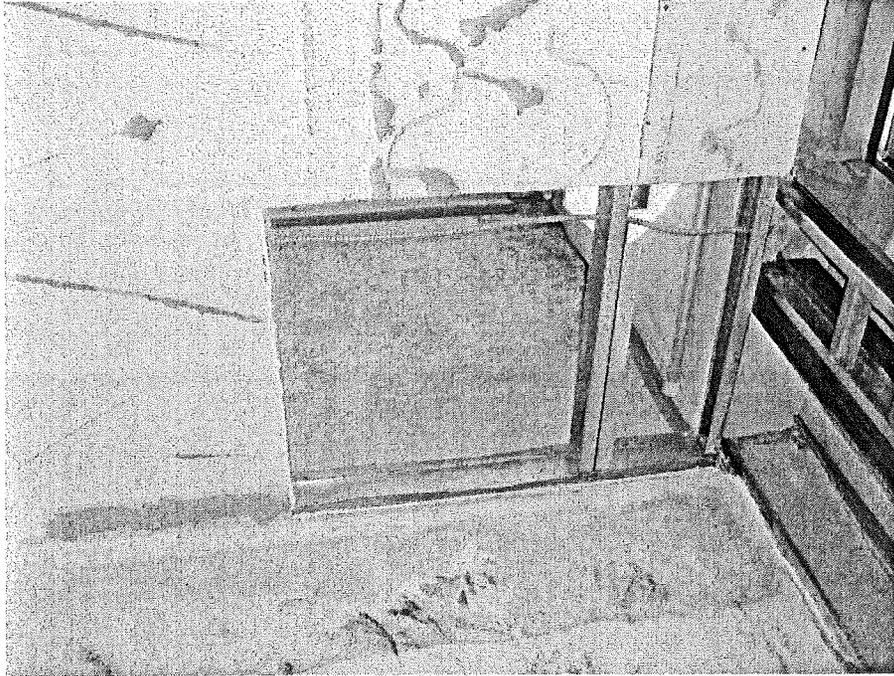
5) Image within containment 2304 indicating interior wall section removal at perimeter wall as removed during mitigative effort.

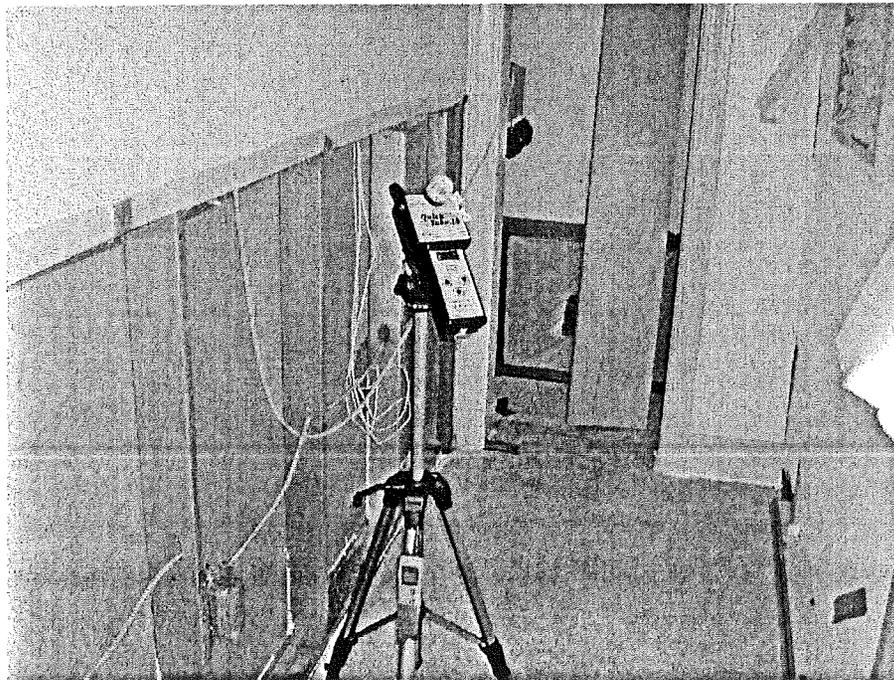
6) Image of air sampling activity performed within room 2339 within same containment and adjacent to Edwards Corridor at time of assessment.

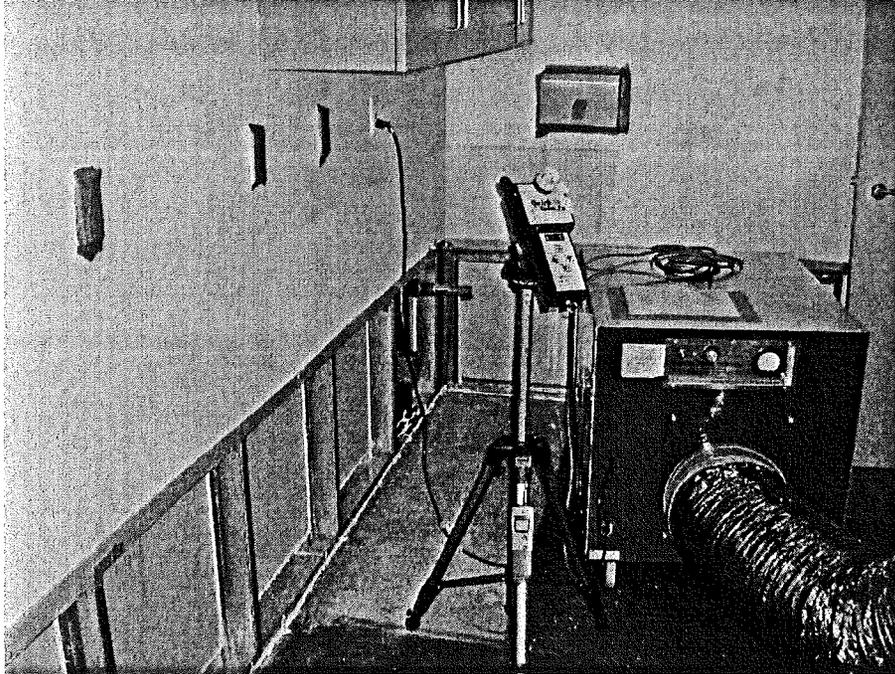
7) Image of air sampling performed within interior of break room containment 704 indicating extent of wallboard removal.

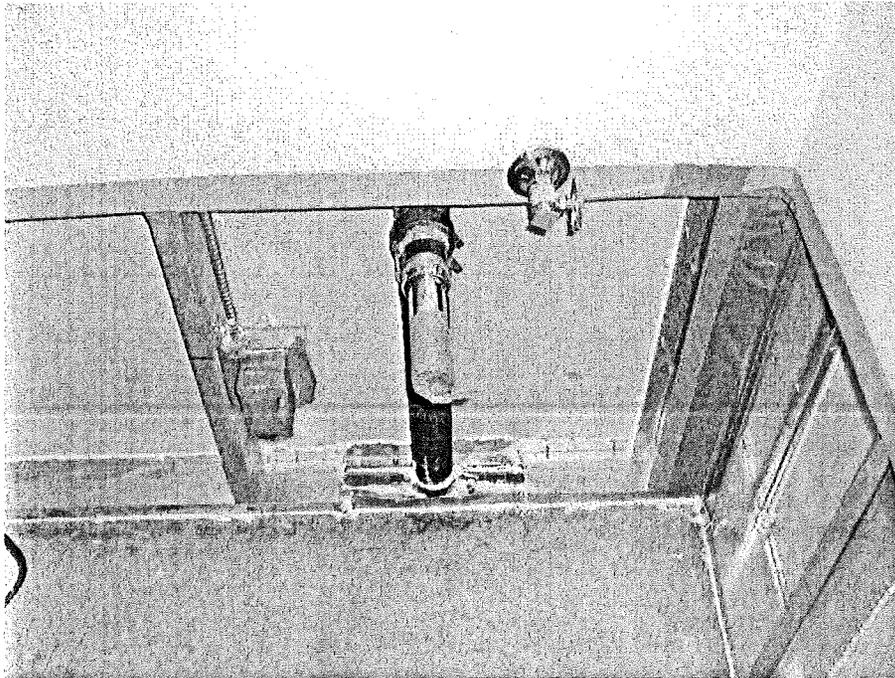
8) Close-up image of plumbing and wall cavity areas at former location of break room cabinetry within 704 at time of post mitigation assessment.

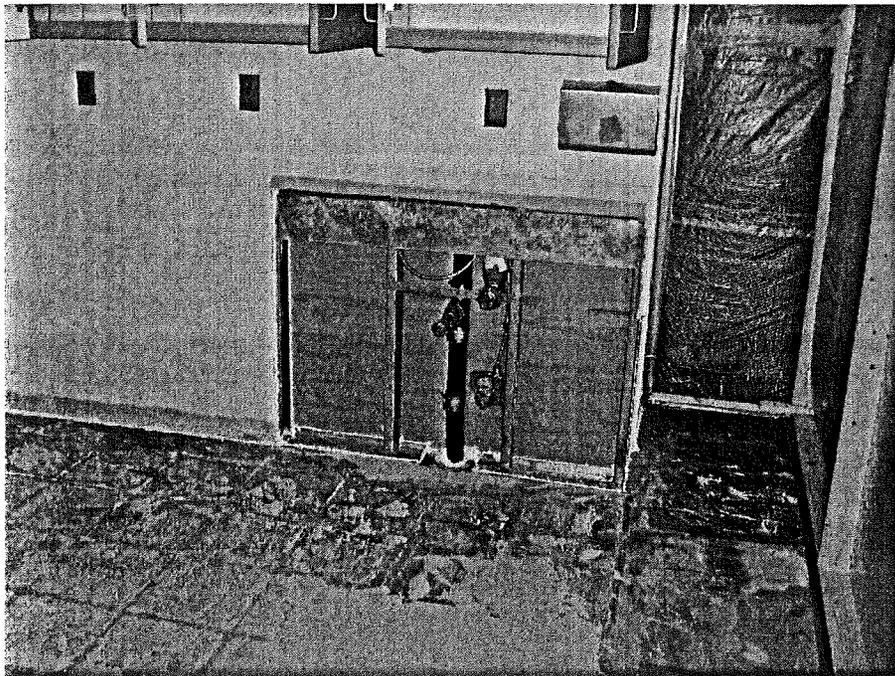
9) Image of interior of break room area 143 at time of assessment. Cabinets were removed and wallboard and concrete slab exposed during mitigative process.

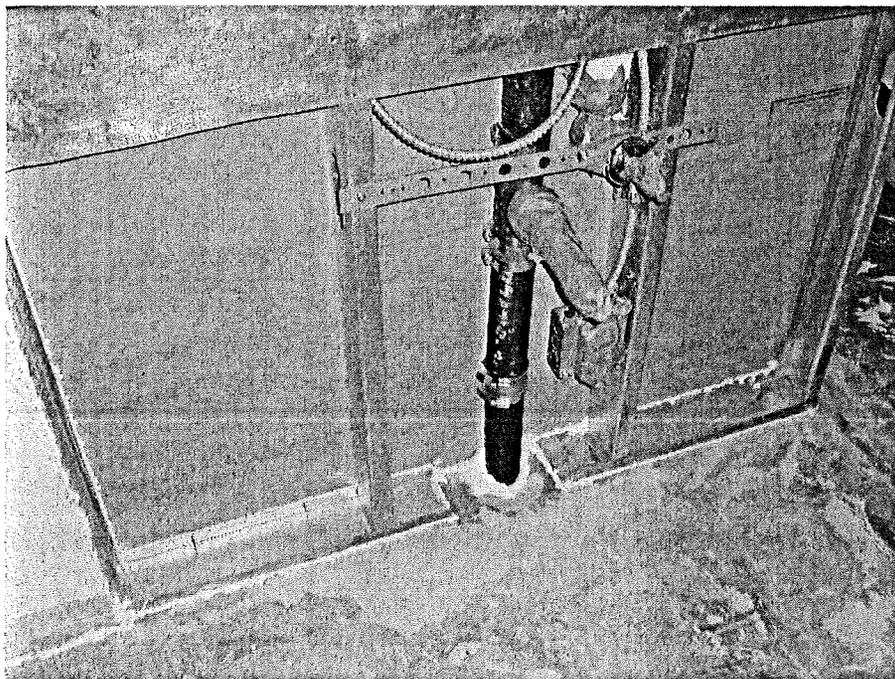
10) Additional image of interior wall plumbing within 143 break room area at time of assessment.

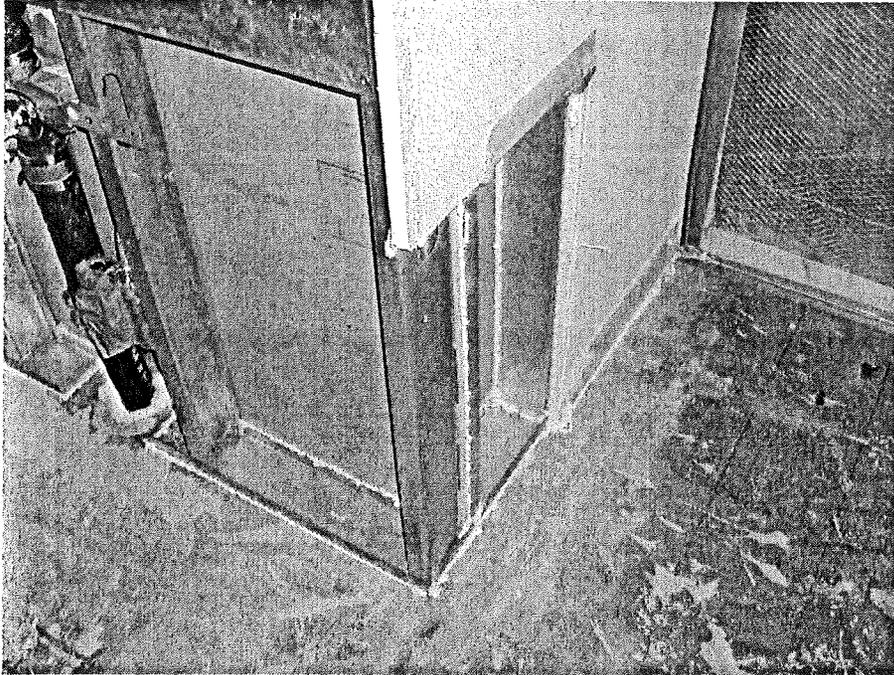
11) Corner view image of wallboard removal extent within break room 143 containment area at time of assessment.

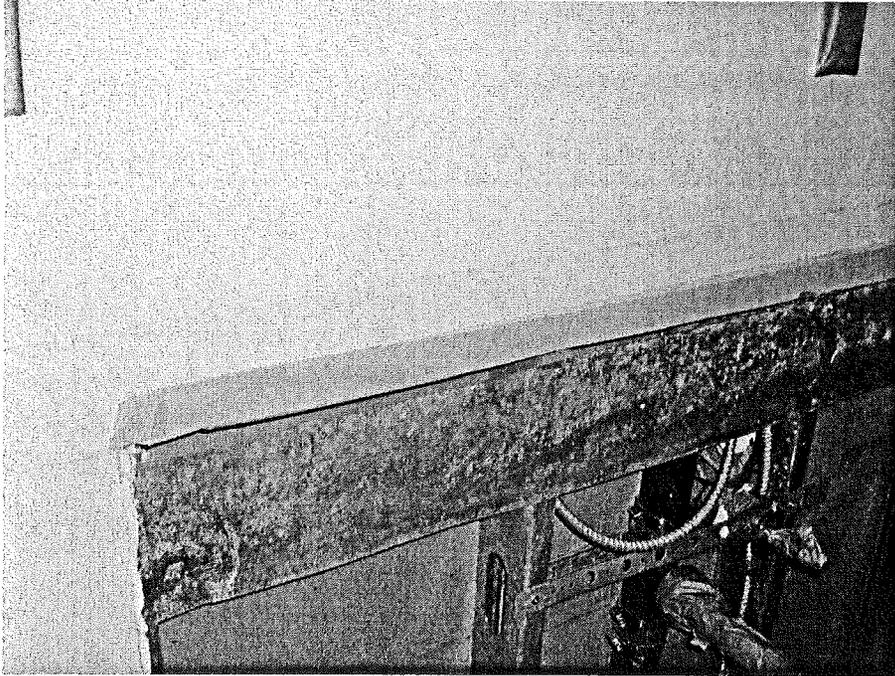
13) Image of metal flashing material remaining within wall cavity at prior cabinetry location. Such material surfaces were sampled by BioMax with sample S02 at time of assessment.

Analytical findings as presented in Table 4 above clearly indicated the presence of unique microbial fragments (spores) present in the metal cabinet framing and exposed concrete floor surface. As a result, BioMax recommends that the mitigation contractor (JLS) apply an encapsulant/sealant product onto these exposed surfaces as an additional precautionary measure.

2. As previously noted in this report, BioMax also sampled and submitted for analysis a series of supplemental surface tape samples collected from "suspect" surfaces of concern identified by BioMax within the break room 143 area. Upon review of the analytical findings, BioMax recommended that JLS apply a sealant/encapsulant product onto the exposed surfaces of the concrete slab as well as wall cavity surfaces as an additional precautionary measure prior to reconstruction. BioMax understands that JLS has performed such activities at this time.

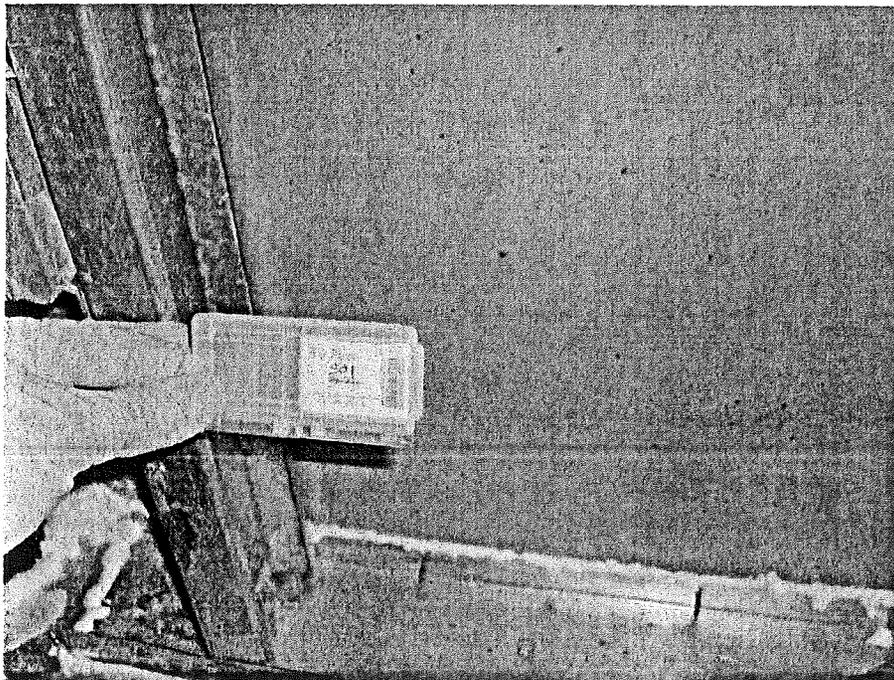
14) Image of surface sample S01 collected from wall cavity paper surface leading to adjacent bathroom area as accessed through cabinet wall space.

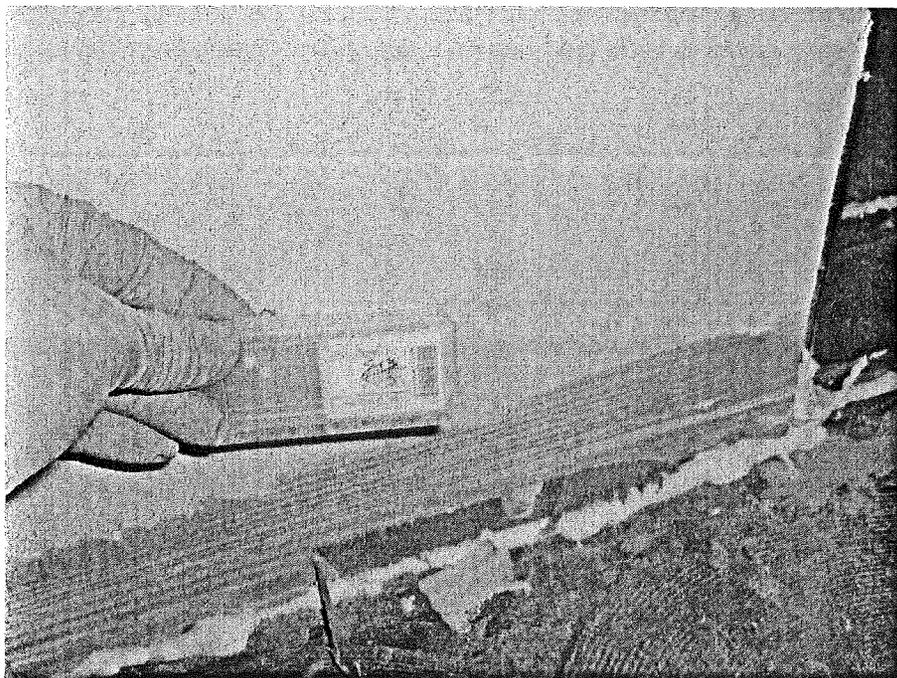
15) Image of surface sample S03 collected from exposed wall surface to left of cabinet material at baseboard level.

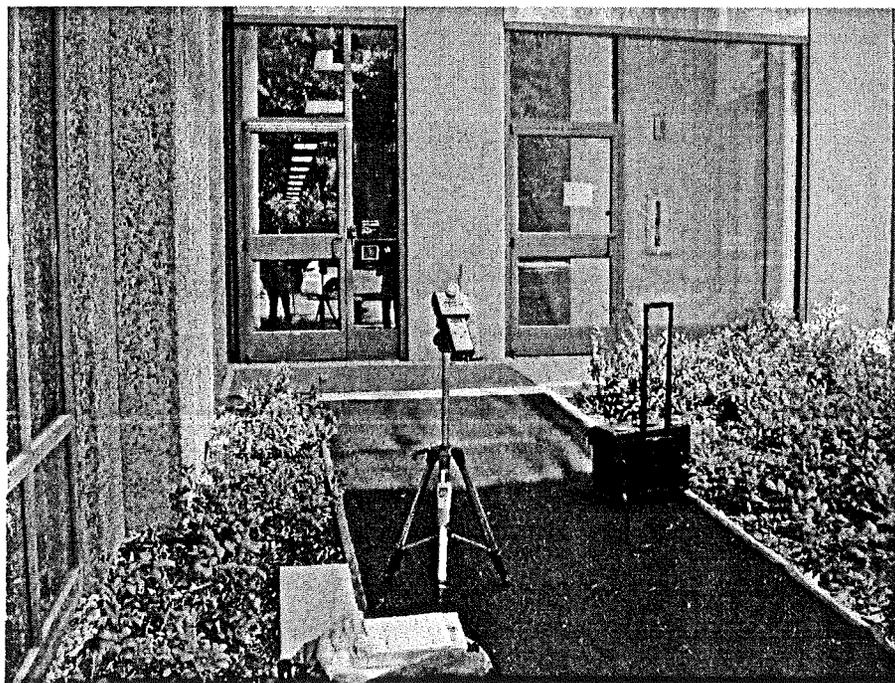
16) Ambient air sampling location to east side entrance of subject building following the collection of interior air samples.
