PROJECT
STATE OF CALIFORNIA, DGS
BOE ASSESSMENT

DESCRIPTION
WATER DAMAGE
SURVEY

LOCATION
23RD FLOOR

SHT NO. SHT NAME
23 A23

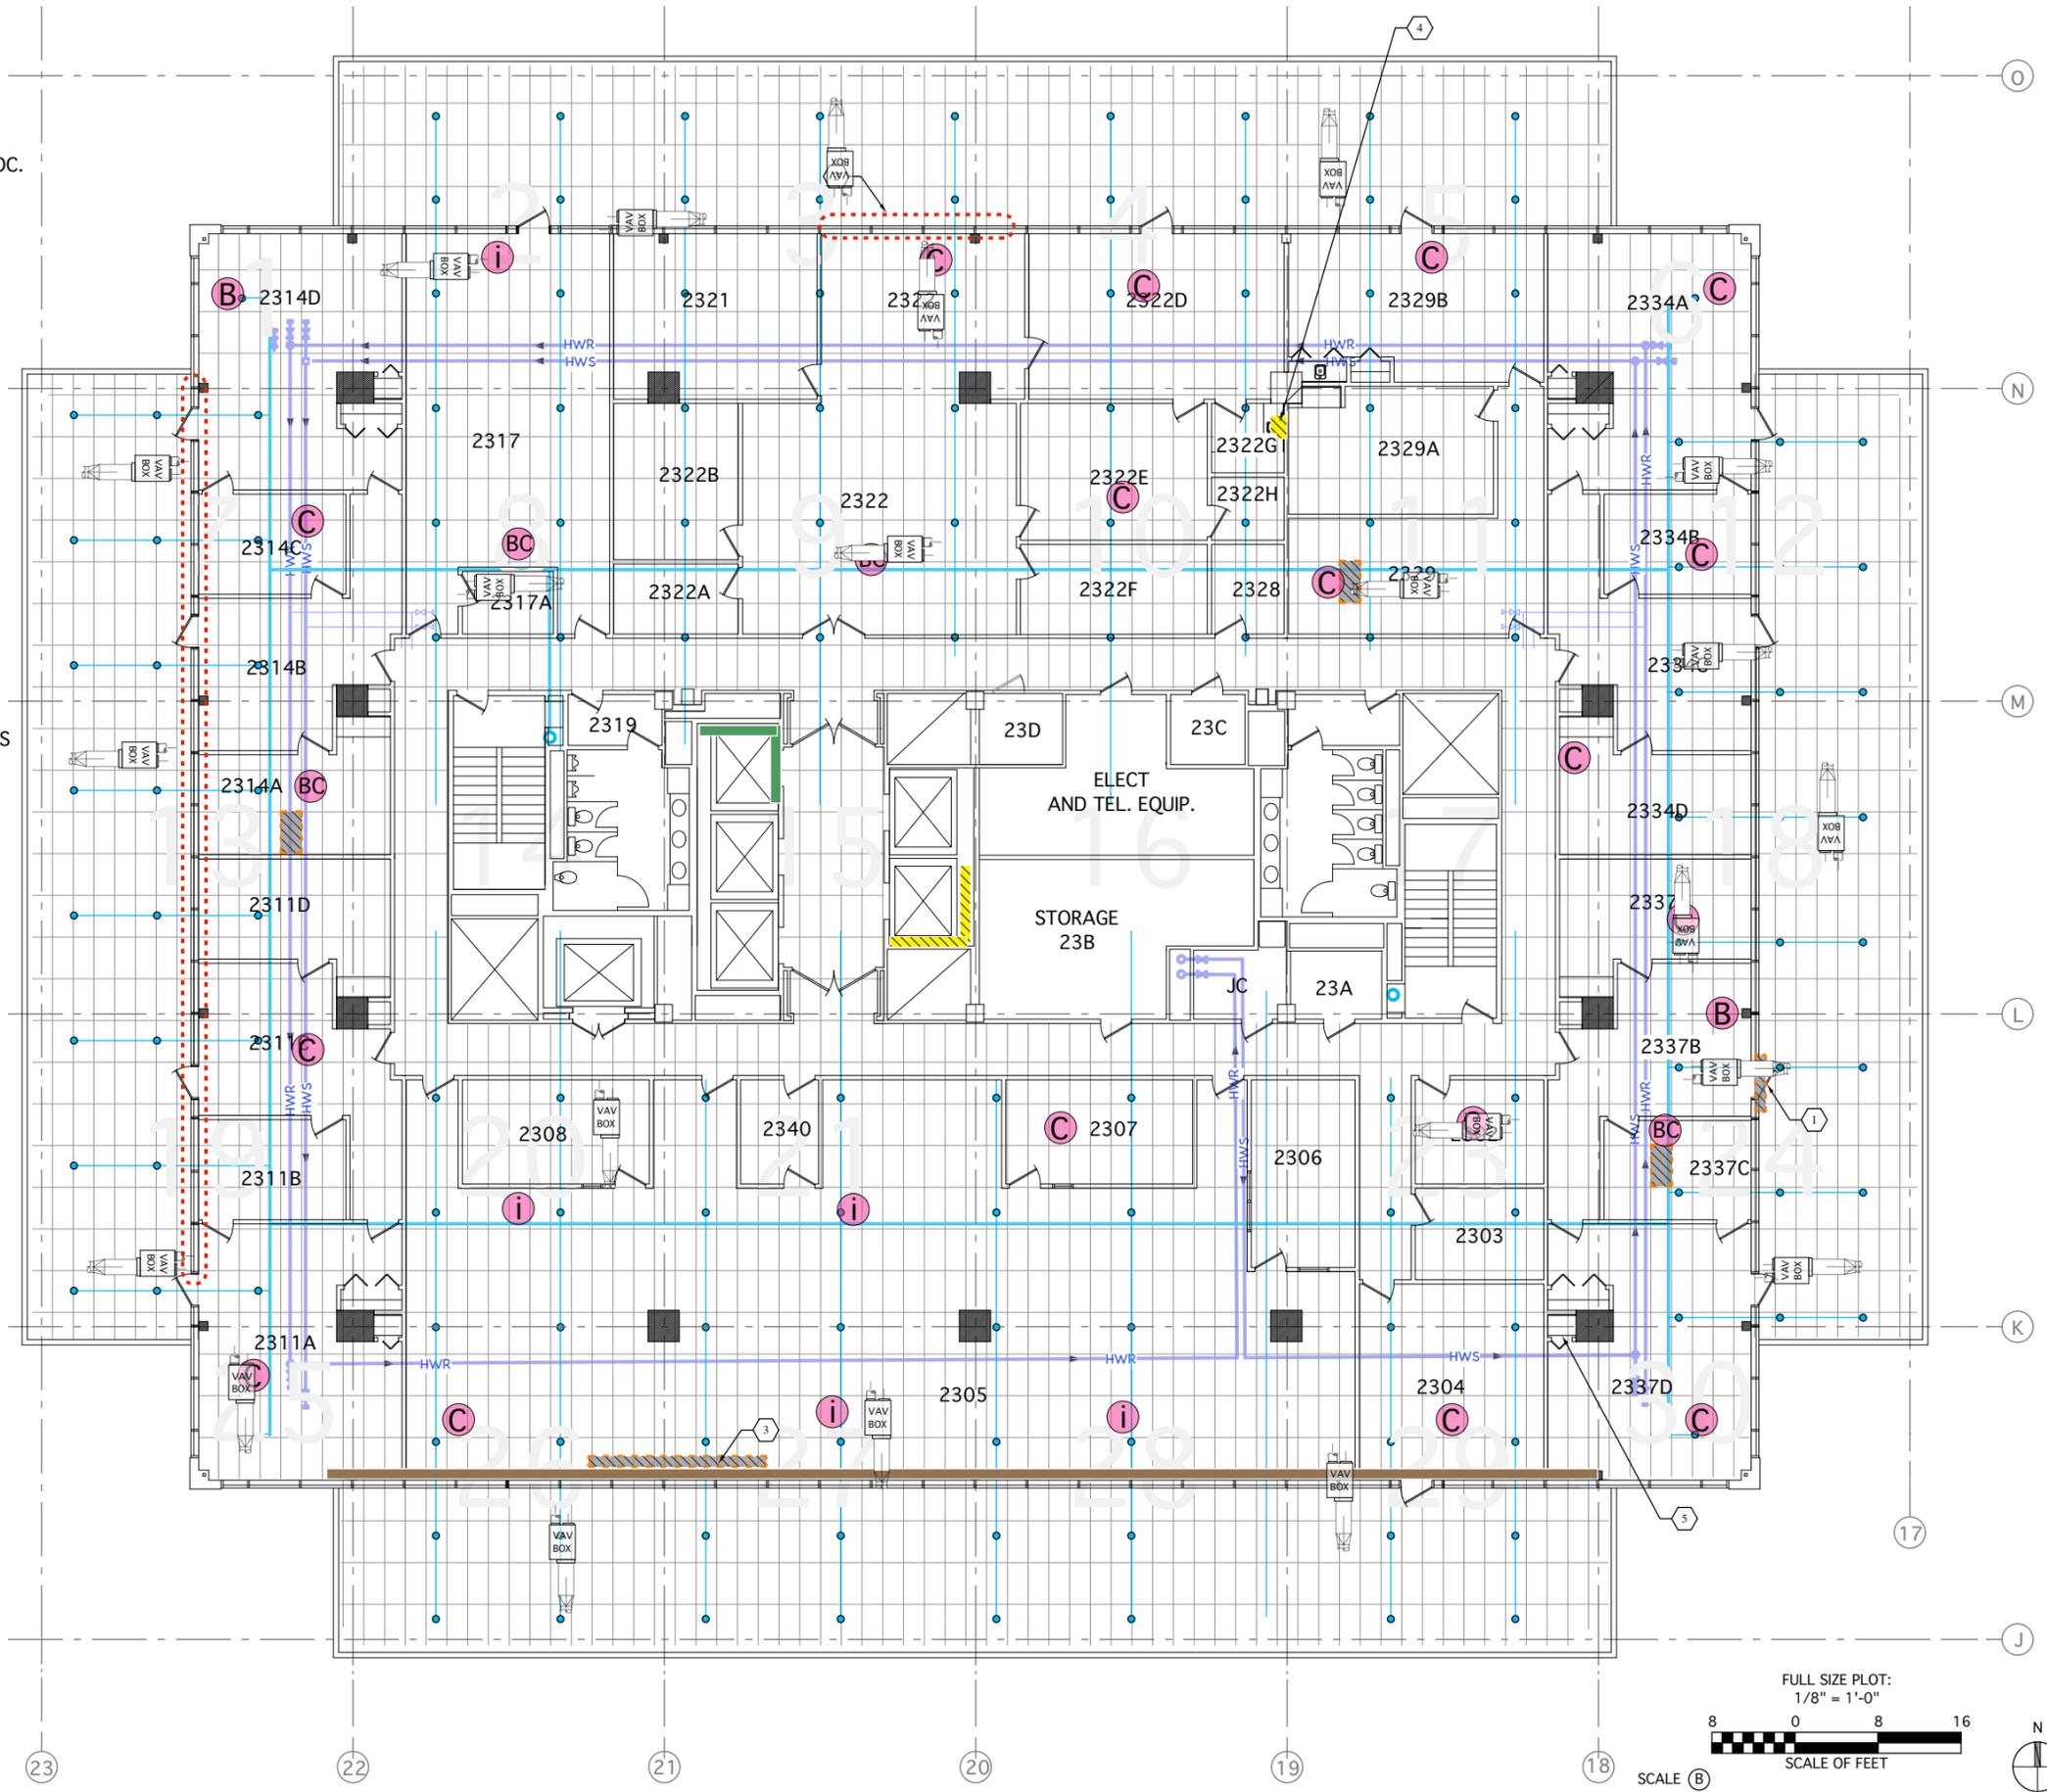
- ① K.6/17.5 BALC. DOOR LEAK
- ② N.5/20 AND L/22.5 DESTRUCT. TESTG LOC.
- ③ J.5/21 WINDOW SEAL LEAK
- ④ WATER STAINED TILE AT SPRKLR HEAD
- ⑤ DAMAGED PAINT FROM SINK (CURRENT)
- ⑥
