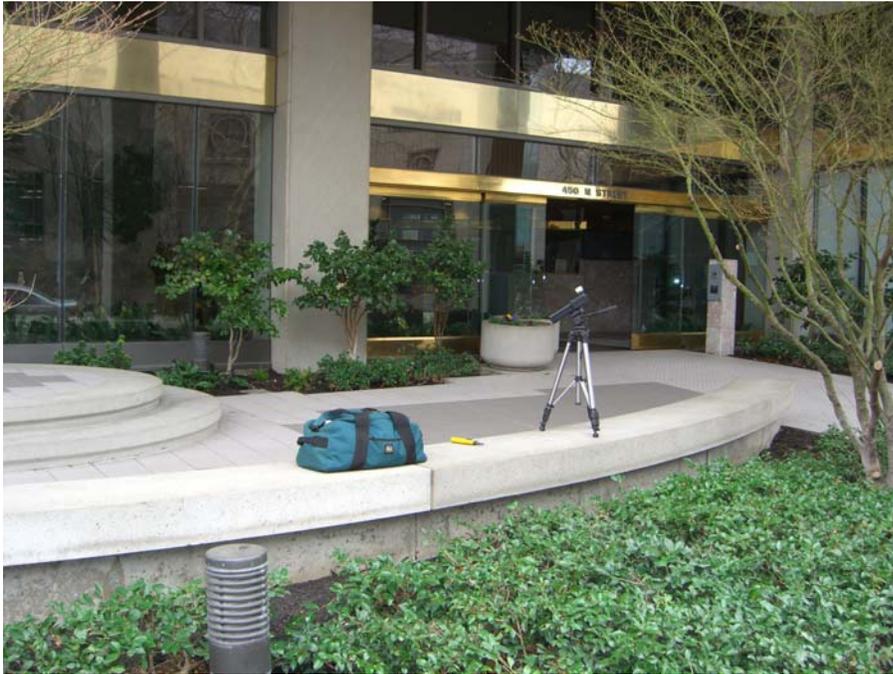
- 1) Image of ambient air sampling location at front entry of BOE Building (Subject Building) located at 450 N Street, Sacramento, California at time of assessment.

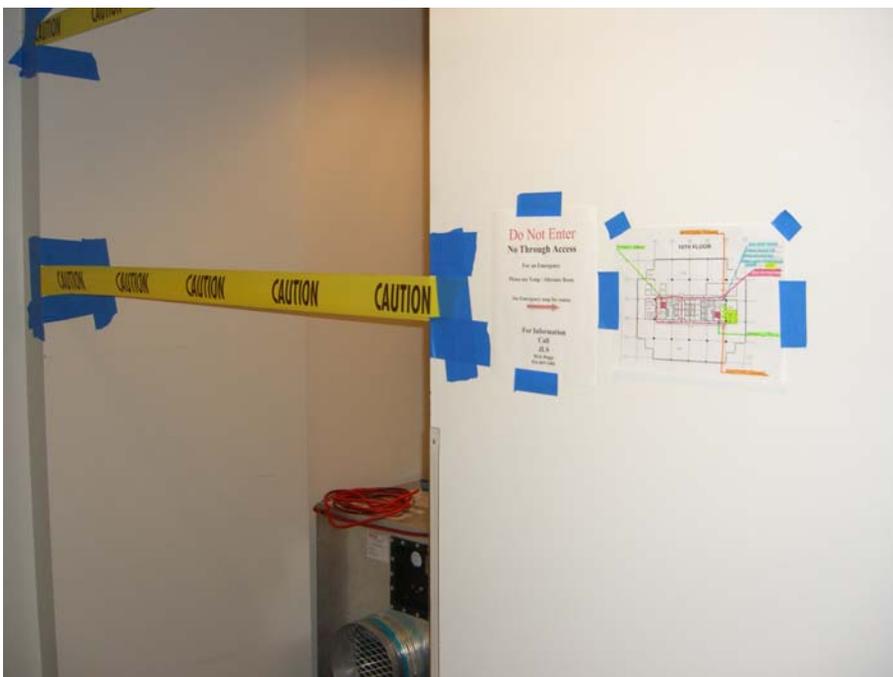
- 2) Image of postings and alternate routing directions for BOE employees at hallway leading to break room containment on the 10<sup>th</sup> floor.

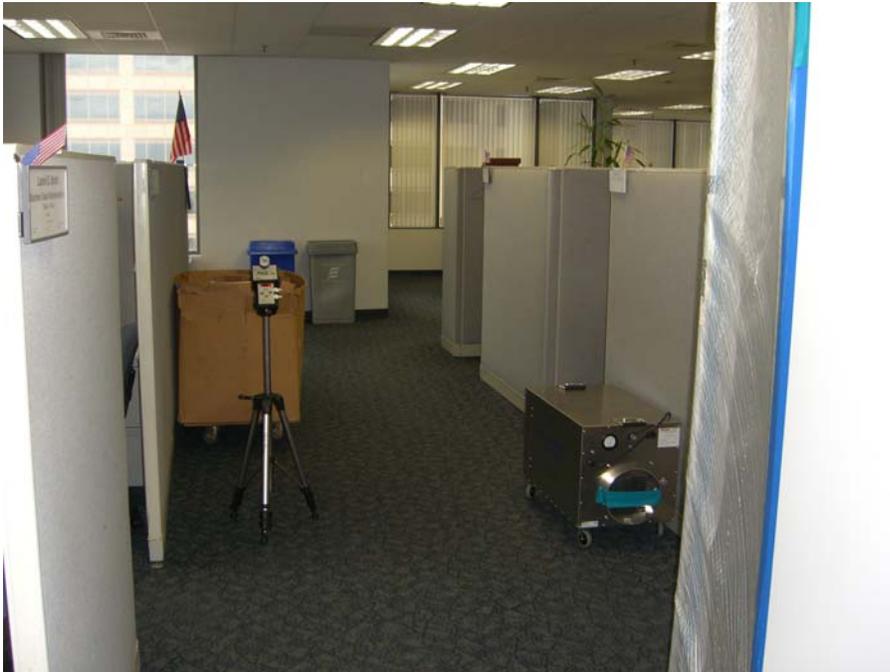
- 3) Image of cubicle work area located outside the established containment system where air sampling equipment is observed present in the foreground at time of assessment.

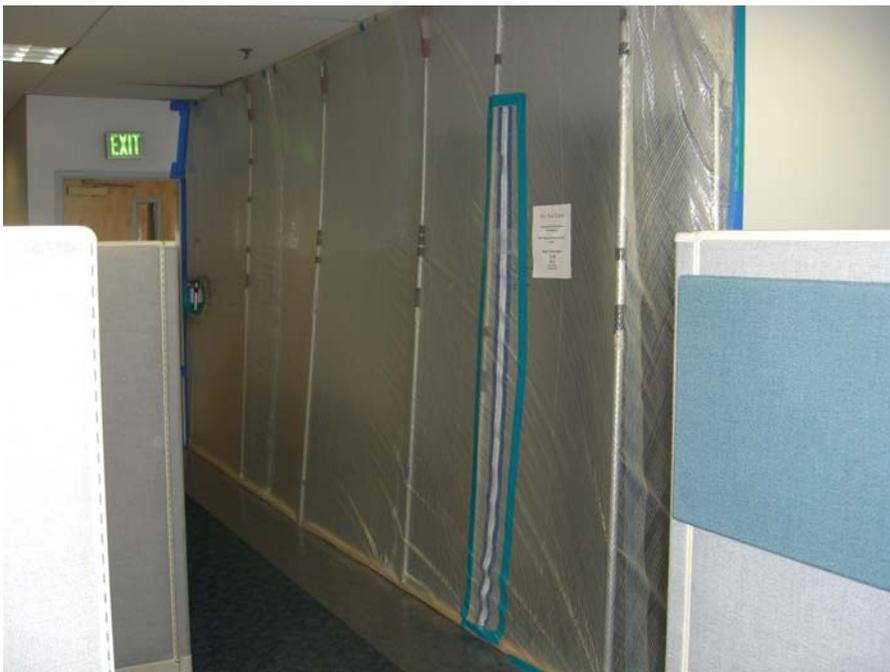
- 4) Image of hallway air sampling location adjacent to Break Room as viewed from 1014 cubicle area (outside containment) at time of assessment.

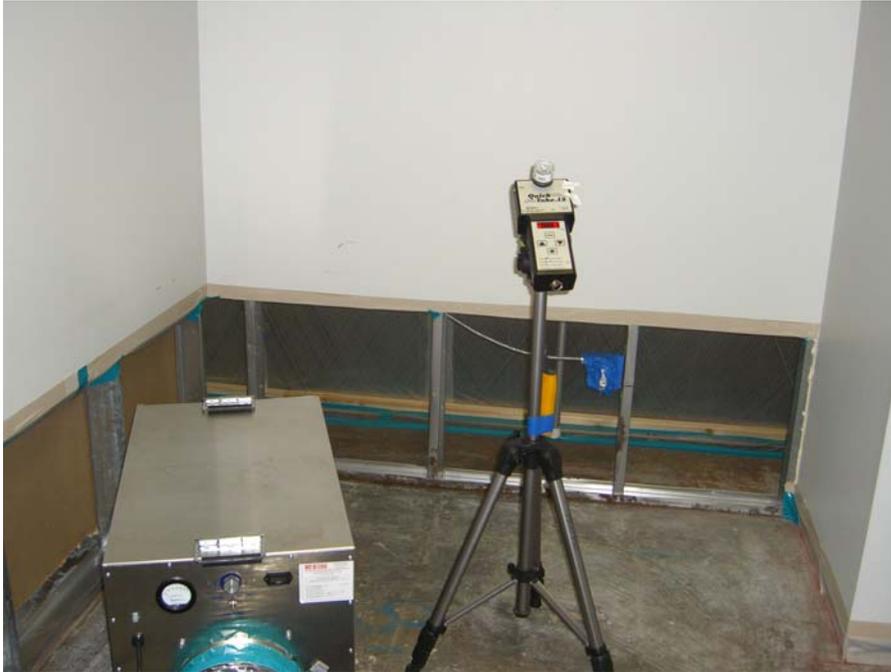
- 5) Image within 10<sup>th</sup> Floor break room containment 2424 containment indicating location of air sampling equipment and extent of removal of cabinetry and wallboard materials.

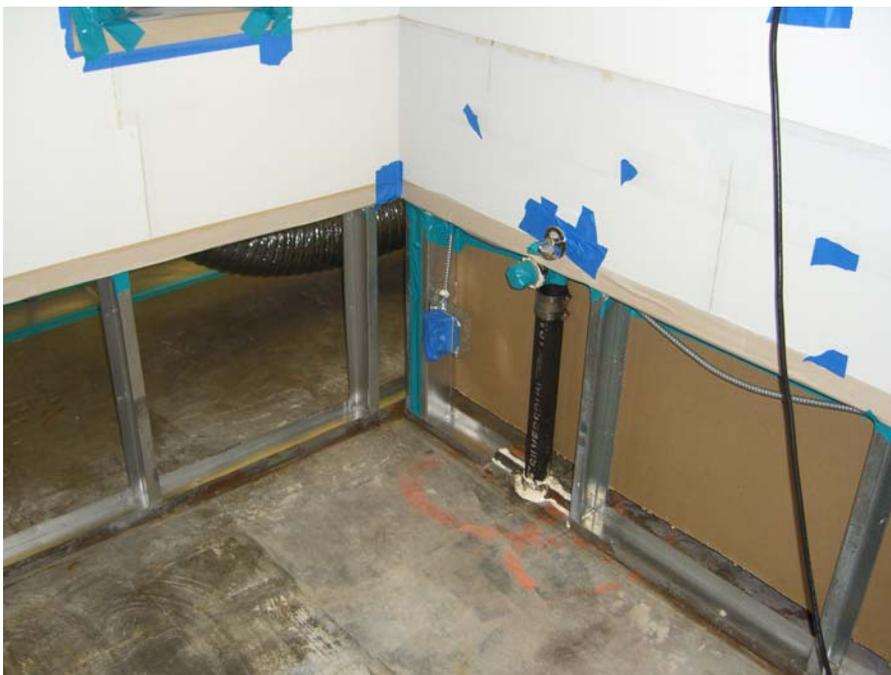
- 6) Additional image within Break Room containment area viewing corner where previous cabinetry had existed prior top removal.

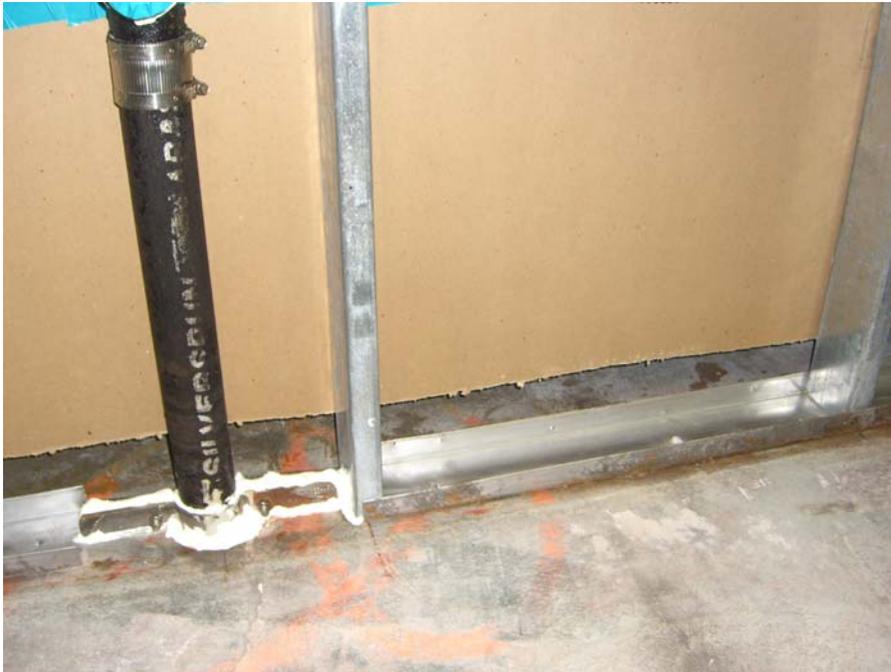
- 7) Close-up image within Break Room containment showing plumbing detail and wall space cavity following physical removal of damaged materials.

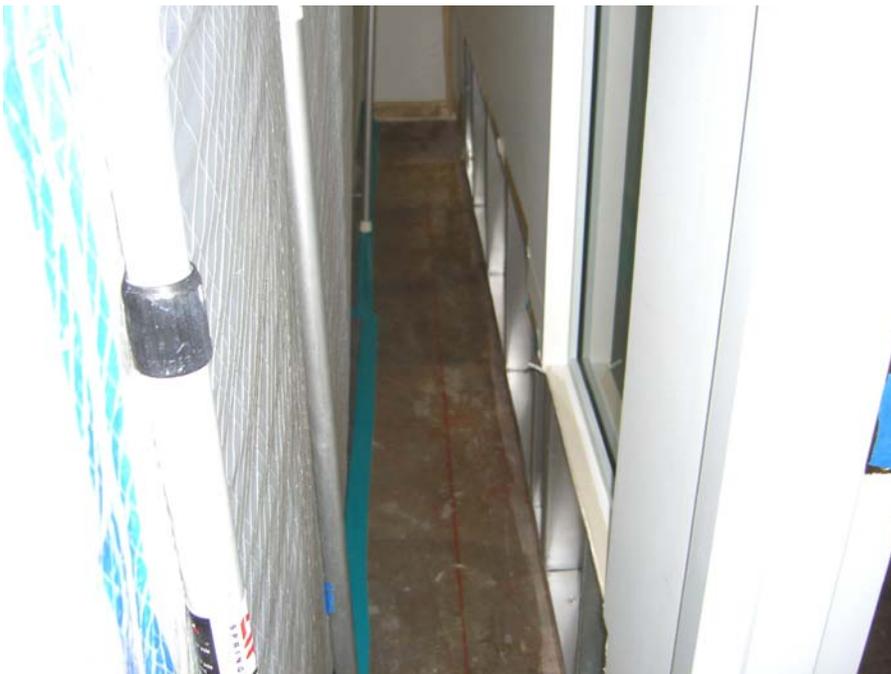
- 8) Image of containment space located along north facing hallway adjacent to break room and office area.

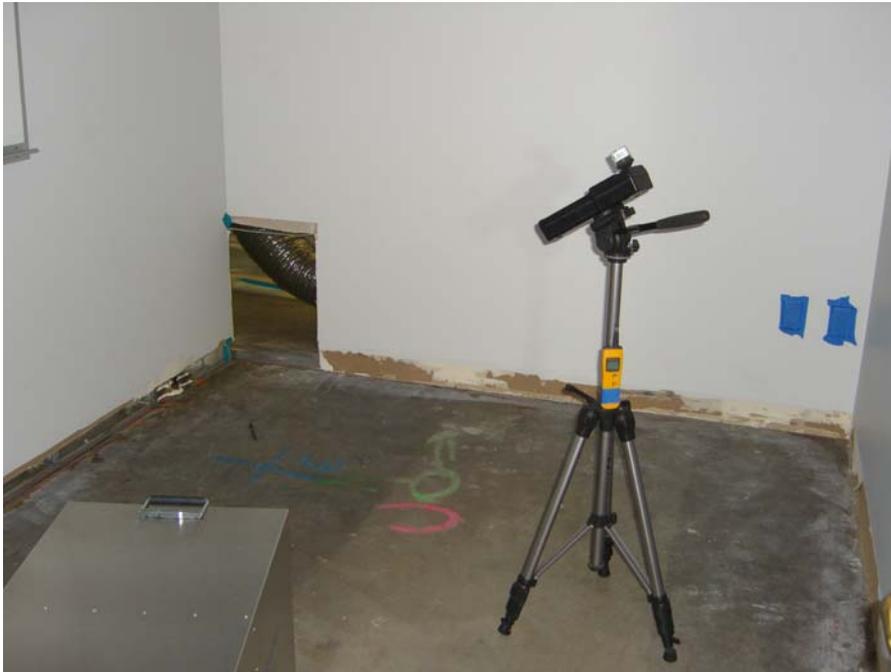
9) Image of air sampling equipment location within office (1003) inside containment adjacent to break room at time of assessment.

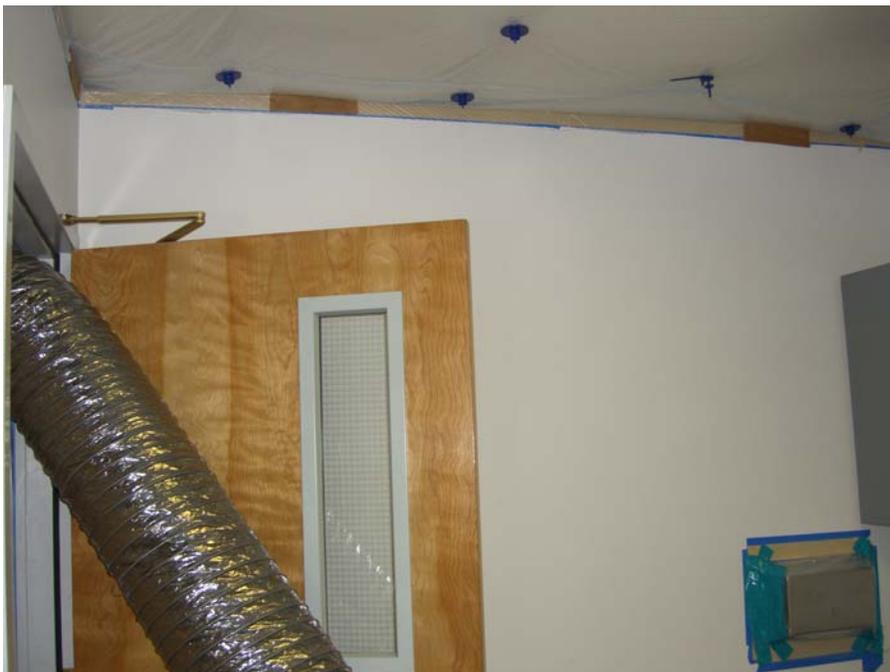
10) Image within break room containment area showing establishment of ceiling barrier and negative air exhaust ducting onto hallway.
