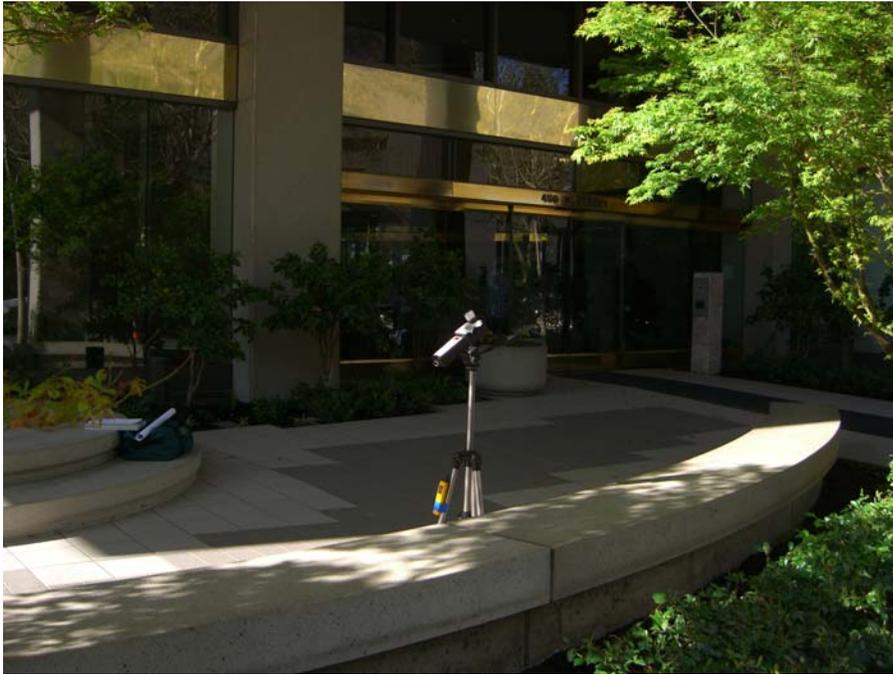
- 1) Image of ambient air sampling location at front entry of BOE Building (Subject Building) located at 450 N Street, Sacramento, California at time of assessment.

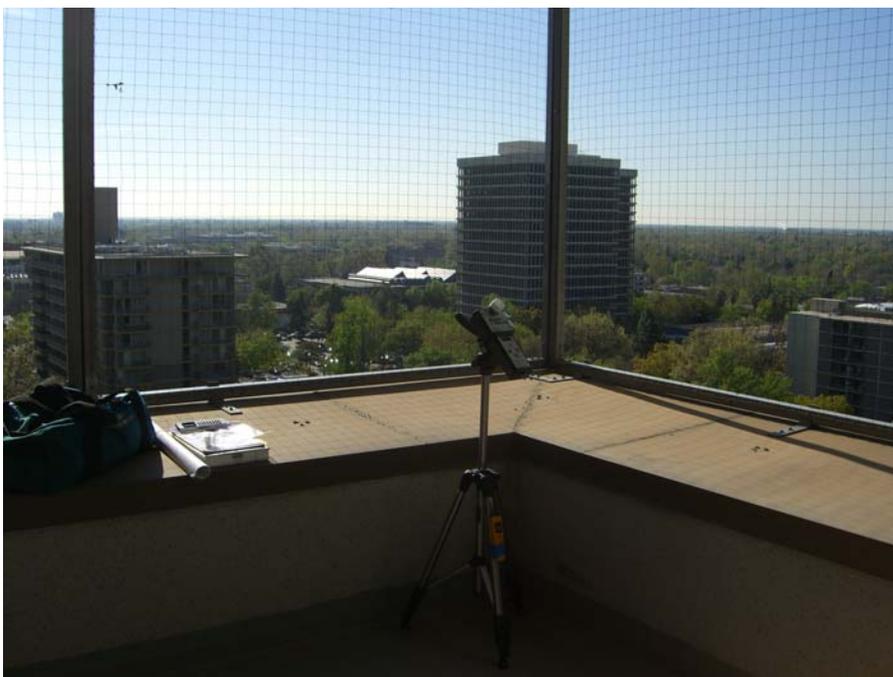
- 2) Image of ambient air sampling location on 12th Floor southeast deck area at time of assessment.

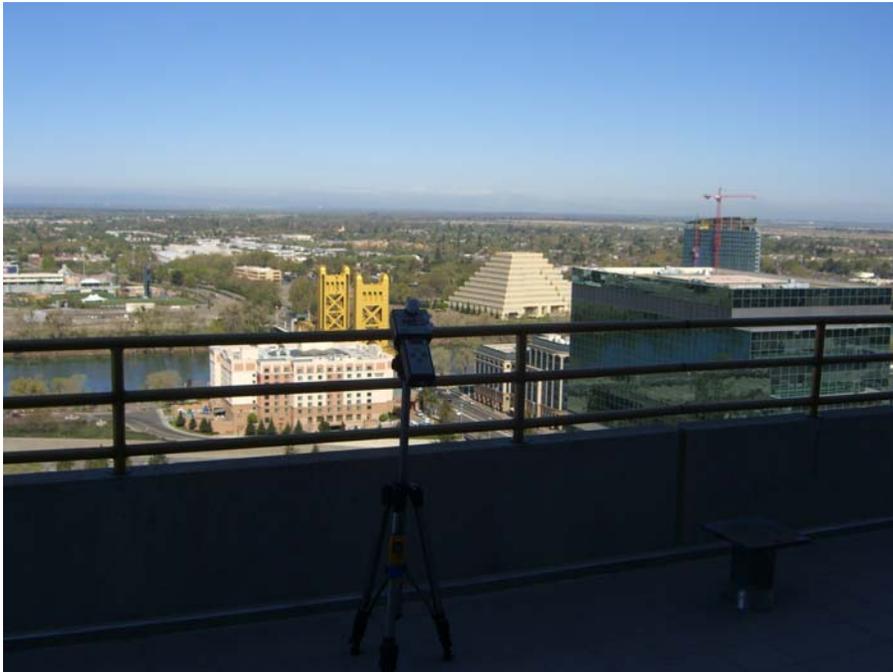
3) Image of ambient air sampling location on 23rd floor western deck area at time of assessment.

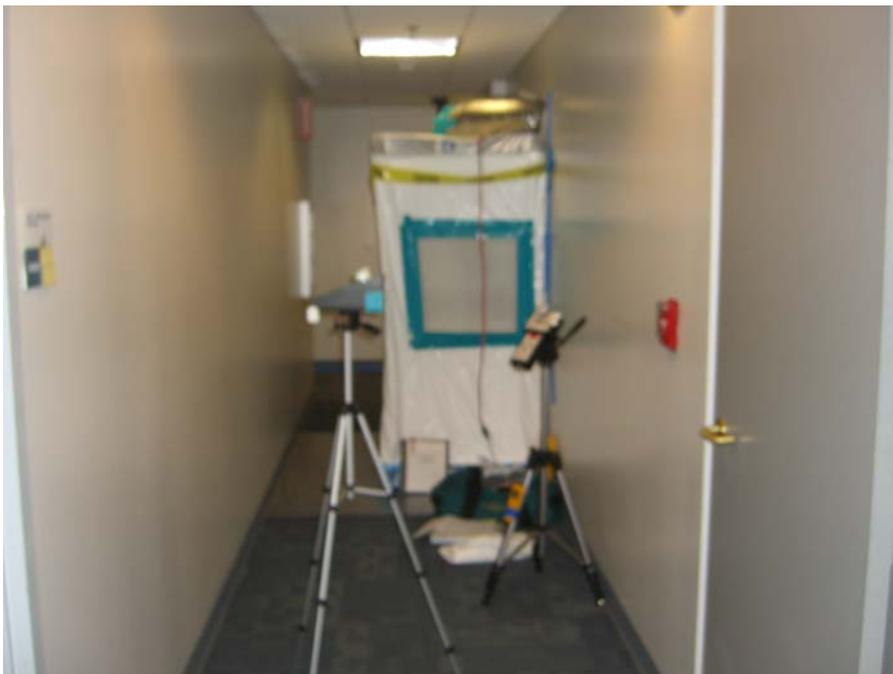
4) Image of hallway air sampling location adjacent to Room 2424 containment (outside containment) at time of assessment.

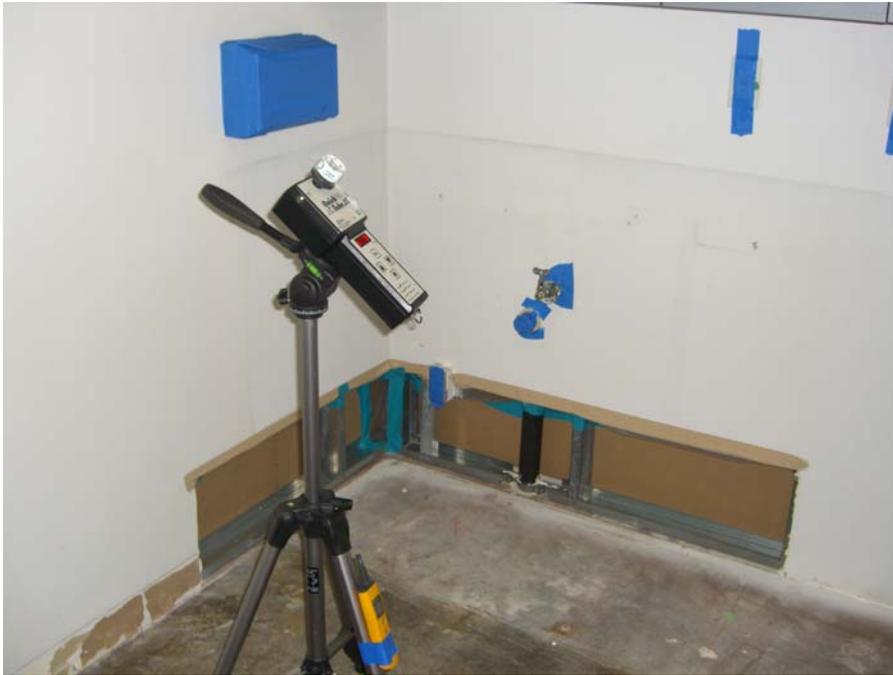
- 5) Image within 2424 containment indicating location of air sampling equipment and removal of cabinetry and wallboard materials.

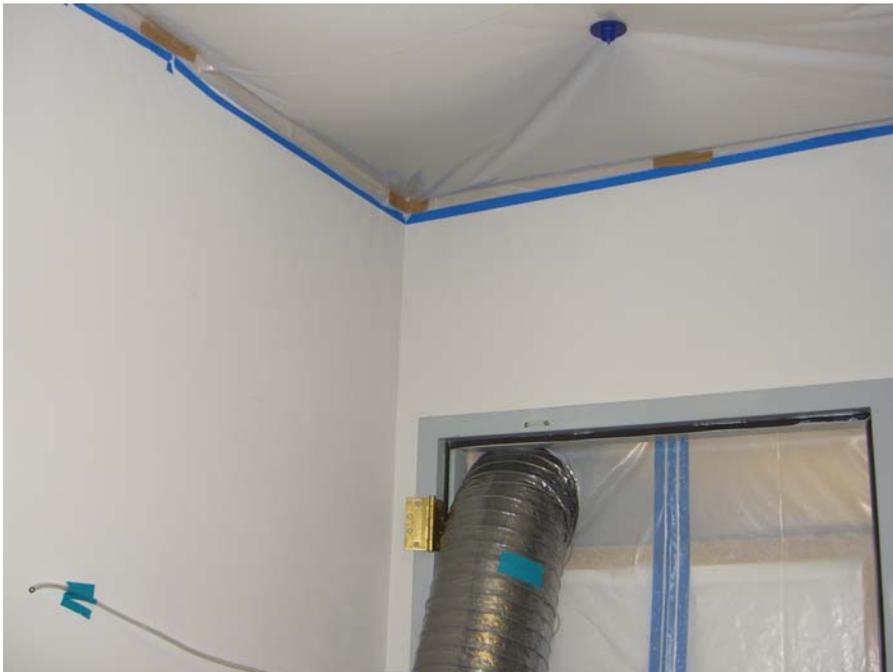
- 6) Image within 2424 containment viewing ceiling containment and exhaust ventilation at entry/exit chamber doorway.

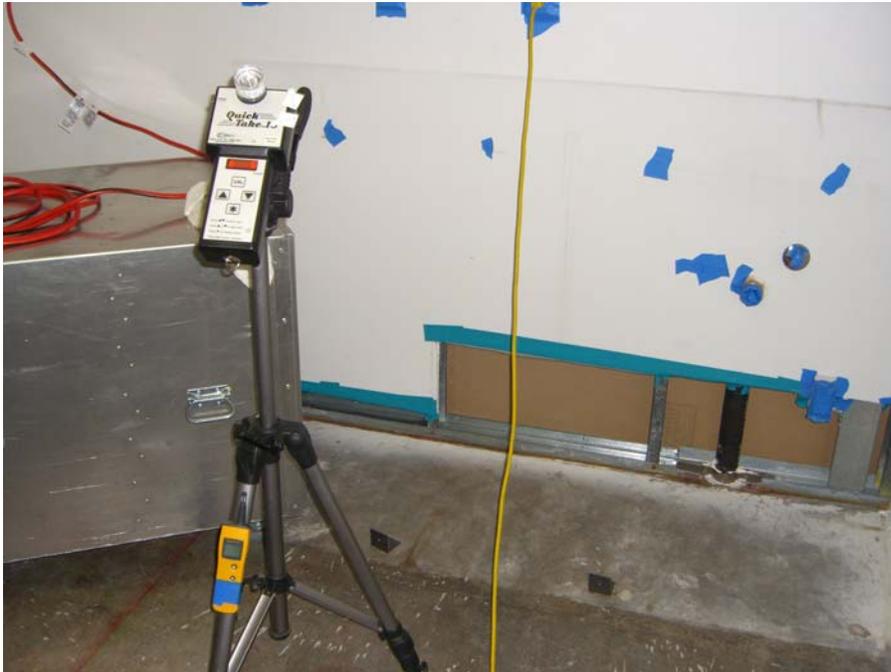
- 7) Image within 2402 Break Room containment indicating location of air sampling equipment and physical cabinet and wallboard removal at time of clearance assessment.

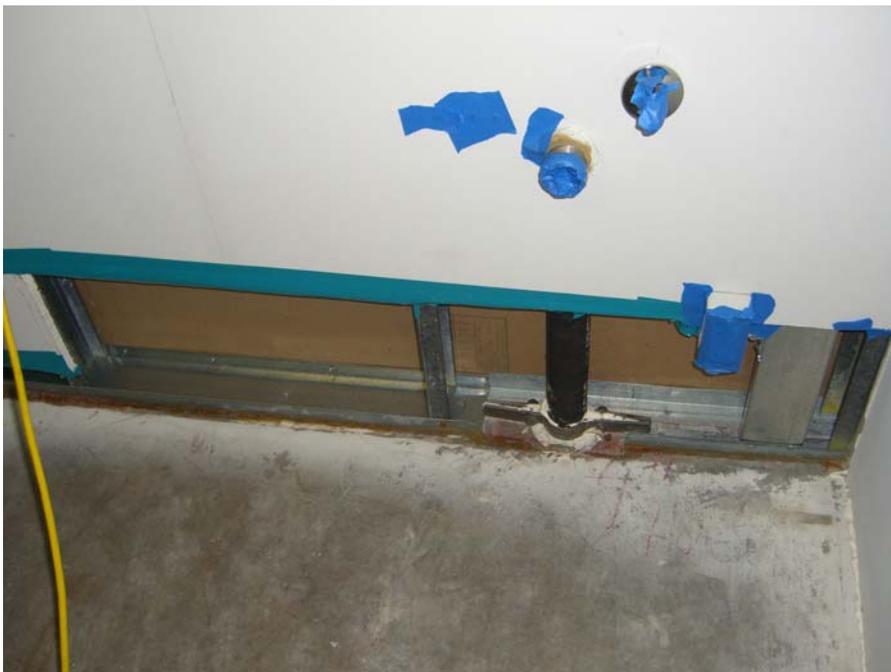
- 8) Close-up image of location within 2402 containment where cabinetry and wallboard materials were removed by mitigation contractor.

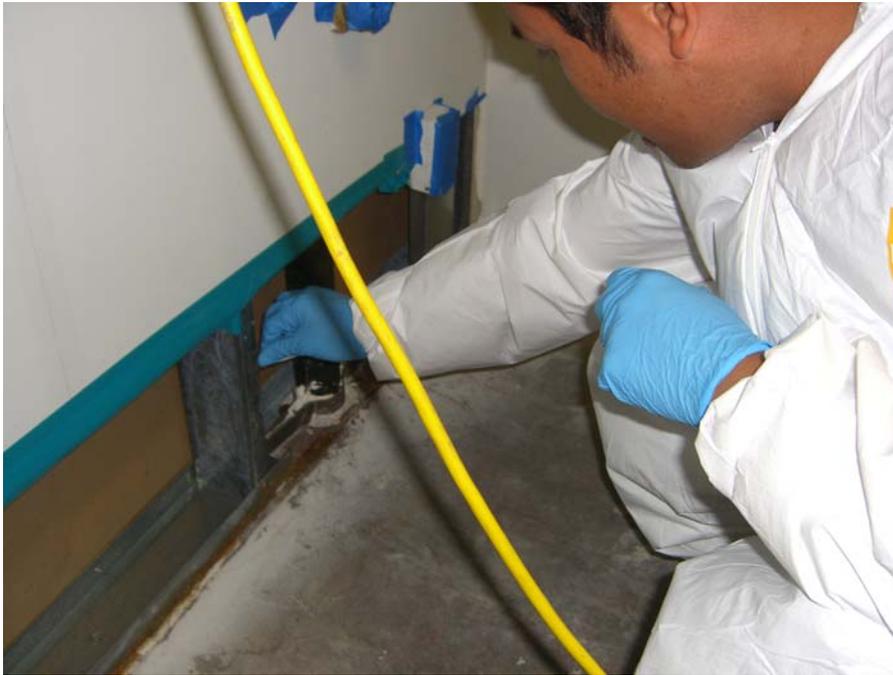
9) Image of Hygientech (HTI) technician collecting surface tape sample at time of assessment within Break Room 2402 containment.

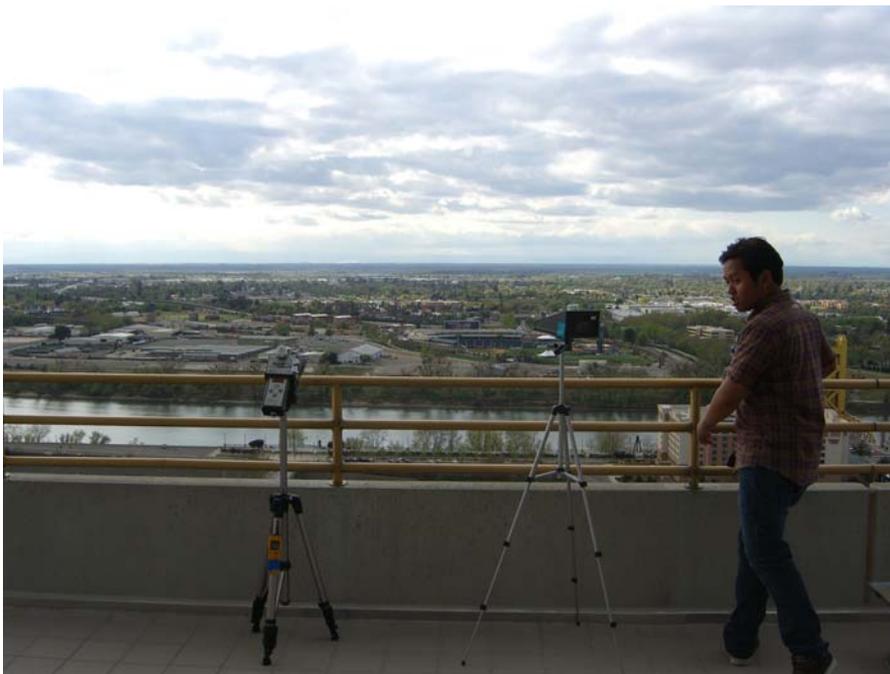
10) Image of Hygientech (HTI) technician collecting parallel spore trap air sample on 23rd Floor West Balcony following interior assessment.
