February 6, 2014

Document No. 21402001.1

Regarding: 7th Floor Women's Restroom Water Leak
450 N Street, Sacramento

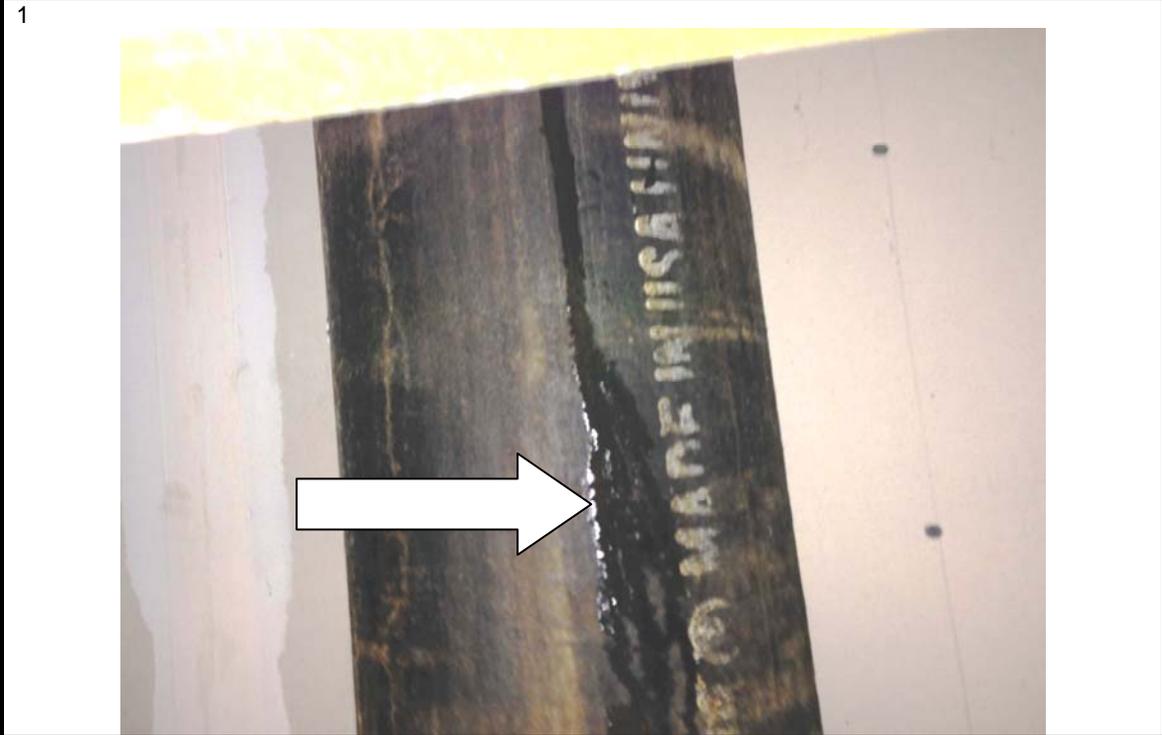
Upon visual inspection on the afternoon of January 31, 2014 in the 7th Floor Women's Restroom, an active water leak was observed at the waste pipe located within the plumbing cavity area directly behind the toilet stalls (Photos 1 and 2). Water impacted building materials, such as gypsum board wall material, plumbing pipes, concrete floor and pipe insulation, were also observed in that area. Please note that the inspection was performed through the toilet seat cover dispenser opening located at the eastern partition wall behind one of the toilet stall and there was no evidence of visual mold growth observed on any of the accessible building materials. Minor sewer like odors was noticed in the plumbing cavity area at that time.

Date	Address	Photo Location – Description	Up
01/31/14	450 N Street Sacramento, California	7 th Floor; Women's Restroom; looking east; view of plumbing cavity area within the eastern partition wall opening at toilet seat cover dispenser area; showing water streaks on main waste pipe riser	↑

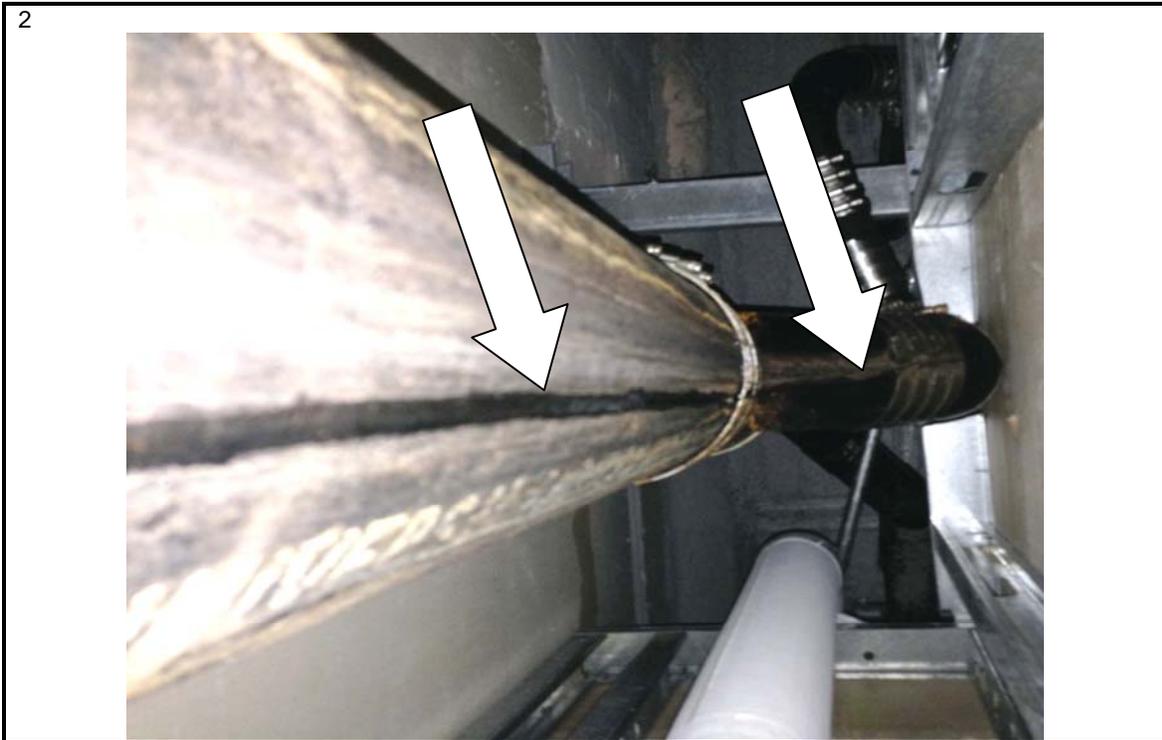
Date	Address	Photo Location – Description	Up
01/31/14	450 N Street Sacramento, California	7 th Floor; Women's Restroom; looking up; view of plumbing cavity interior area within the eastern partition wall opening at toilet seat cover dispenser area; showing water streak on main waste pipe riser and adjacent pipe fitting	↑

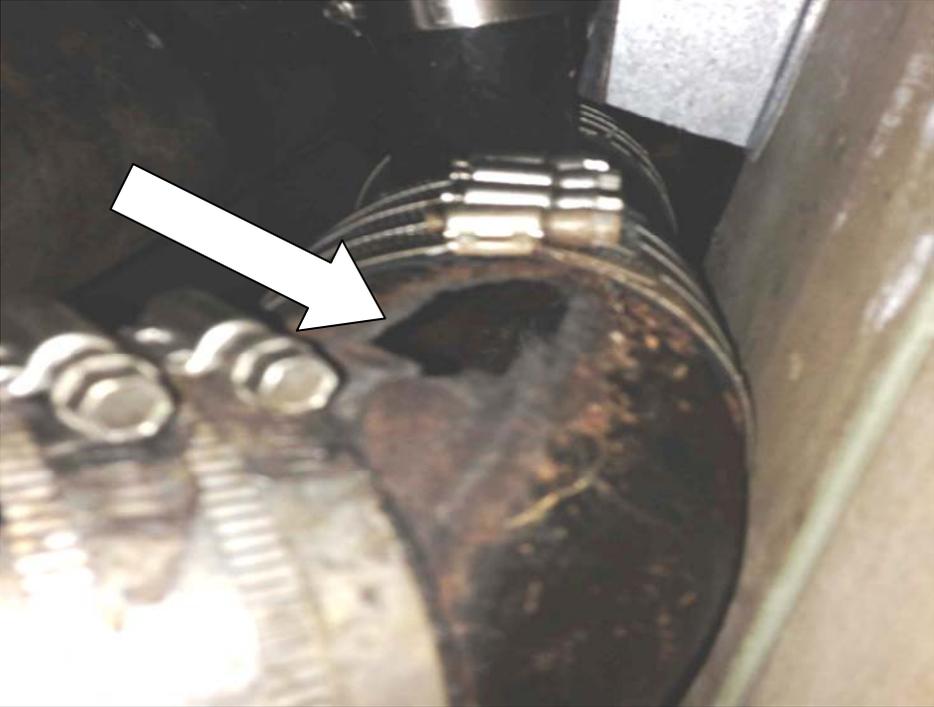
Please note that upon removal of the gypsum board material at the eastern partition wall in the 7th Floor Women's Restroom, damaged pipe fitting was observed (Photos 3 and 4). Prior to starting the repair work, water supply was reportedly shut off in the eastern flank of the building from floors 5 through 24 involving restrooms, janitor closets, break rooms, and/or other sink areas.

Date	Address	Photo Location – Description	Up
01/31/14	450 N Street Sacramento, California	7 th Floor; Women's Restroom; looking up; view of plumbing cavity interior area within the eastern partition wall cavity opening; showing hole at the pipe fitting adjacent to the main waste pipe riser behind the gypsum board	↑
