**RE: California State Board of Equalization
Closure Report Addenda**

**Mold Remediation – 16th Floor
Closure Report Addendum**

Project No. 2372.02-572

Addendum Date: October 31, 2012

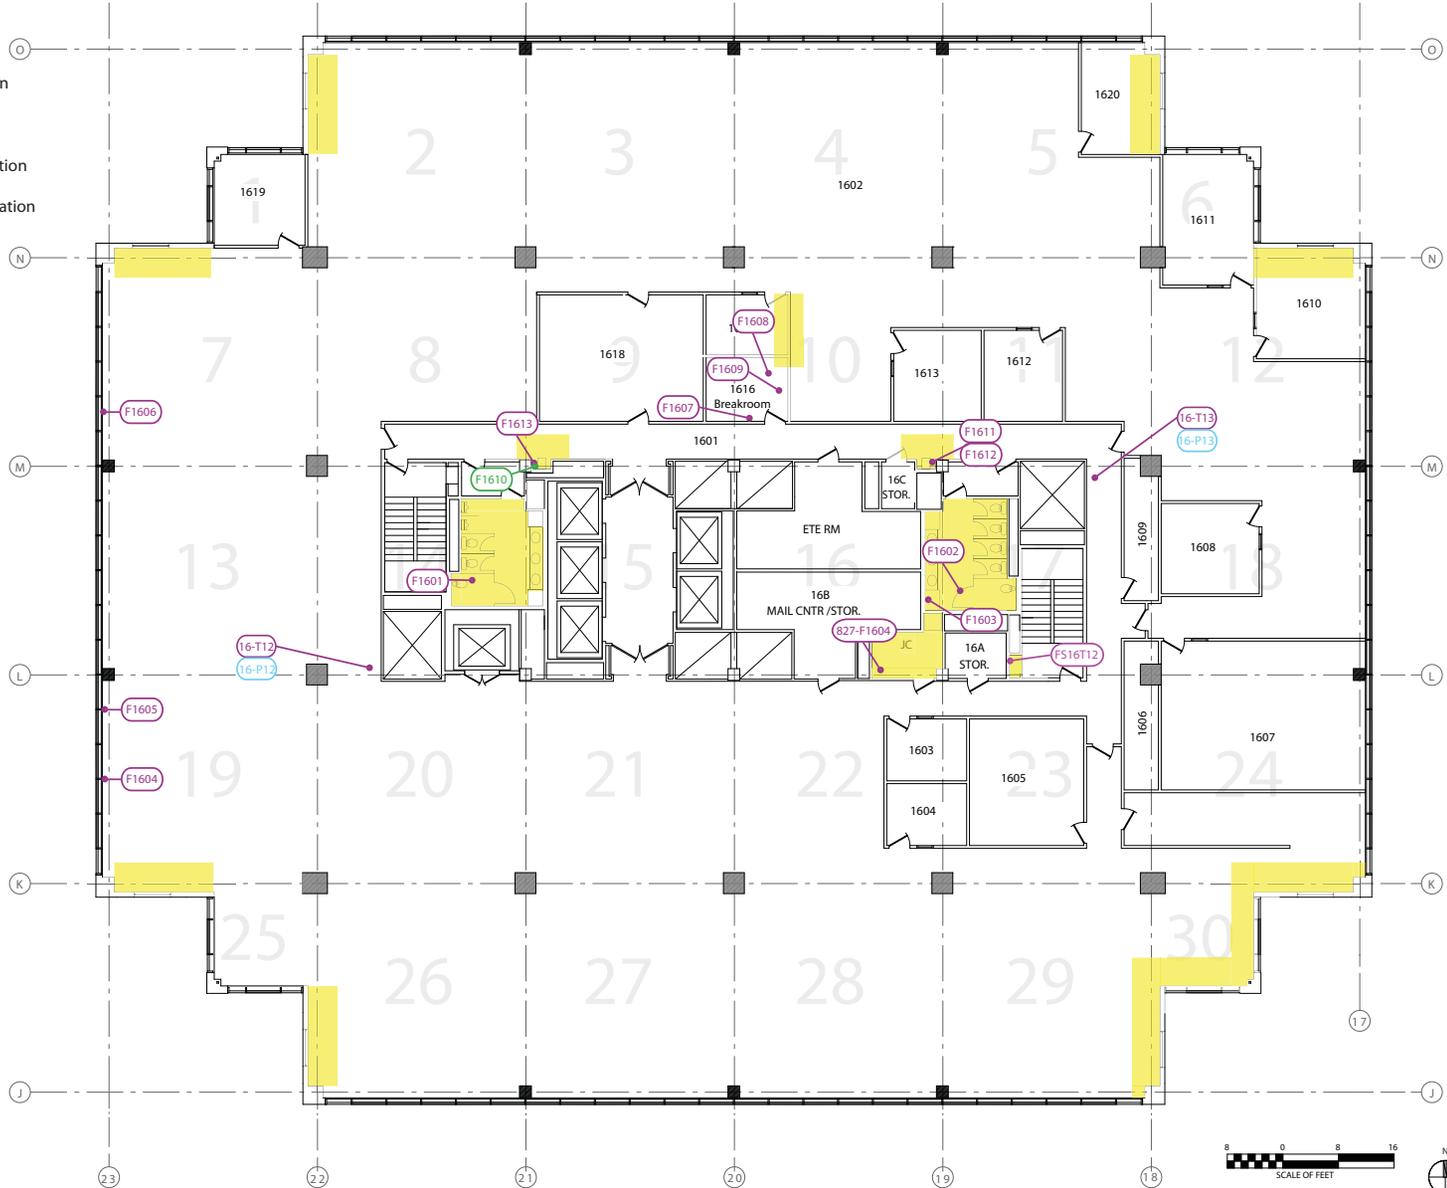
Subsequent to the completion of the closure report, a need for additional investigation and/or remediation activities was identified. Identified areas were subjected to sampling. Using a combination of surface tape lift and/or bulk samples, LCD tested stains on walls and other building materials to determine if the stains were indicative of mold growth. The sample locations are depicted in a revised Figure 2 attached to this addendum.

Containment and Sample Locations (Oct 2012)
Board of Equalization Building, Mold Remediation
450 N Street, Sacramento, California

16th Floor
