**RE: California State Board of Equalization
Closure Report Addenda**

California State Board of Equalization
450 N Street, Sacramento, California

**Mold Remediation – First Floor
Closure Report Addendum**

Project No. 2372.02-572

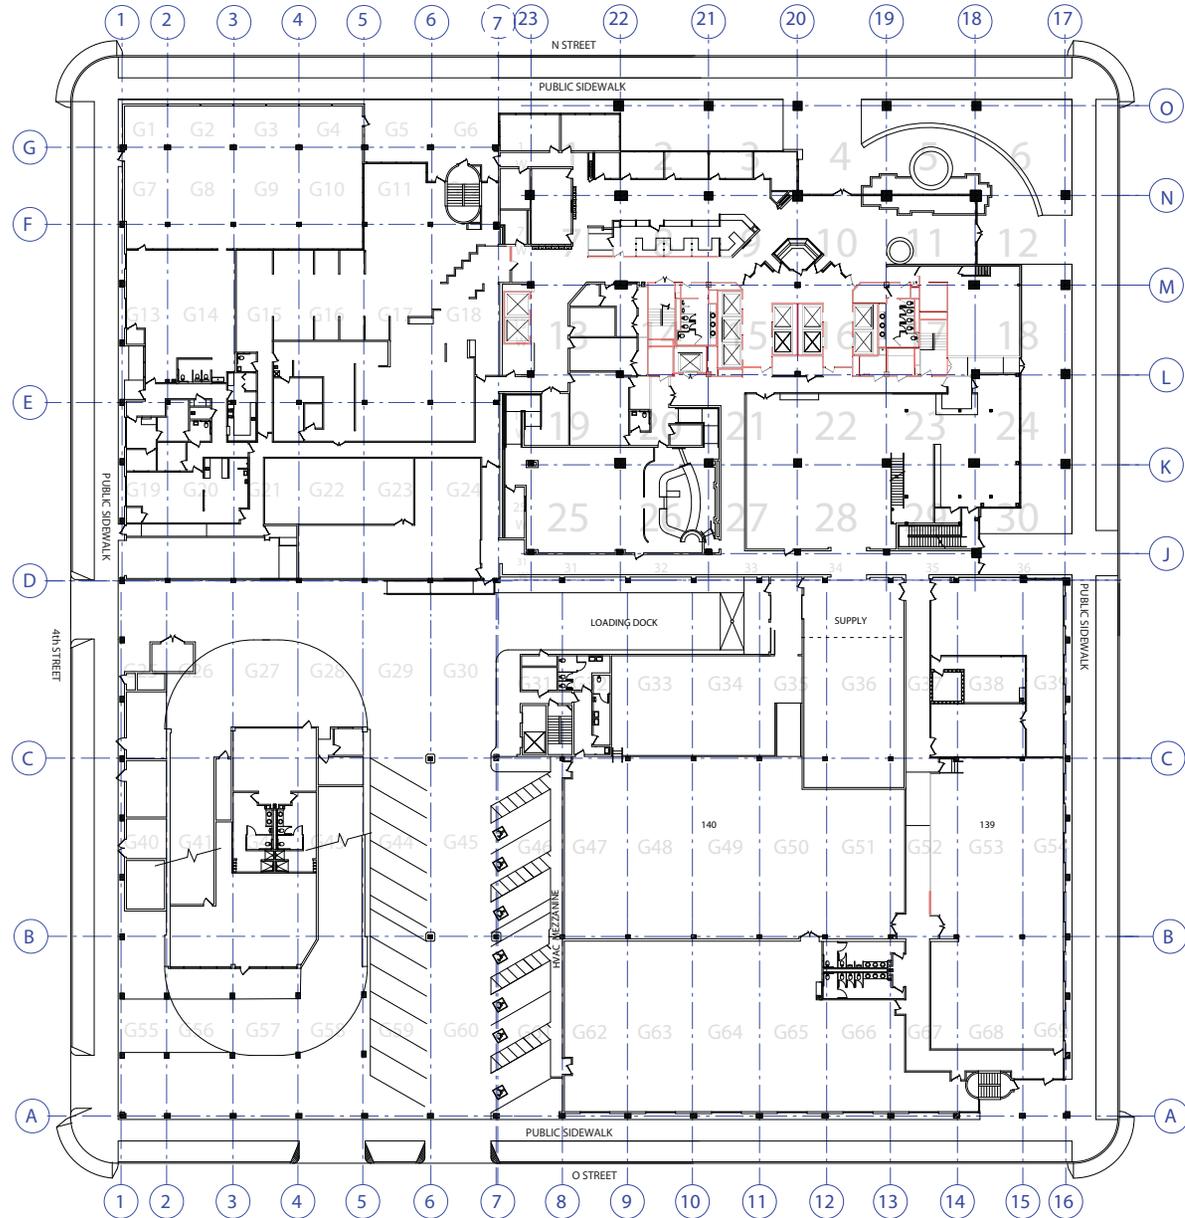
Figure 3

Suspect Mold - February 2012 (Oct 2012)
Board of Equalization Building, Mold Remediation
450 N Street, Sacramento, California

1st Floor

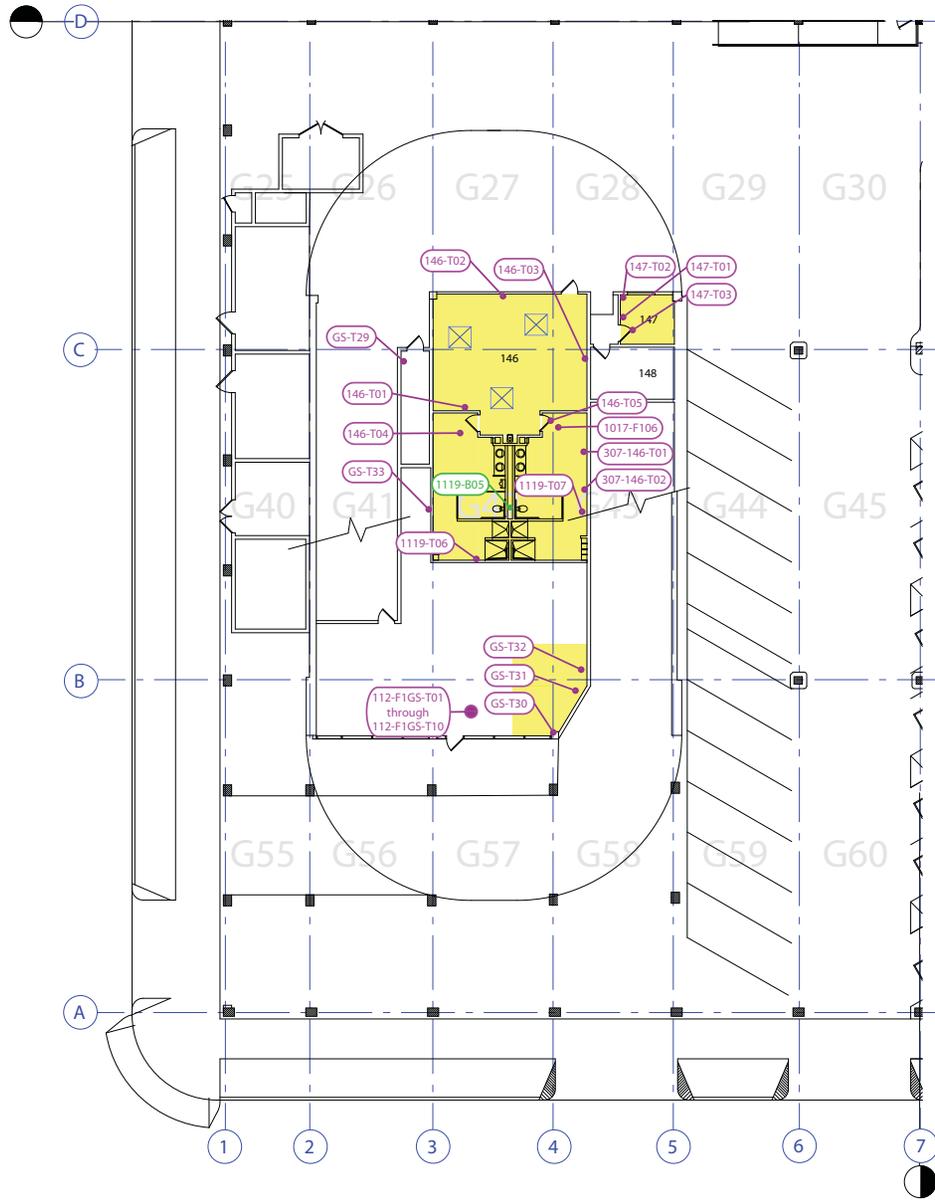
Figure 2d

Containment and Sample Locations
 Board of Equalization Building, Mold Remediation
 450 N Street, Sacramento, California

1st Floor
 SW Quadrant

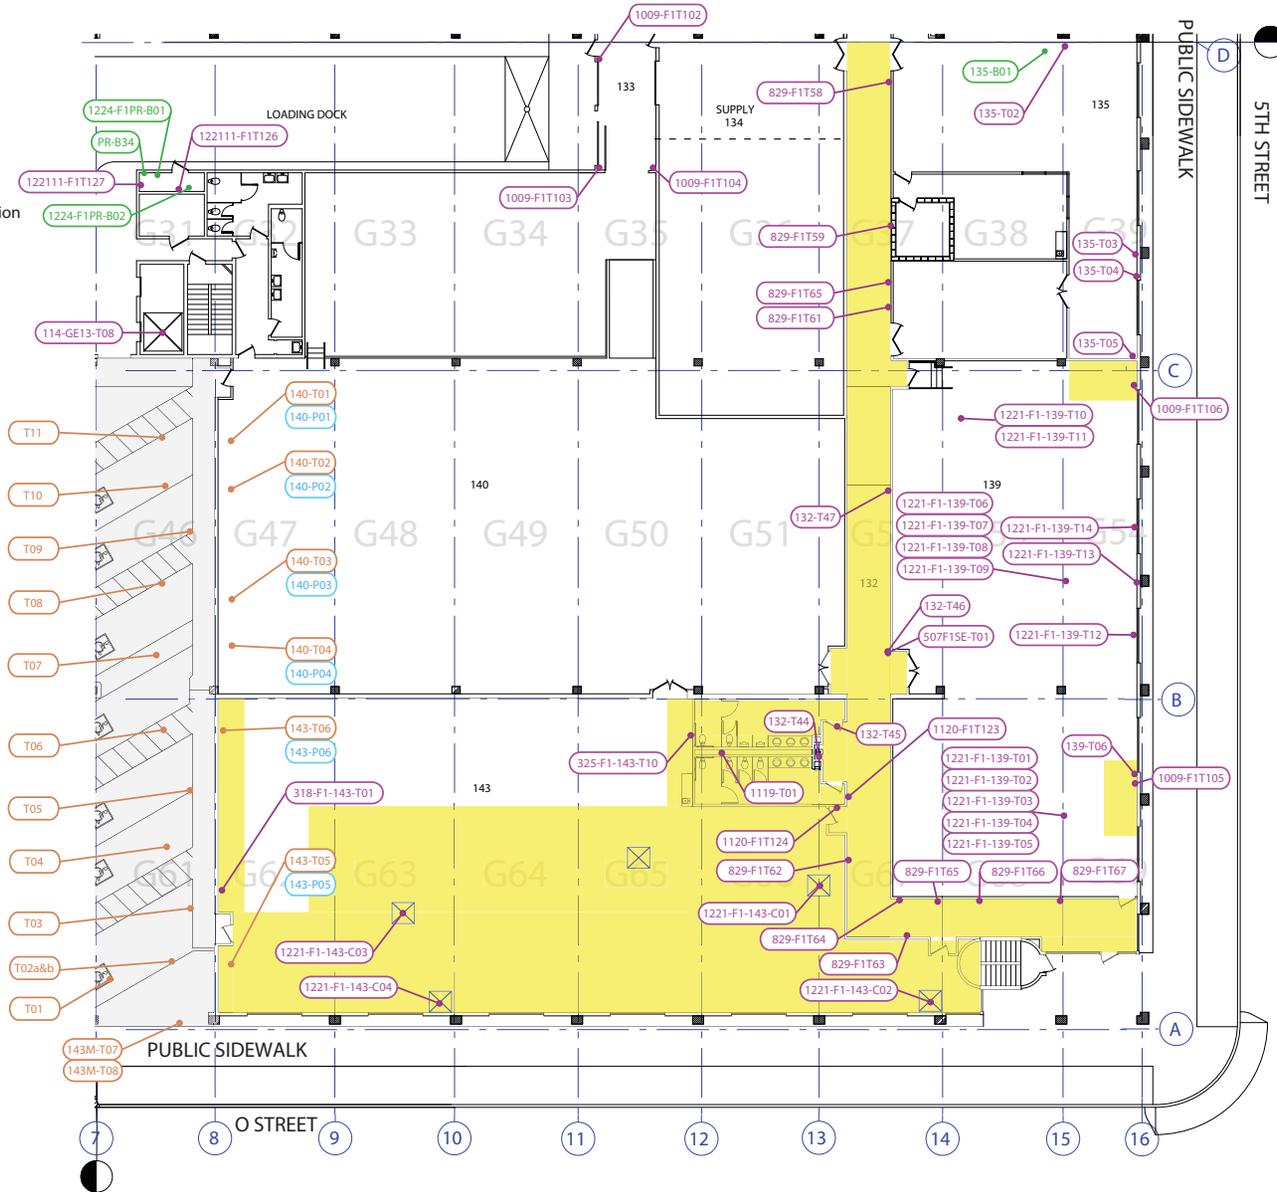
Figure 2c

Containment and Sample Locations (Oct 2012)

1st Floor
 SE Quadrant

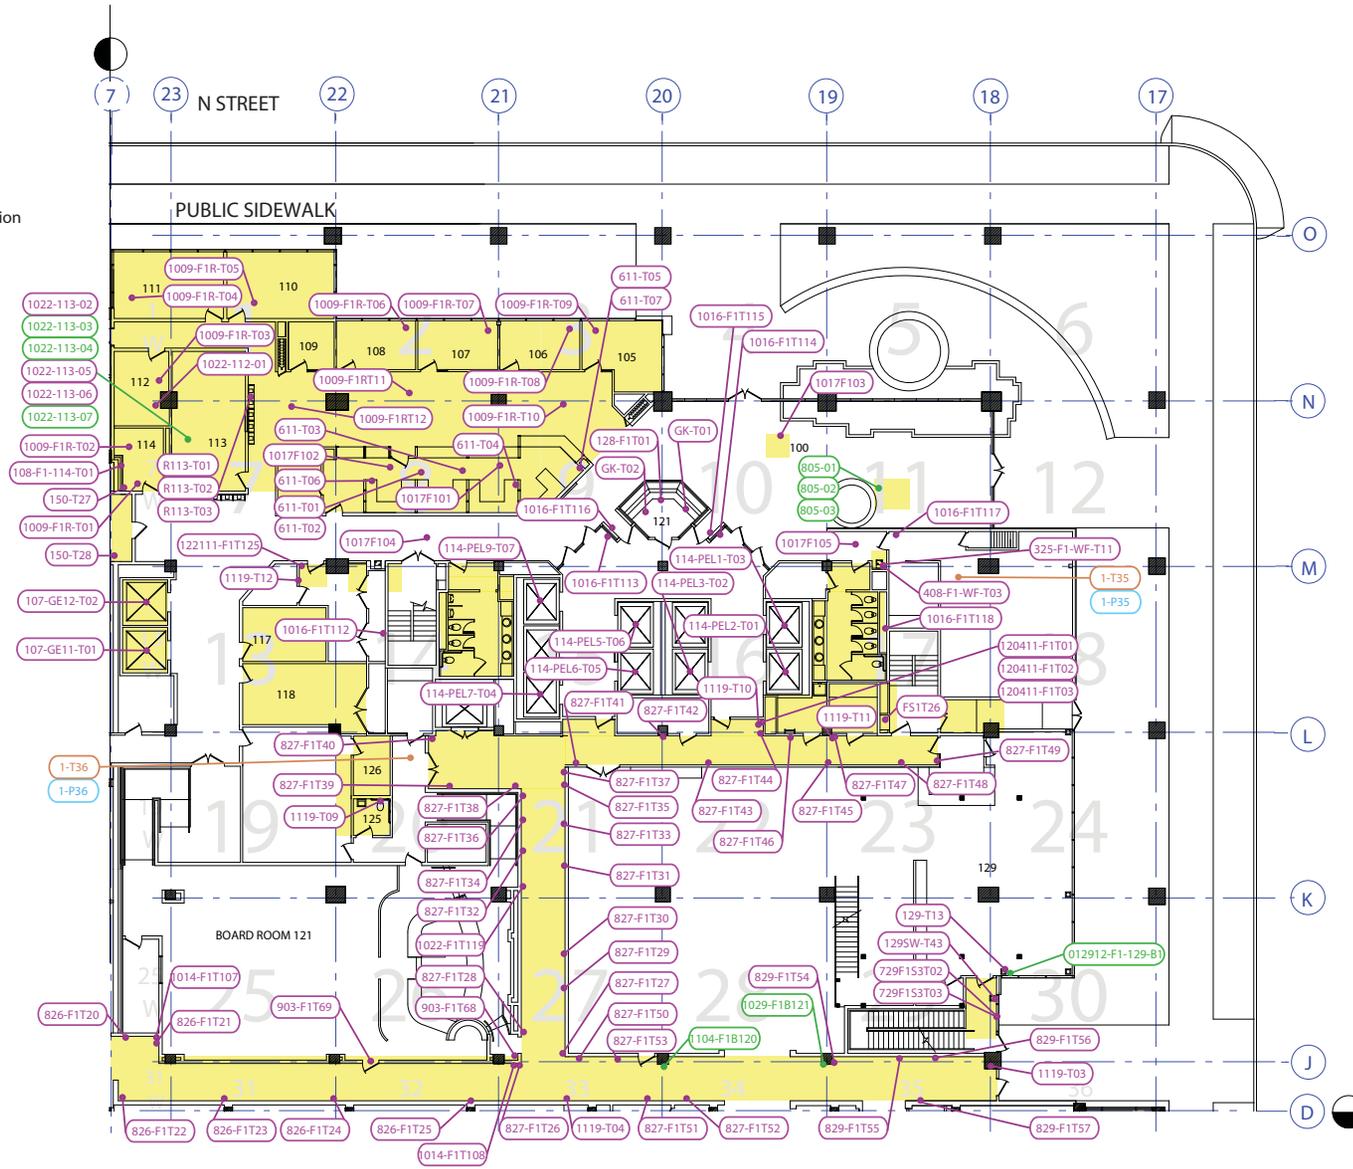
Figure 2b

Containment and Sample Locations (Oct 2012)
 Board of Equalization Building, Mold Remediation
 450 N Street, Sacramento, California

1st Floor
 NE Quadrant

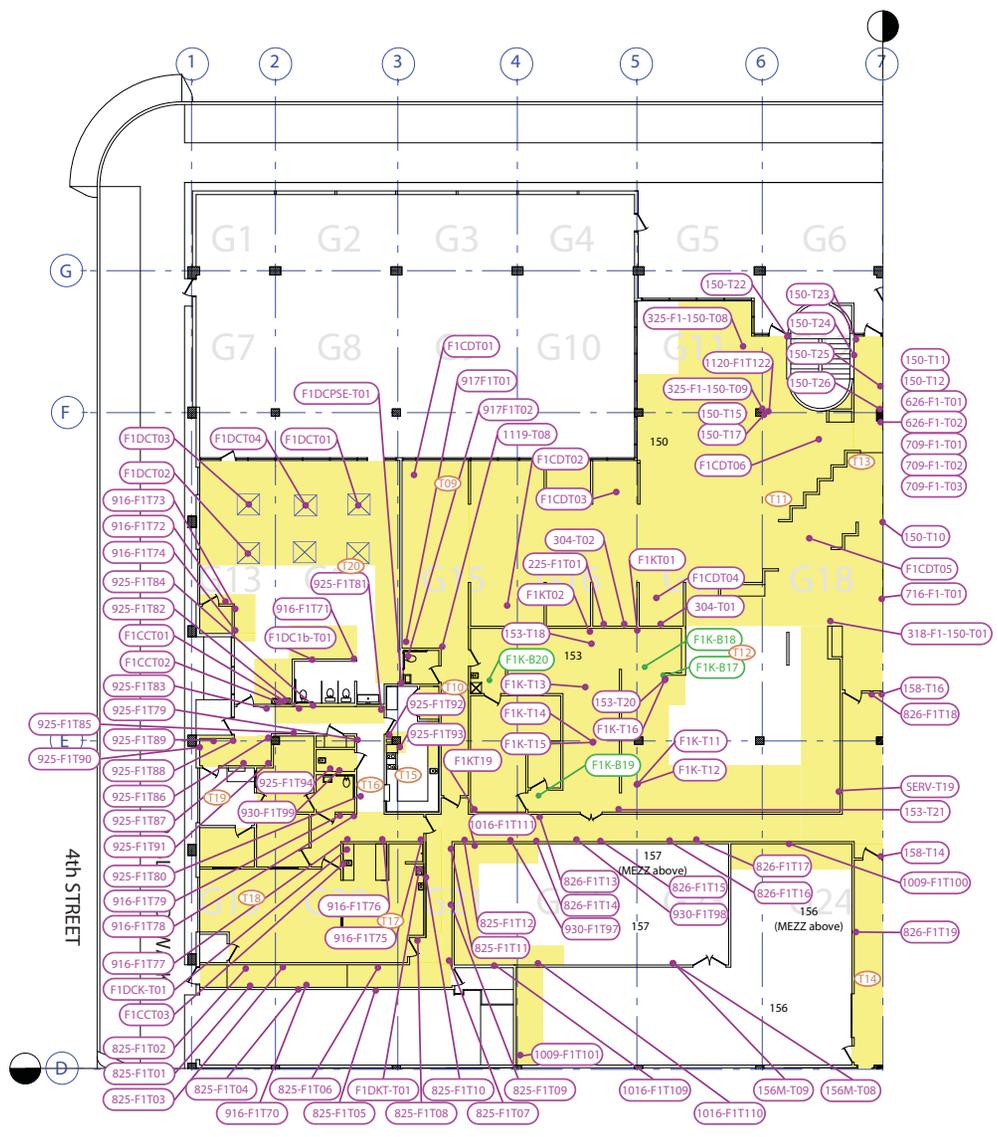
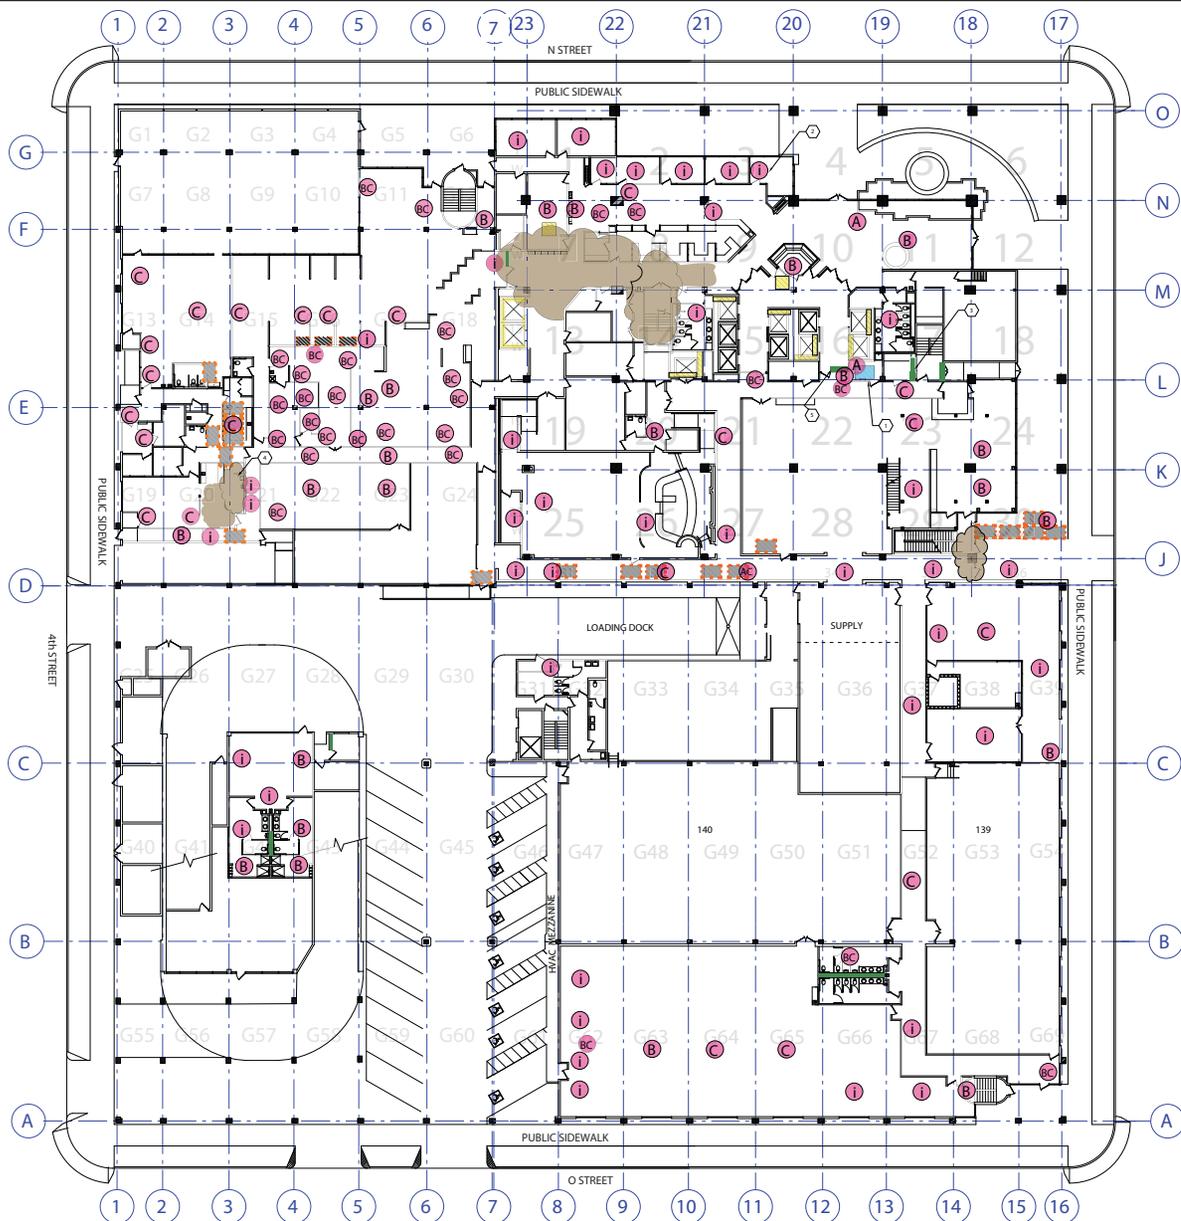
Figure 1

- ① Weeping pipes with water stains on walls and ceilings
- ② City storm drain cause of historic water damage
- ③ Visible mold growth on walls in fire sprinkler riser cabinet
- ④ Floor drain cause of historic water damage
- ⑤ Visible mold growth above ceiling in hallway

Water Damage Assessment - Revised (Oct 2012)
 Board of Equalization Building, Mold Remediation
 450 N Street, Sacramento, California

1st Floor

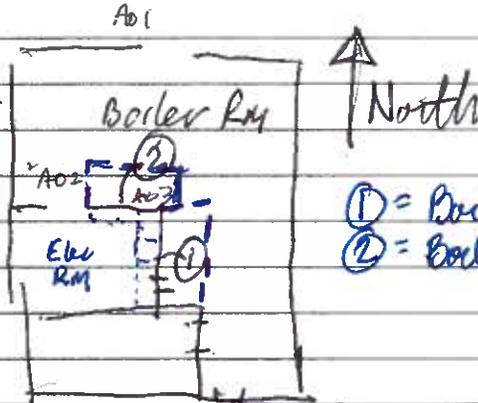
① = Boiler Room #1 Containment
② = Boiler Room #2 Containment

8:40 JLS begins dismantling of containment ①
