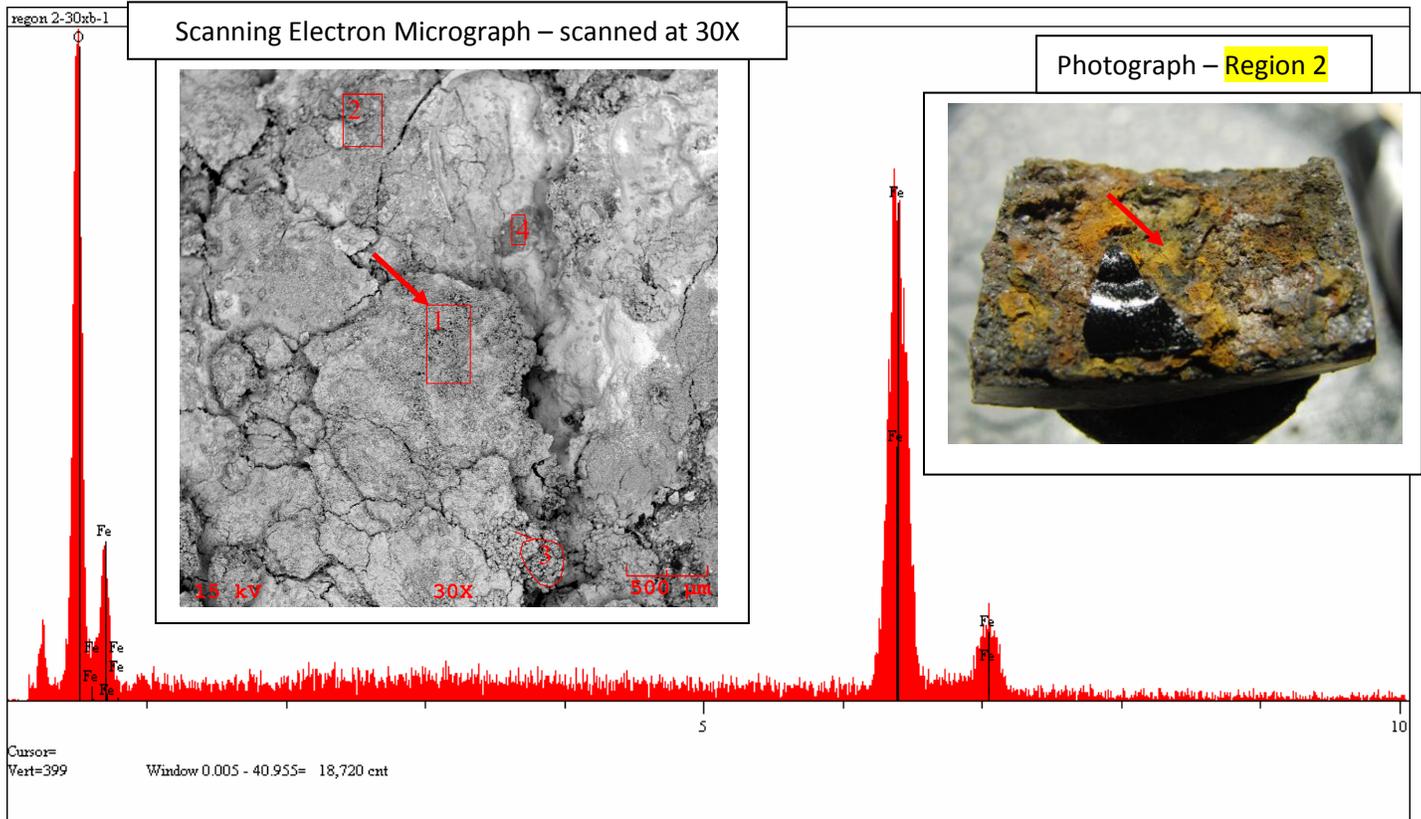
Sample 1/8 – SEM/EDS – elemental analysis – scanned at 30X – BSE detector

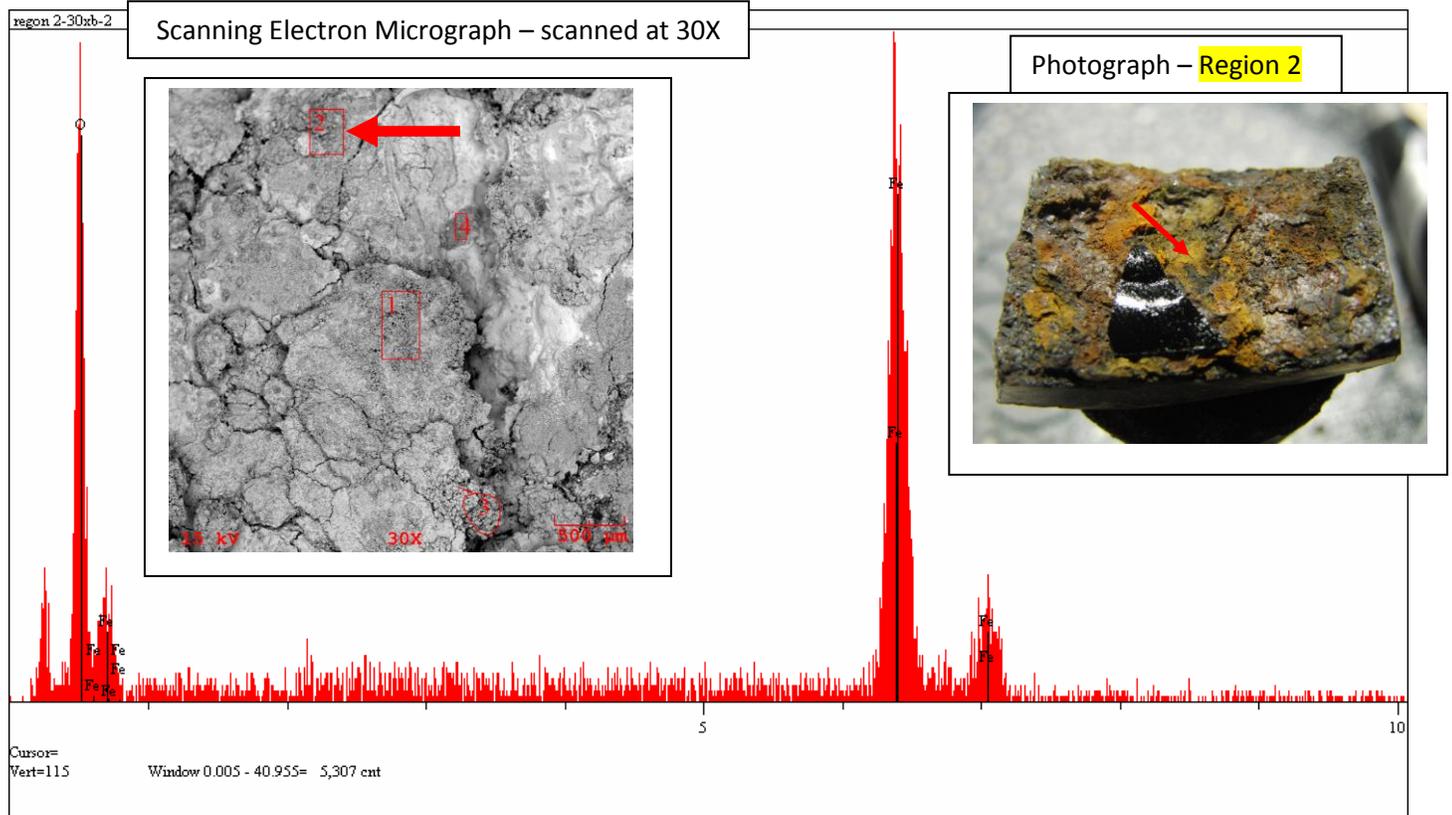
Defect region -- SEM/EDS – elemental analysis – scanned at 30X

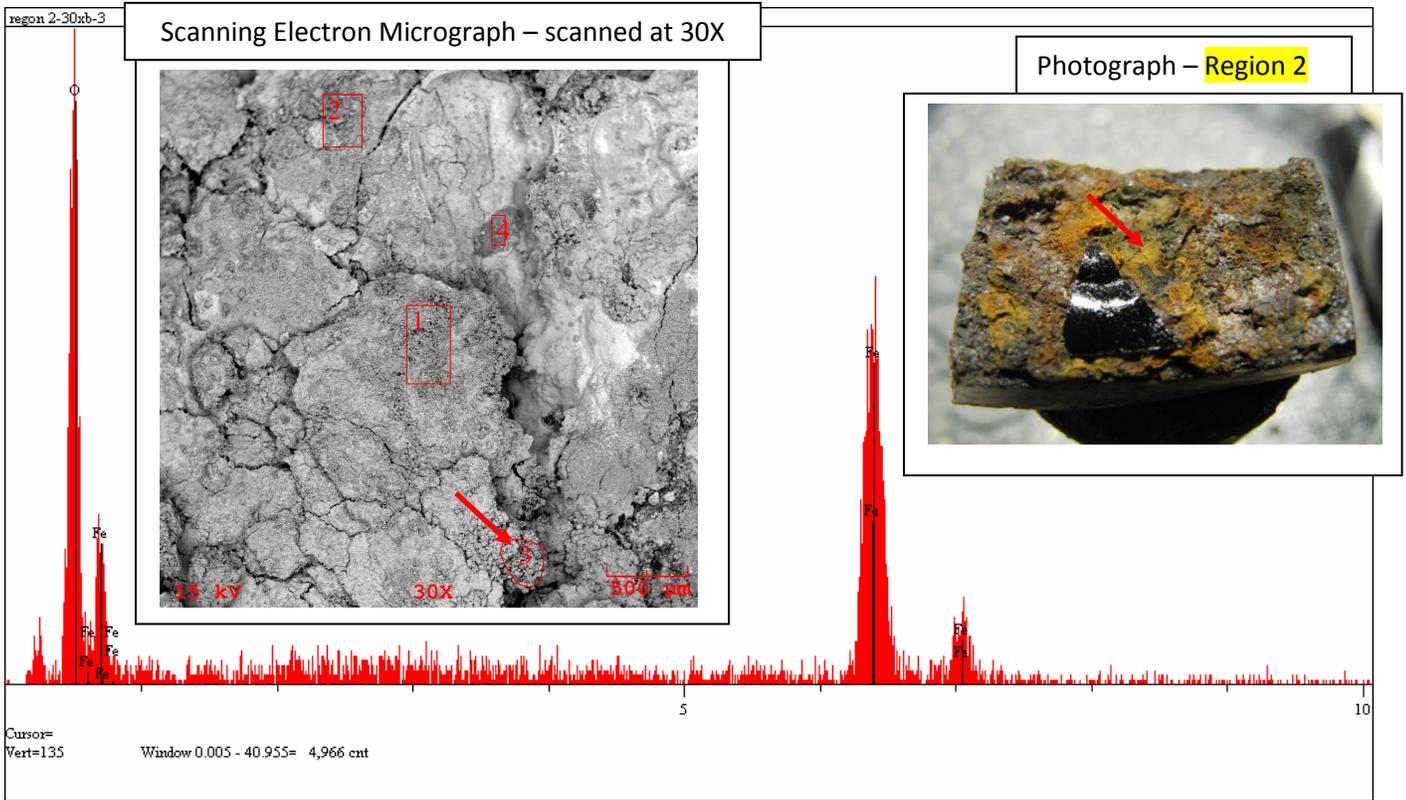
Sample 1/8 – SEM/EDS – elemental analysis – scanned at 30X – BSE detector

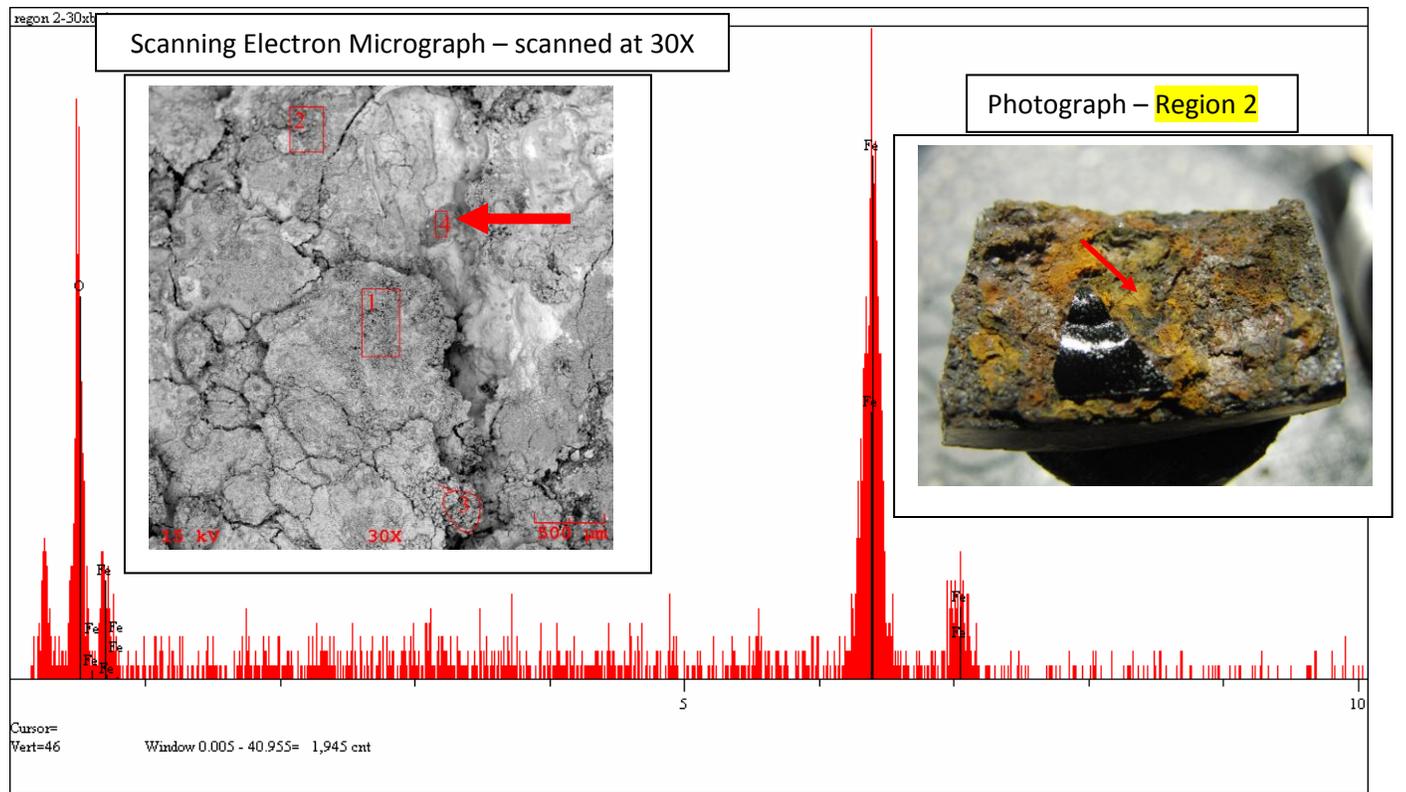
Defect region -- SEM/EDS – elemental analysis

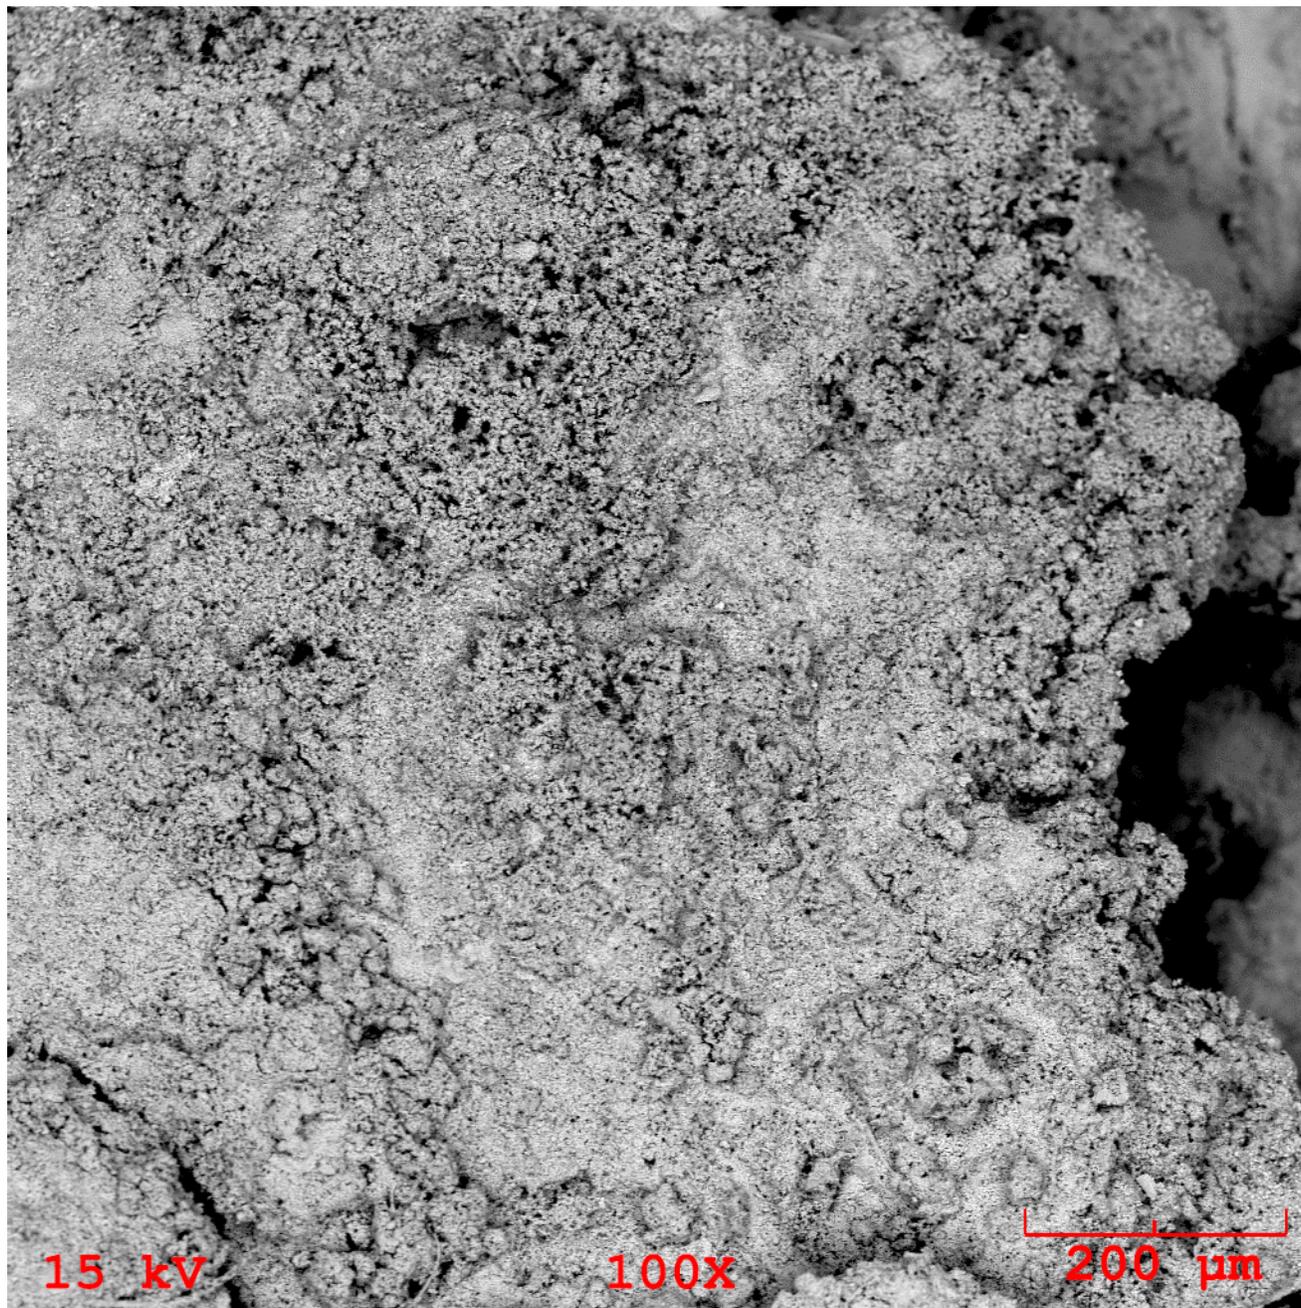
SEM Micrograph – Scanned at 100X – Region 2 from Photomicrograph

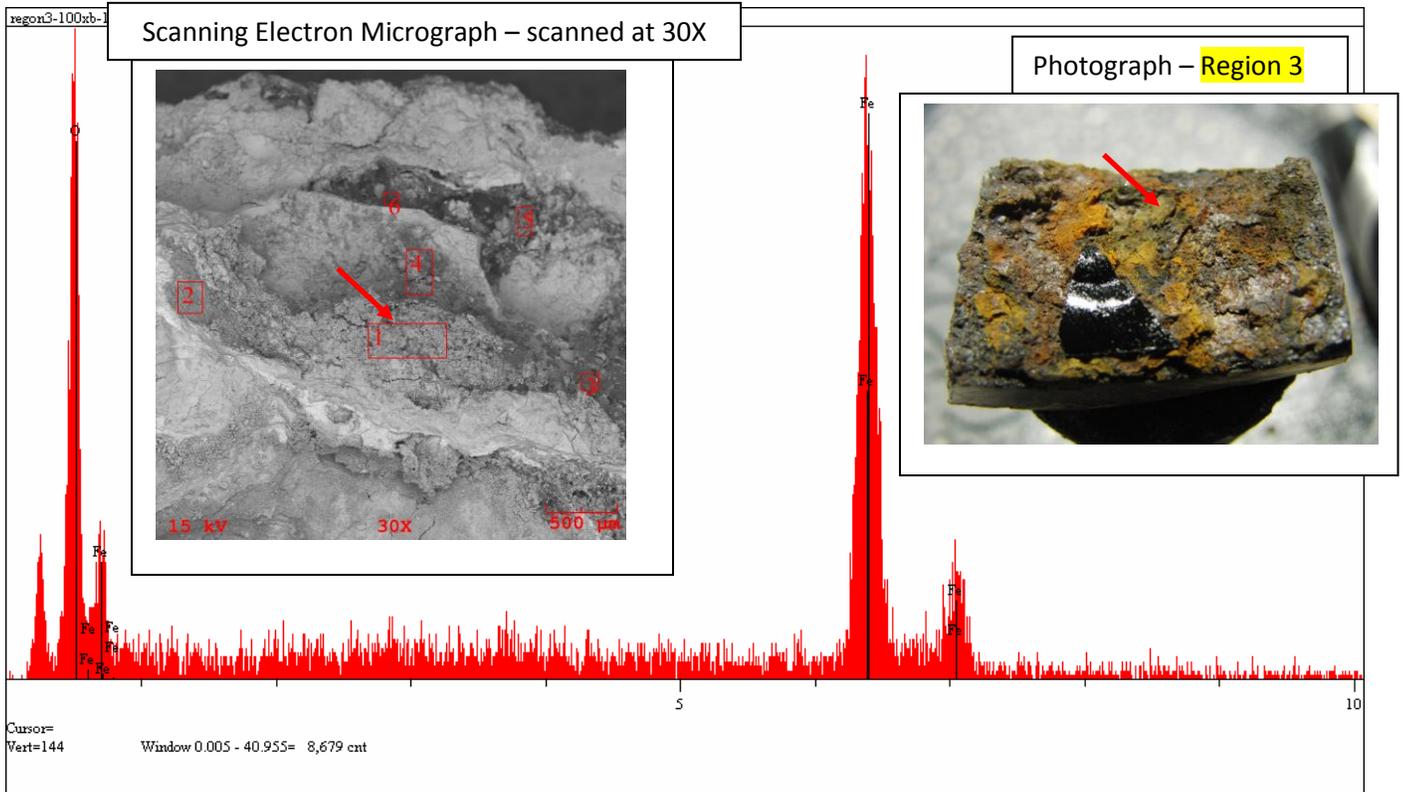
Sample 1/8 – SEM/EDS – elemental analysis – scanned at 30X – BSE detector

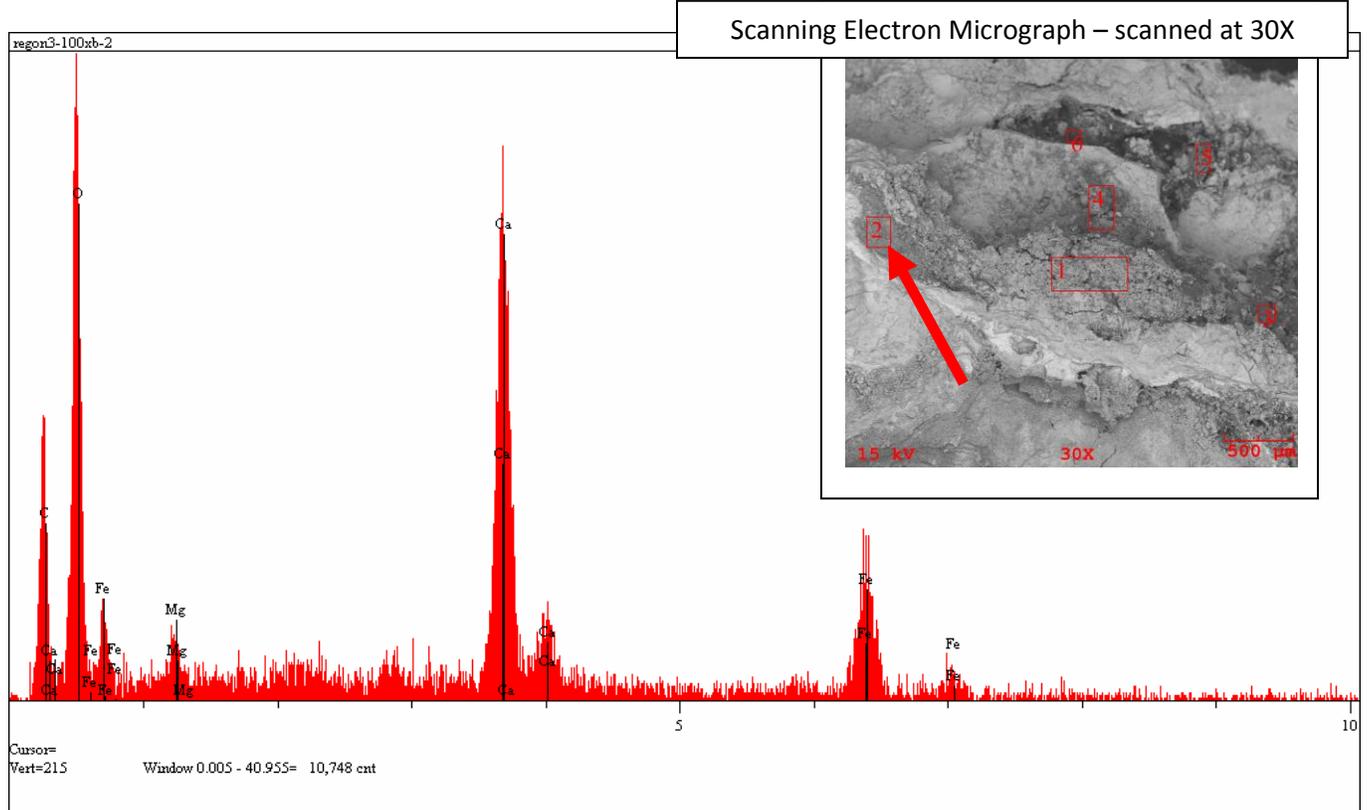
Defect region -- SEM/EDS – elemental analysis – scanned at 30X

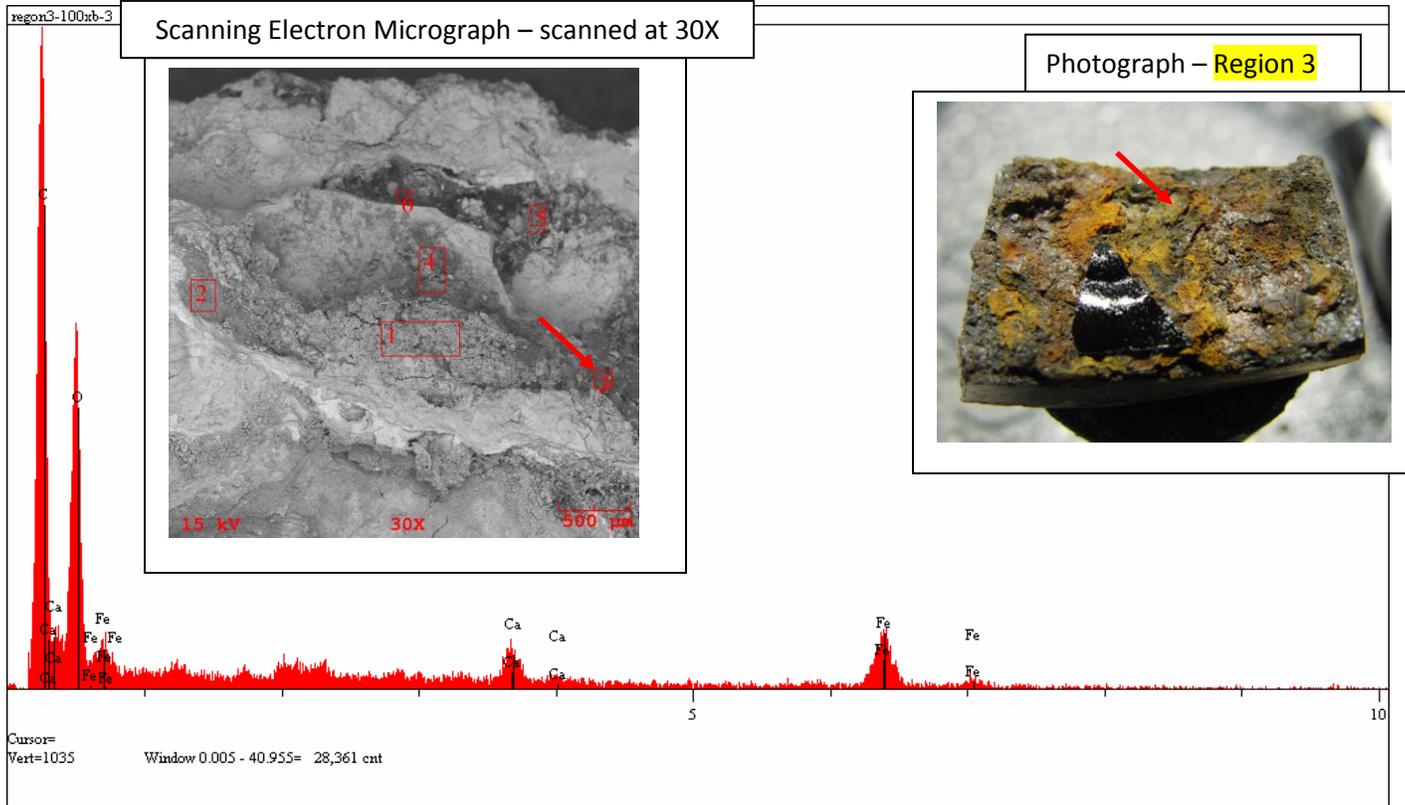
Sample 1/8 – SEM/EDS – elemental analysis – scanned at 30X – BSE detector

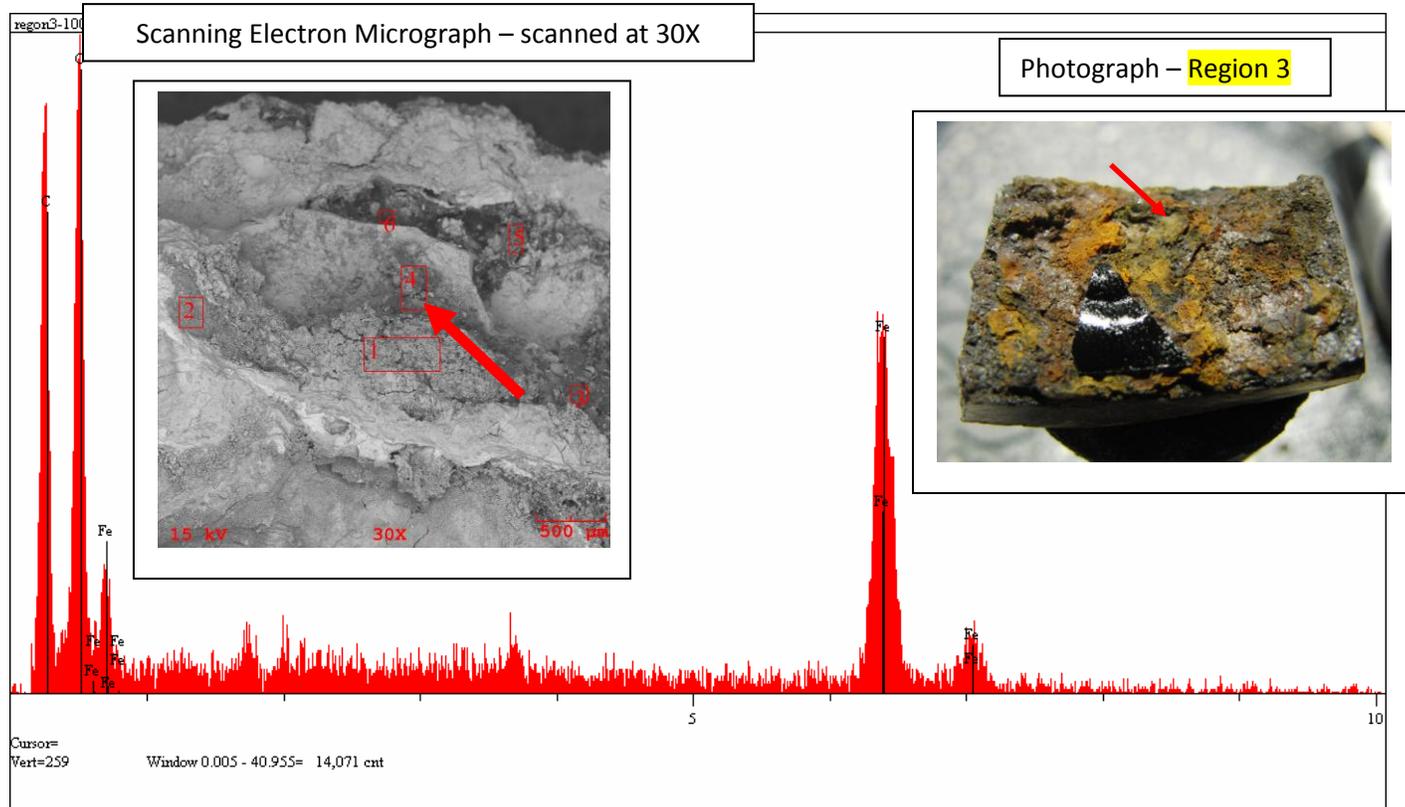
Defect region -- SEM/EDS – elemental analysis – scanned at 30X
