## Electrical Photographs

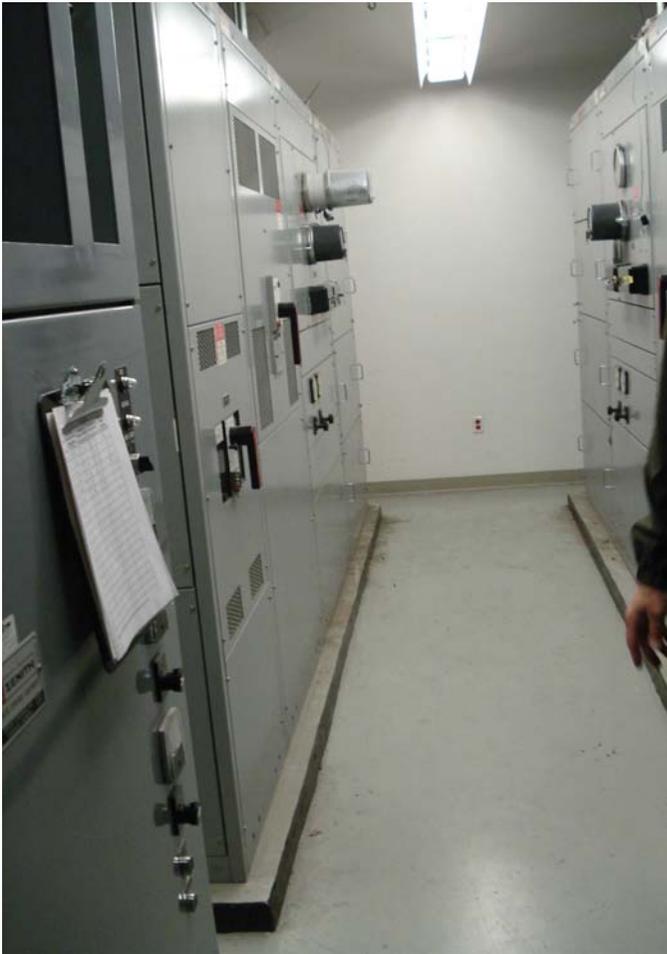
**Photo No. 1– Main Electrical Room:** Main Switchboards No. 1 and No. 2 each have their own SMUD meter. Note that the two panels face each other.

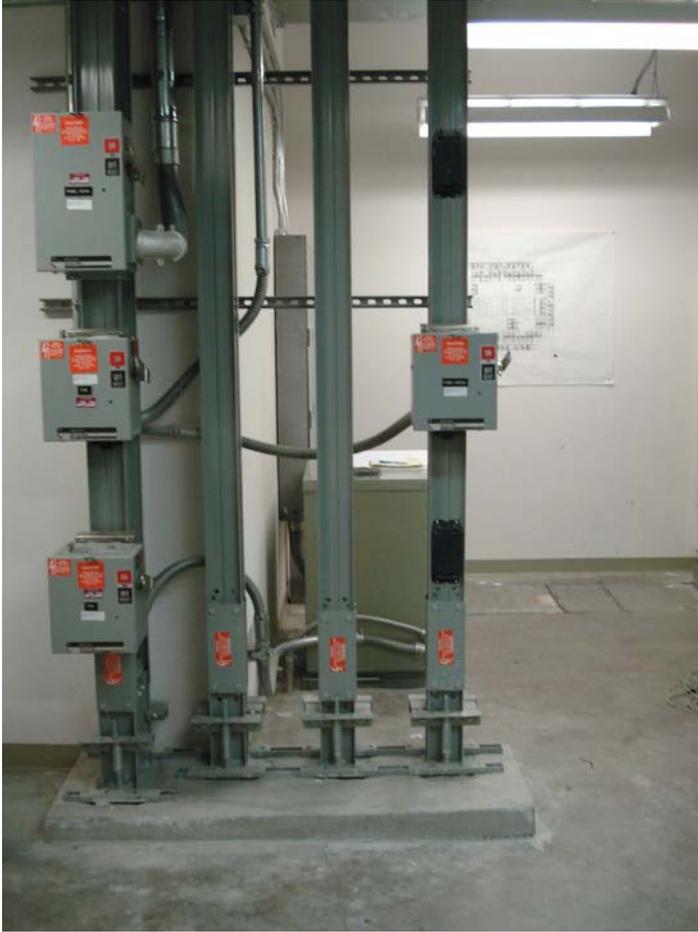
**Photo No. 2– Distribution Bus Duct Risers:** Risers typical of distribution bus duct on each floor.

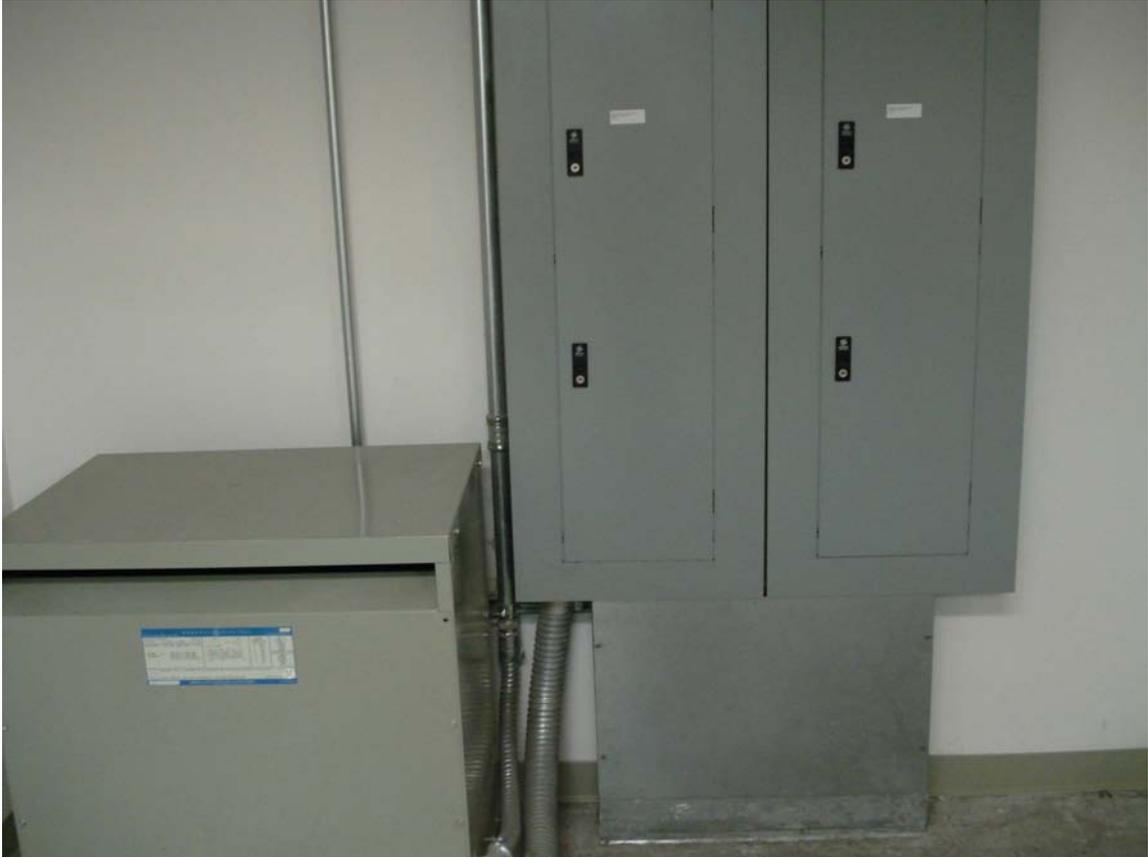
**Photo No. 3– Distribution System:** Typical dry type distribution transformer and electrical panel.

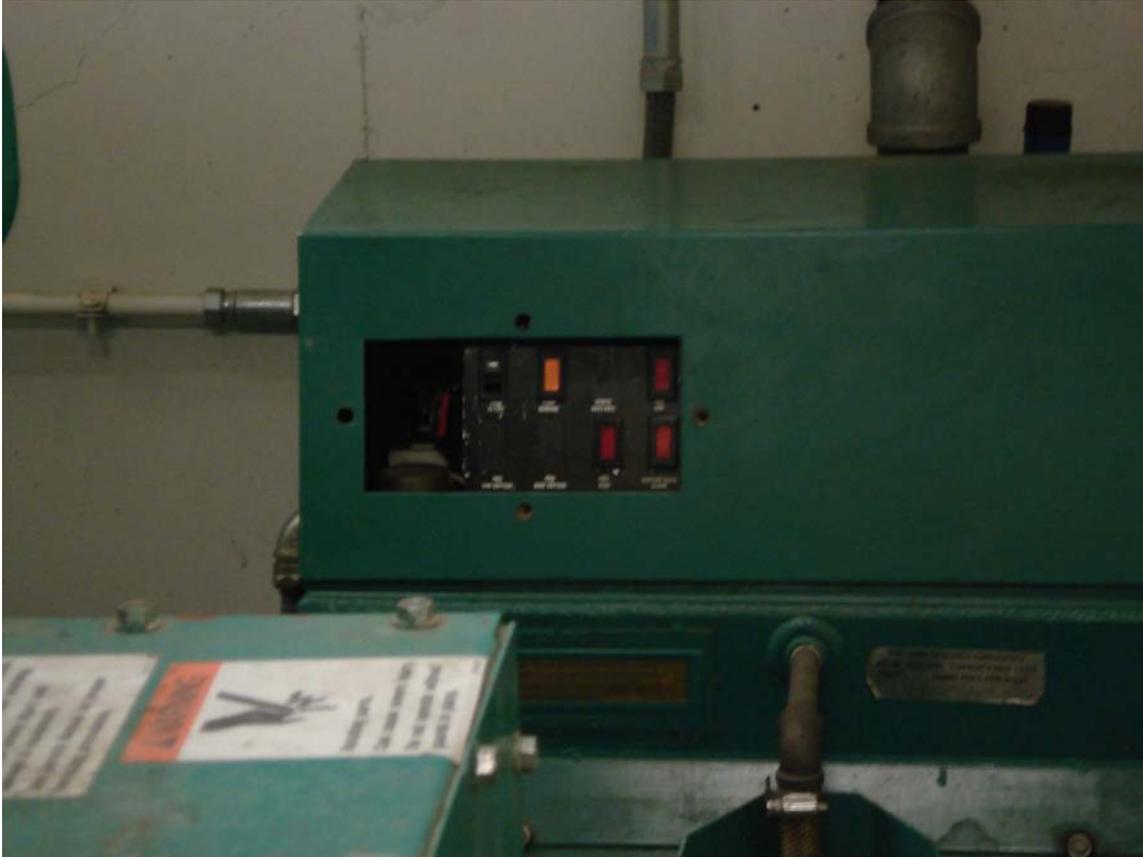
**Photo No. 5 – Damaged Control Panel, Generator Room:** Control panel is damaged and some retaining bolts are missing. Equipment should be cleaned and repaired.

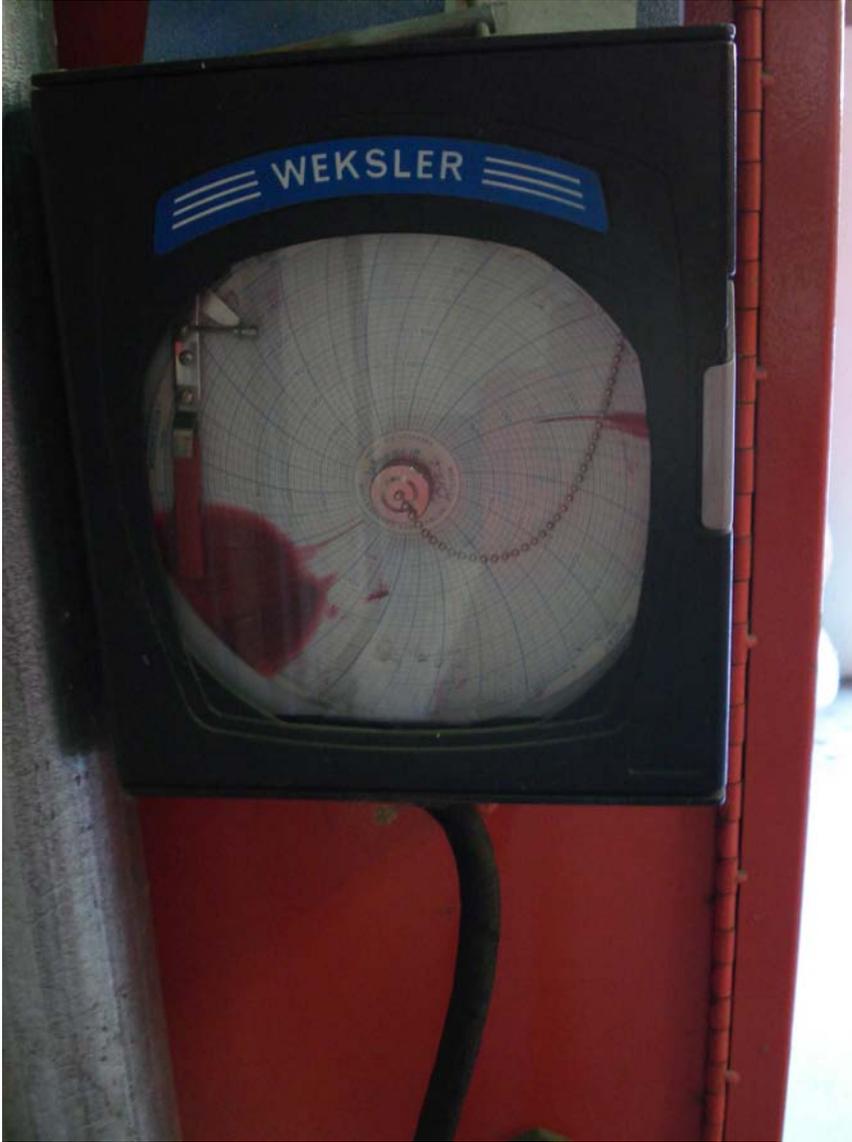
**Photo No. 6 – Monitoring Equipment in Generator Room:** A damaged piece of monitoring equipment seems to have been broken for some time.

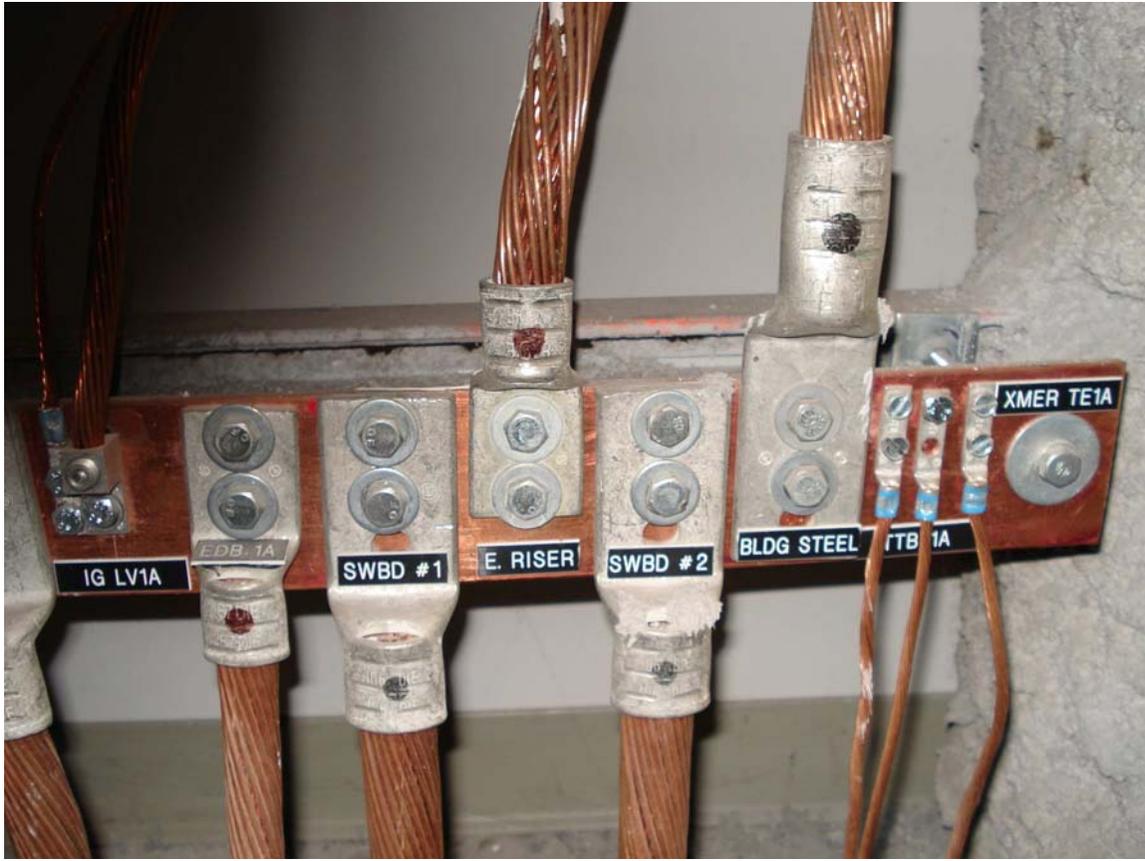
**Photo No. 7– Main Grounding Electrode in Main Electrical Room:** The main ground bar for the grounding electrode system.

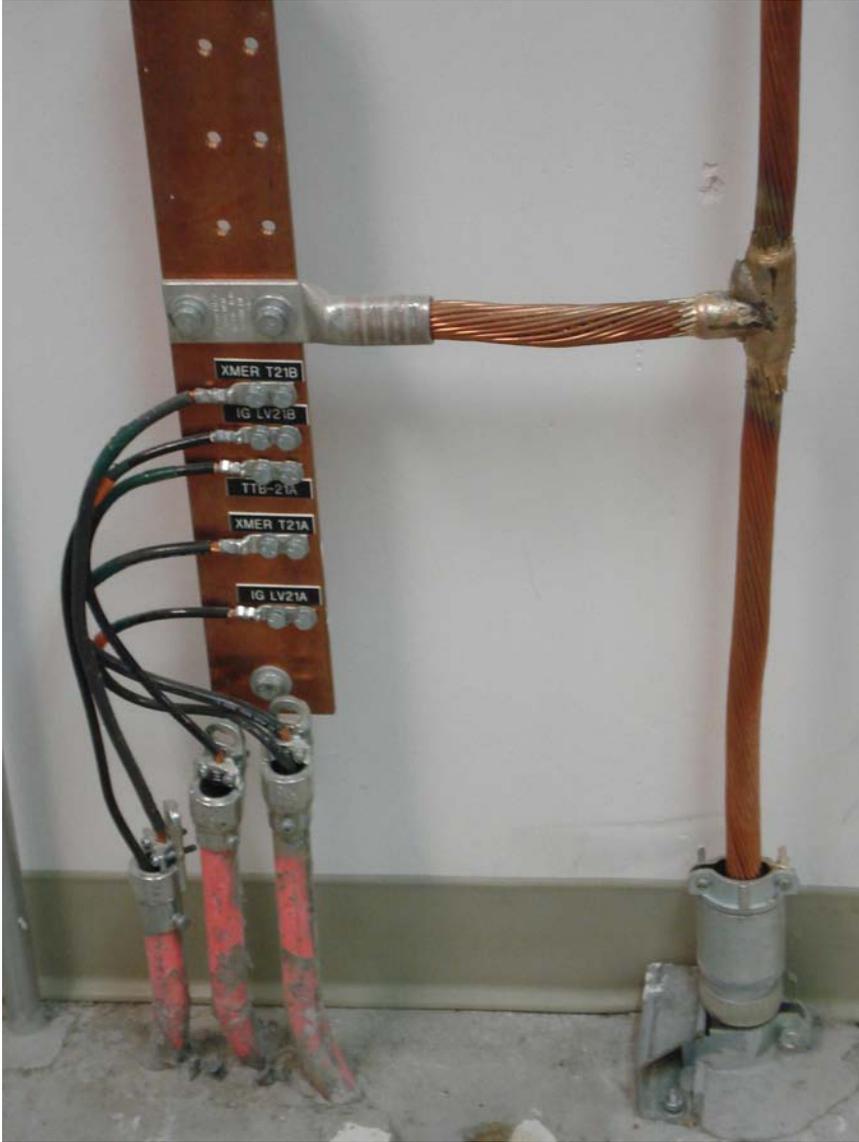
**Photo No. 8 – Typical Grounding Bar:** A similar grounding bar is installed in each electrical room and electrical closet.

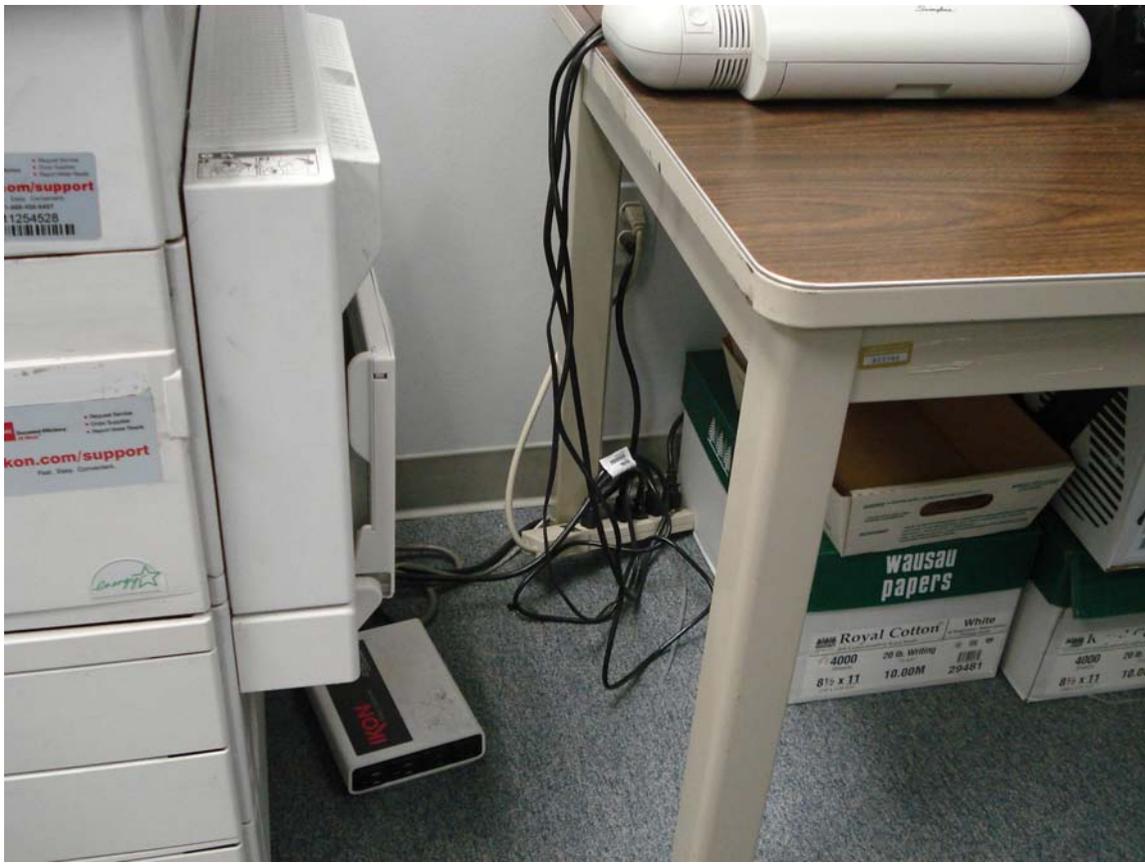
**Photo No. 9 – Printer Power Strips:** Overloaded power strips were observed at various printer areas throughout the review.

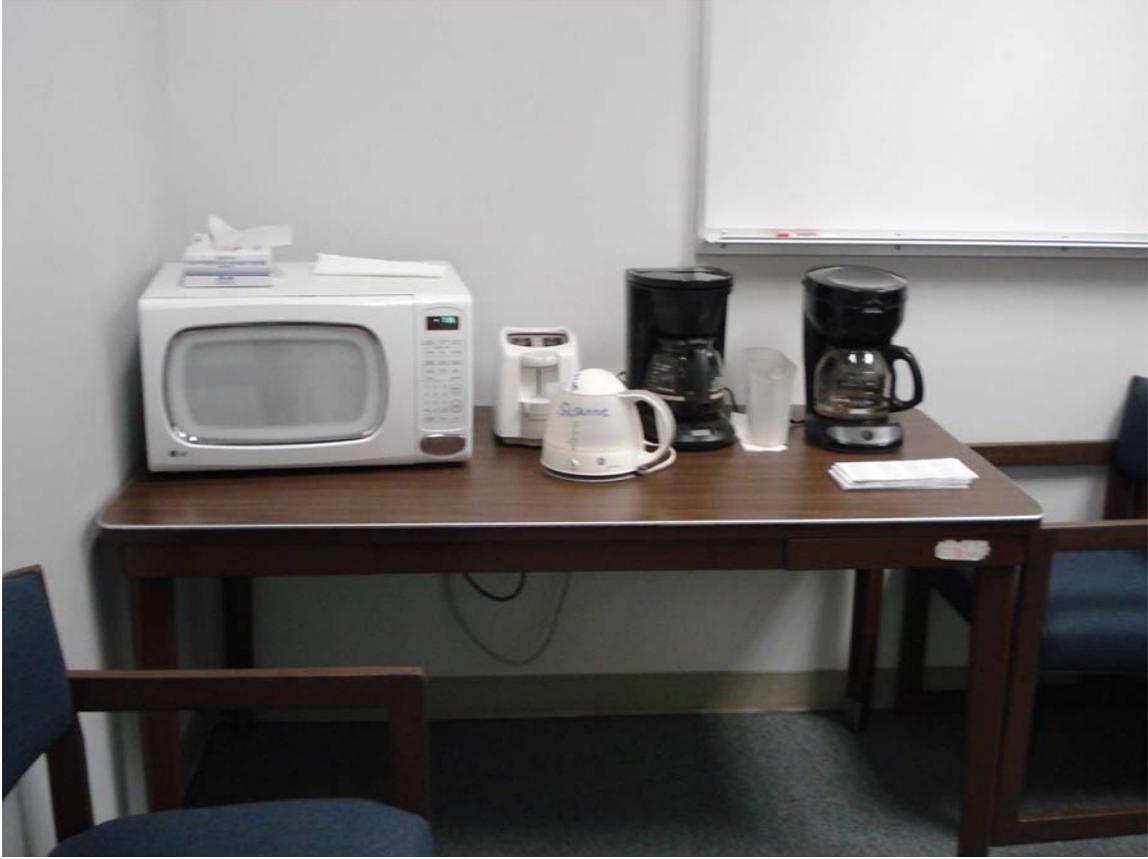
**Photo No. 10 – Break Room Power Strips:** This conference room has been converted into a break room and several kitchen appliances connected to a power strip.

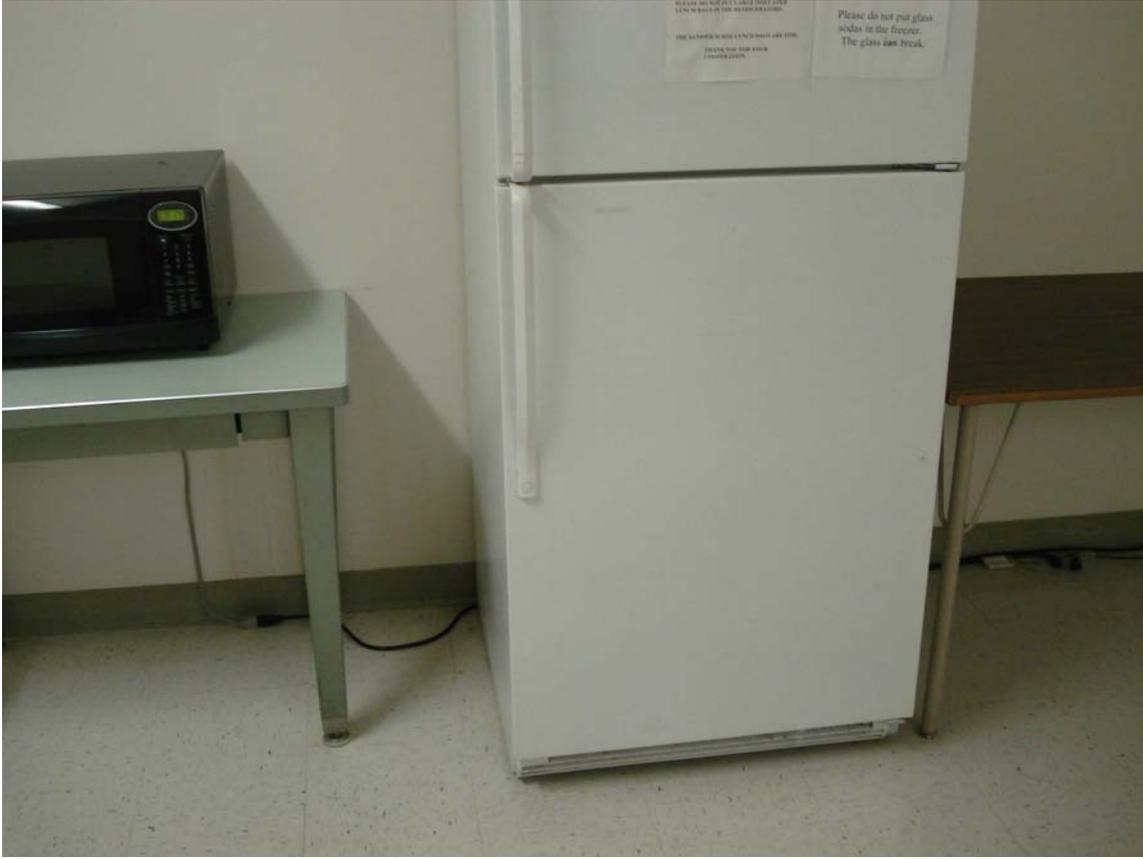
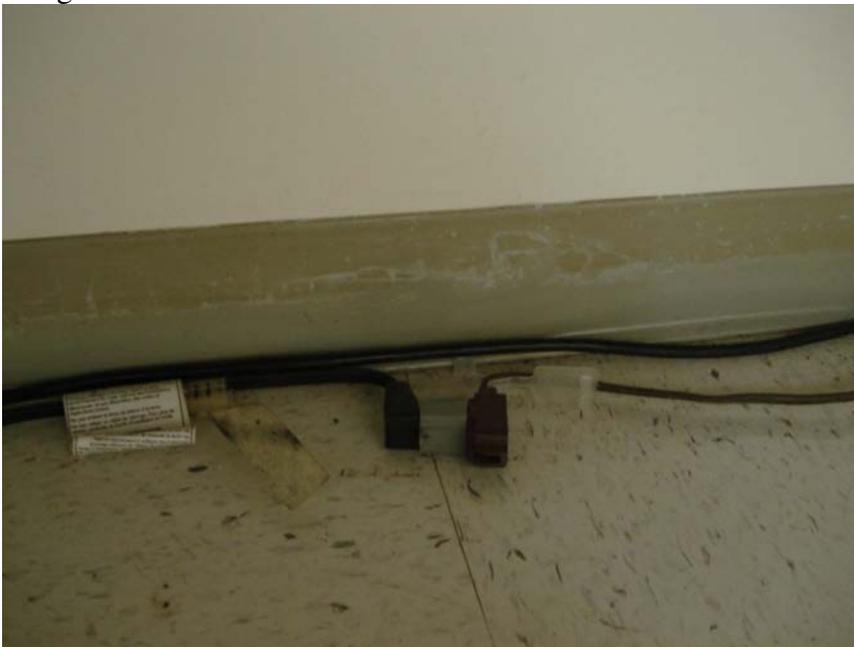
**Photo No. 11 – Appliance Extension Cords:** This microwave is plugged into a non-grounding, light duty extension cord, see photo below. Note that this break room has been rearranged, with a coffee station occupying the location designed for the refrigerator.

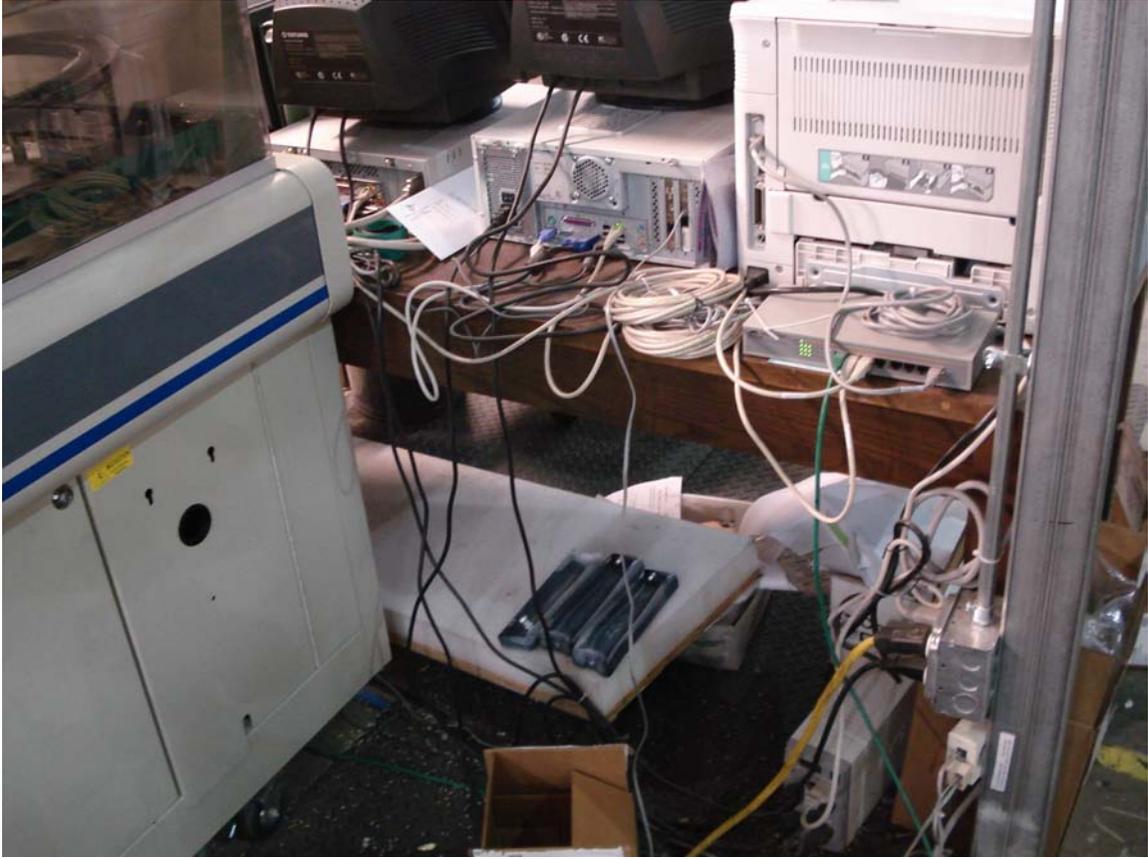
**Photo No. 12 – Workstations in Mail Sorting Room:** These works stations and a shop vacuum are sharing a single circuit.

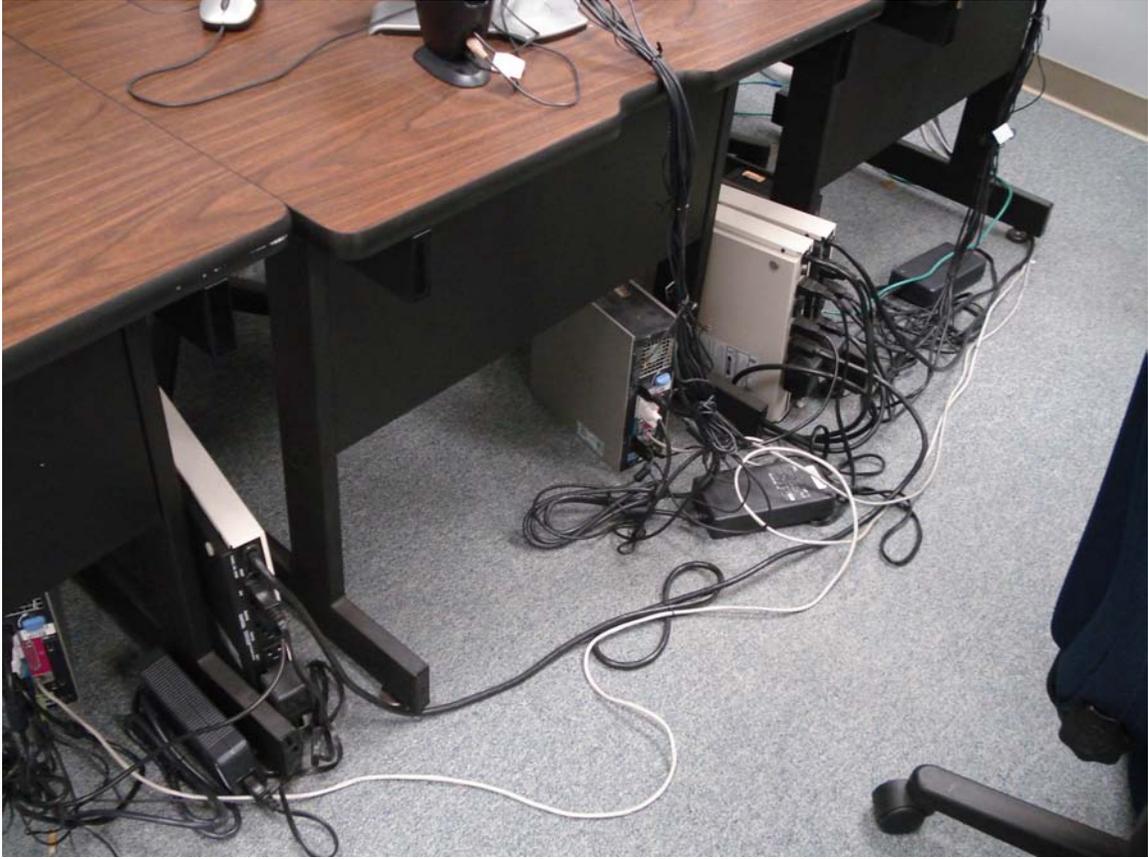
**Photo No. 13 – Workstations in Training Room:** These workstations are powered by three UPS units chained together with one of them plugged into a single receptacle.

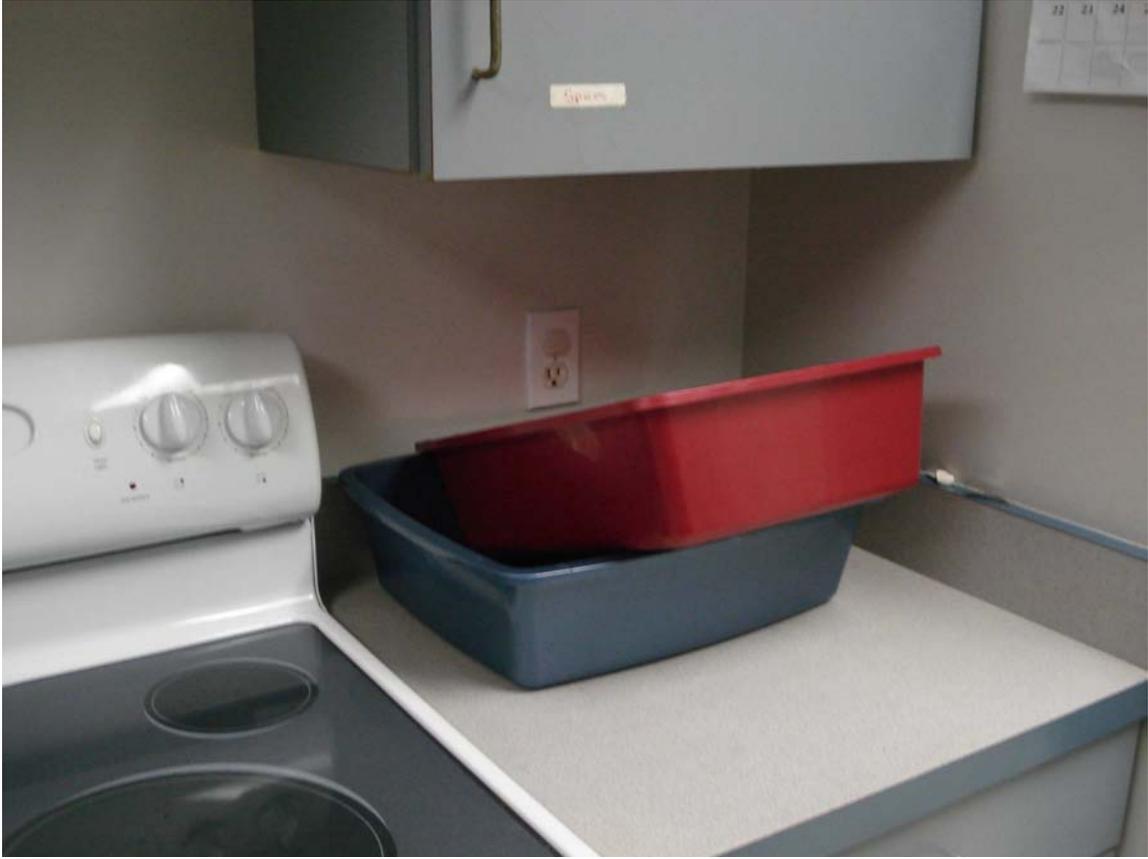
**Photo No. 14 – Countertop Receptacle in Day Care Kitchen:** This is one of two countertop receptacles in the day care kitchen that are not GFCI type.

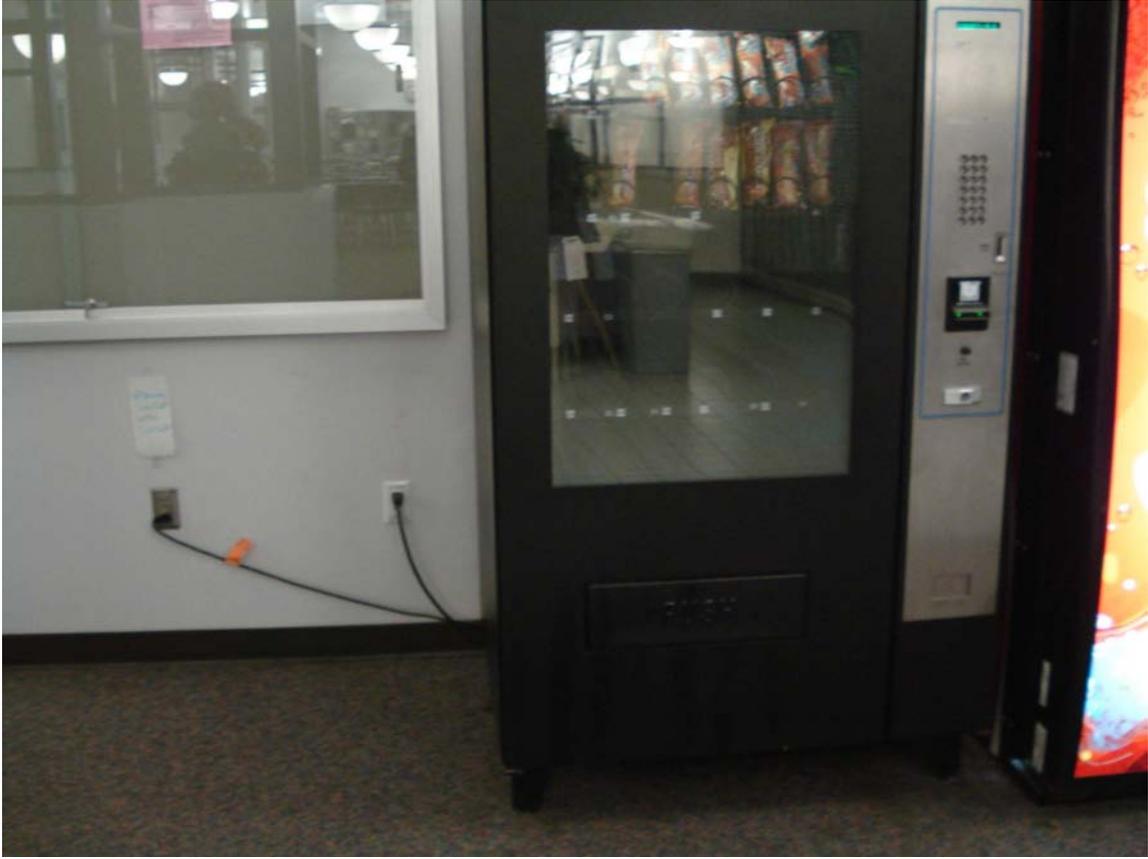
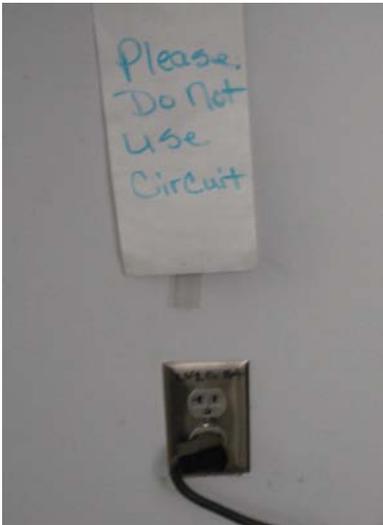
**Photo No. 15 – Vending Machines in Cafeteria:** These vending machines use receptacles that are not effectively dedicated (by placement behind machine). Two adjacent machines share one receptacle. Note the notice posted above one of the receptacles, below.

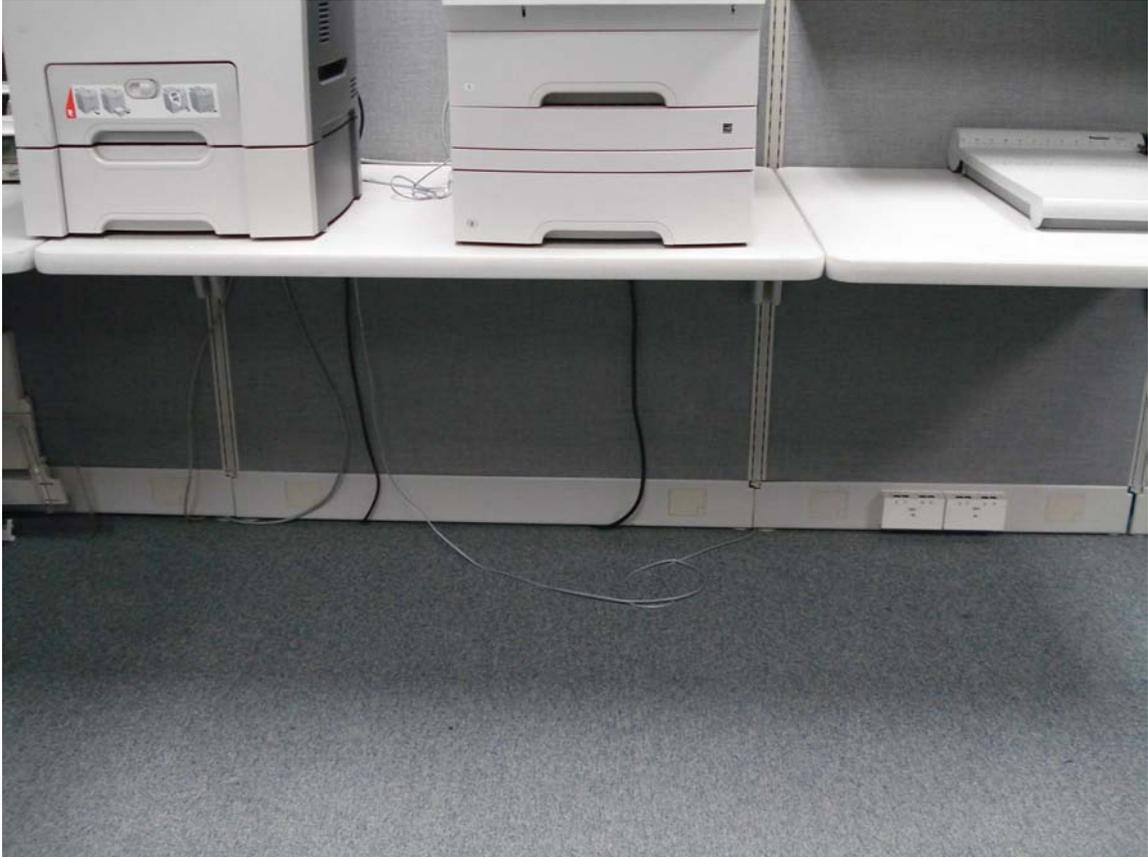
**Photo No. 16 – Printer Station:** These printers are “borrowing” power from the adjacent cubicle. Note the power cords routed under the partition.
