July 31, 2008

Document No. 20807001.2

Regarding: Limited Fungal Growth Assessment Survey
1ST Floor – Print Room 135

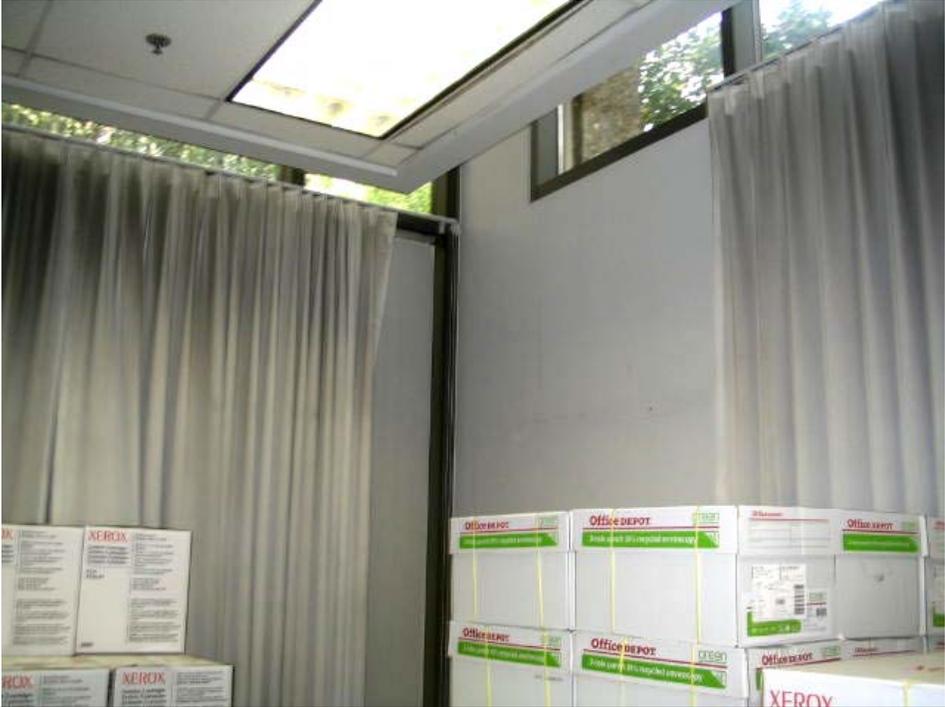
1

Date	Address	Photo Location – Description	Up
07/09/08	450 N Street Sacramento, California	First floor; Print Room 135; northeastern portion of room; looking northeast; view of northeastern corner; general view of area	↑

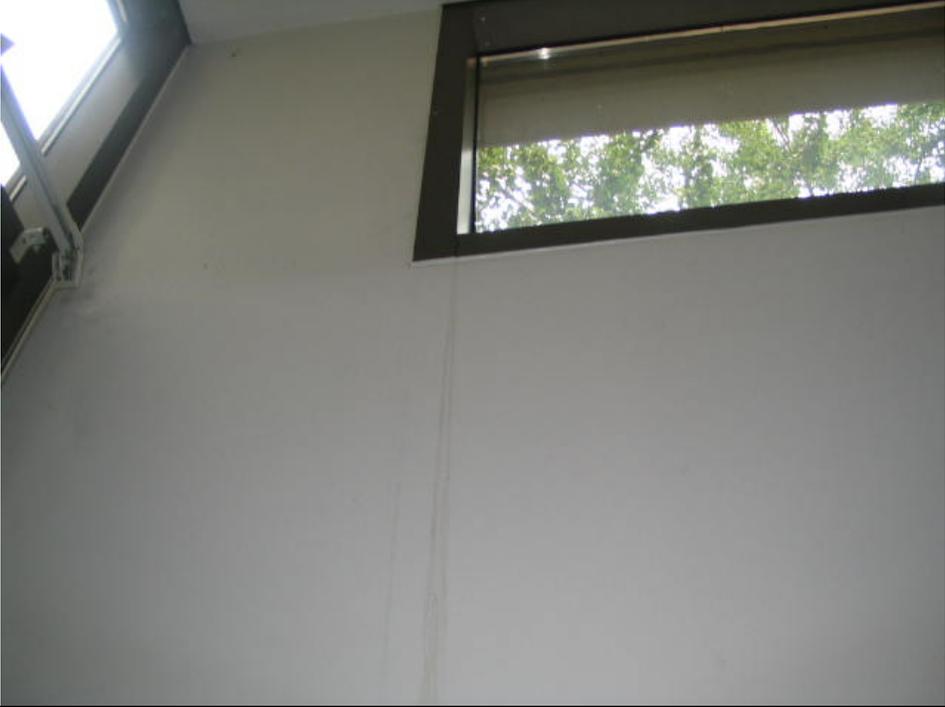
2

Upon visual inspection, evidence of water intrusion was apparent in various areas within the room. In the northeastern portion of the room, water staining was observed on the eastern perimeter wall beneath the upper and storefront windows (Photos 1 through 3). Additionally, suspect fungal growth was observed on the lower portion of the northern perimeter wall in the northeastern corner (Photo 4). Beneath the raised floor system in the subfloor area, water staining and evidence of metal oxidation (rust) were observed on various building materials along the northern and eastern perimeter walls in both the northeastern and southeastern portions of the room (Photos 5 through 12). Additionally, efflorescence was observed on the concrete subfloor at the southern portion of the room (Photo 13). Odors characteristic of fungal growth were not evident in the inspected areas.

Date	Address	Photo Location – Description	Up
07/09/08	450 N Street Sacramento, California	First floor; Print Room 135; northeastern portion of room; looking east and up; view of eastern perimeter wall; showing water staining	↑

- 1) Possible sources of the water intrusion should be identified or confirmed and the subsequent repairs made. If water intrusion occurs in the structure in the future, affected materials should be dried promptly so that fungal growth potentials are minimized.
- 2) Additional building investigative and/or remediation efforts should be performed in this room and any adjacent rooms as necessary.
- 3) All concrete surfaces beneath the raised floor system in the eastern portion of the room should be detail-cleaned with HEPA vacuum and/or other equipment, and sanitized with a suitable biocide.
- 4) Those portions of building materials showing evidence of fungal growth should be isolated using polyethylene sheeting until remediation can be performed.

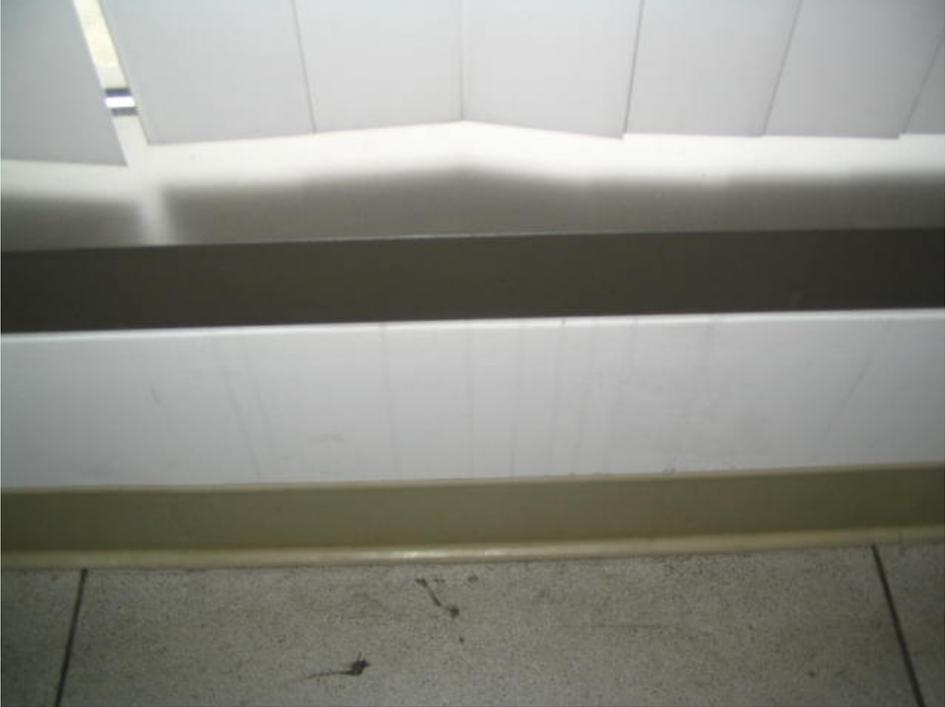
3

Date	Address	Photo Location – Description	Up
07/09/08	450 N Street Sacramento, California	First floor; Print Room 135; northeastern portion of room; looking east and down; view of eastern perimeter wall; showing water staining	↑

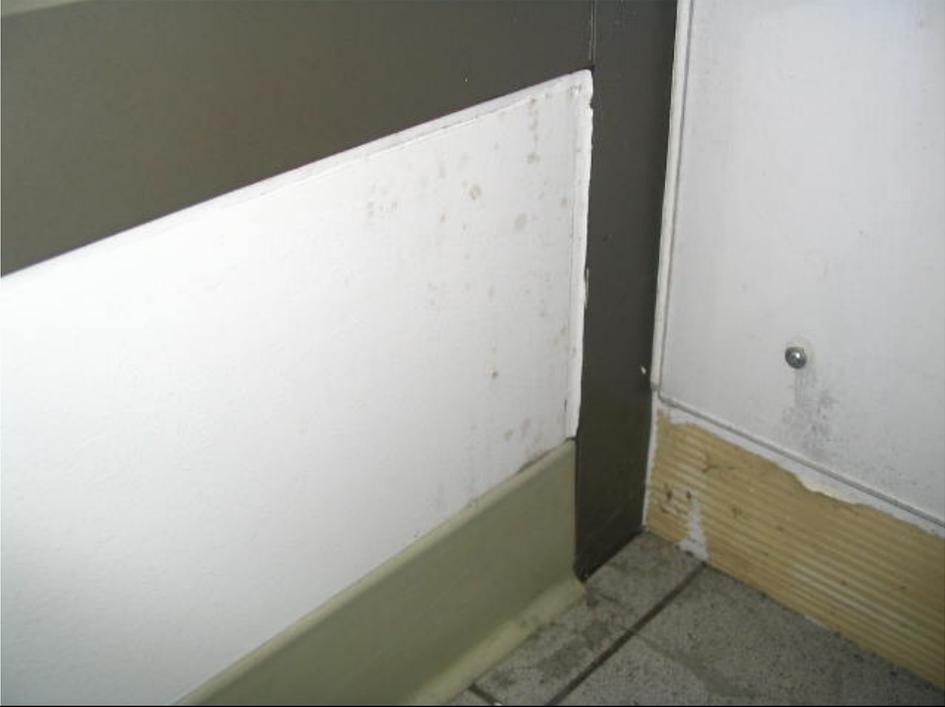
4

The surface assessment data, which appear with supporting information in Table 20807001-3, indicated minimal fungal growth and loose fungal spores involving *Cladosporium* on the lower portion of the northern perimeter wall in the northwestern portion of the room.

Date	Address	Photo Location – Description	Up
07/09/08	450 N Street Sacramento, California	First floor; Print Room 135; northeastern portion of room; looking northeast and down; view of northern perimeter wall; showing suspect fungal growth	↑

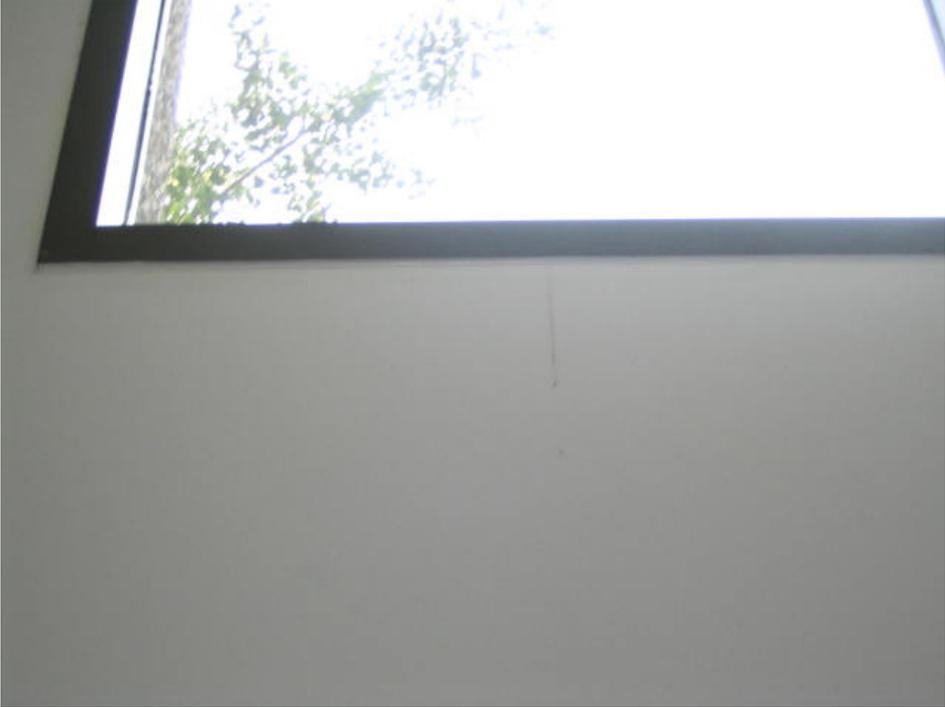
5

Date	Address	Photo Location – Description	Up
07/09/08	450 N Street Sacramento, California	First floor; Print Room 135; southeastern portion of room; looking east and up; view of eastern perimeter wall; showing staining	↑

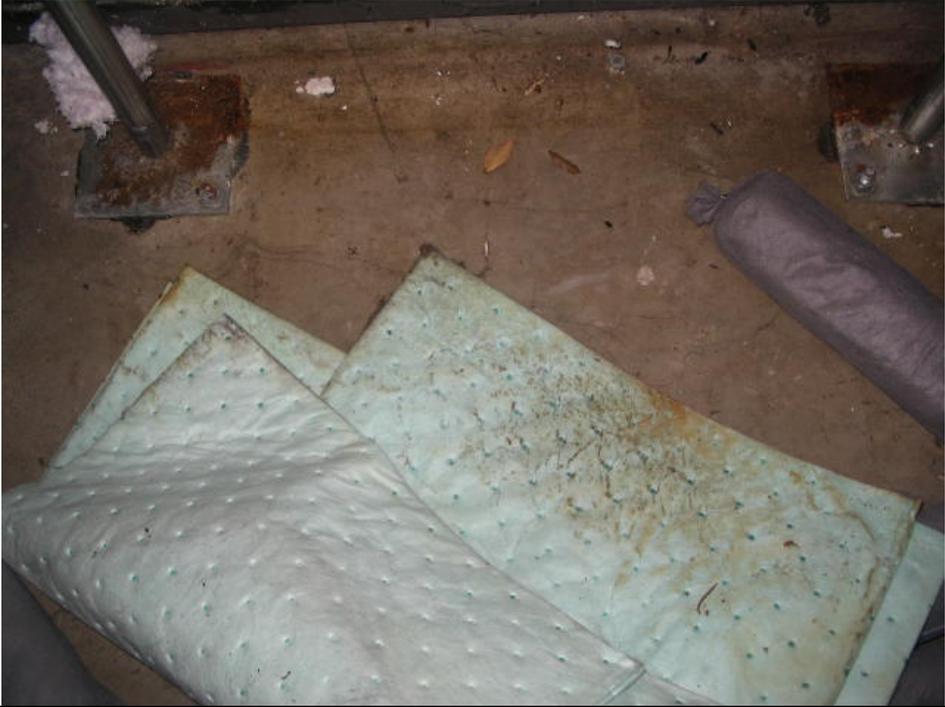
6

Date	Address	Photo Location – Description	Up
07/09/08	450 N Street Sacramento, California	First floor; Print Room 135; northeastern portion of room; looking north and down; view of subfloor area beneath northern storefront window; showing water staining on absorbent pad and rust on metal base plate	↑

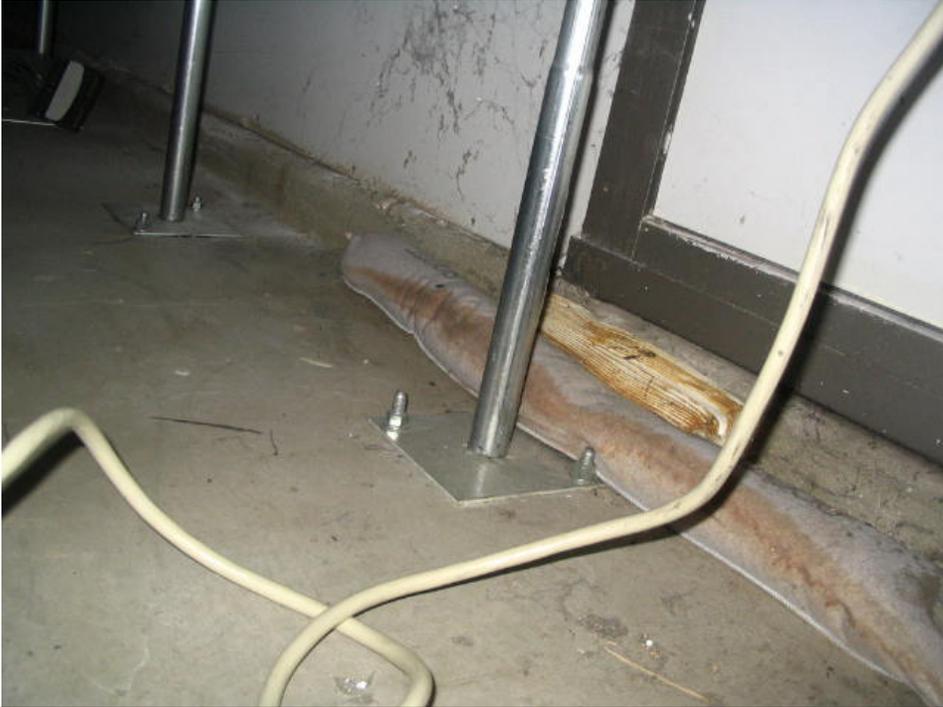
7

Date	Address	Photo Location – Description	Up
07/09/08	450 N Street Sacramento, California	First floor; Print Room 135; northeastern portion of room; looking northeast and down; view of subfloor area beneath eastern storefront window; showing water staining on absorbent sock	↑

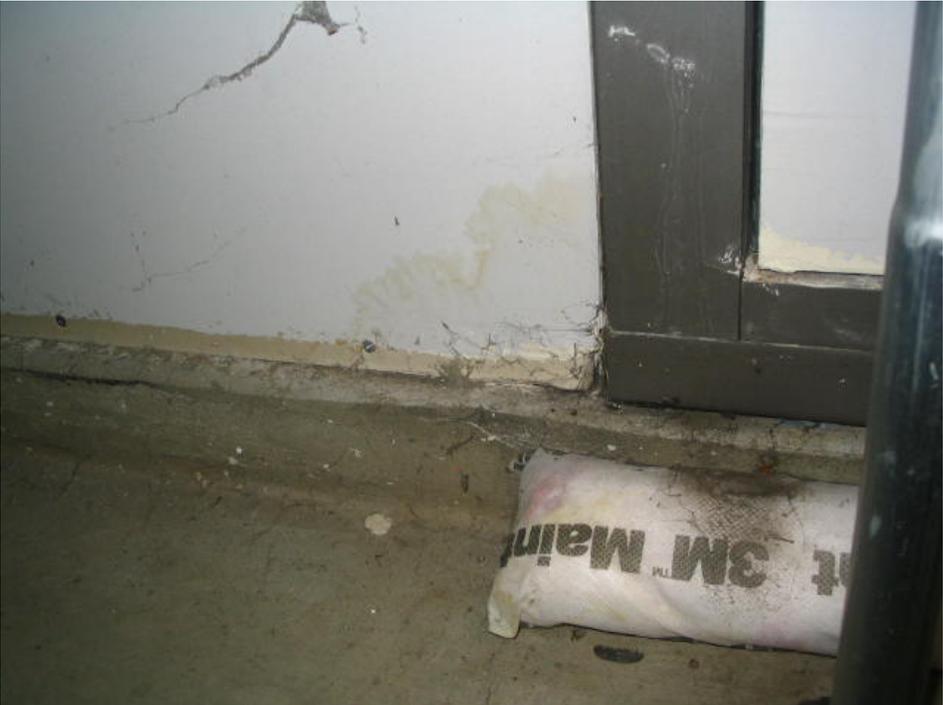
8

Date	Address	Photo Location – Description	Up
07/09/08	450 N Street Sacramento, California	First floor; Print Room 135; southeastern portion of room; looking east and down; view subfloor area beneath eastern storefront window; showing water staining northern perimeter wall and on absorbent sock	↑

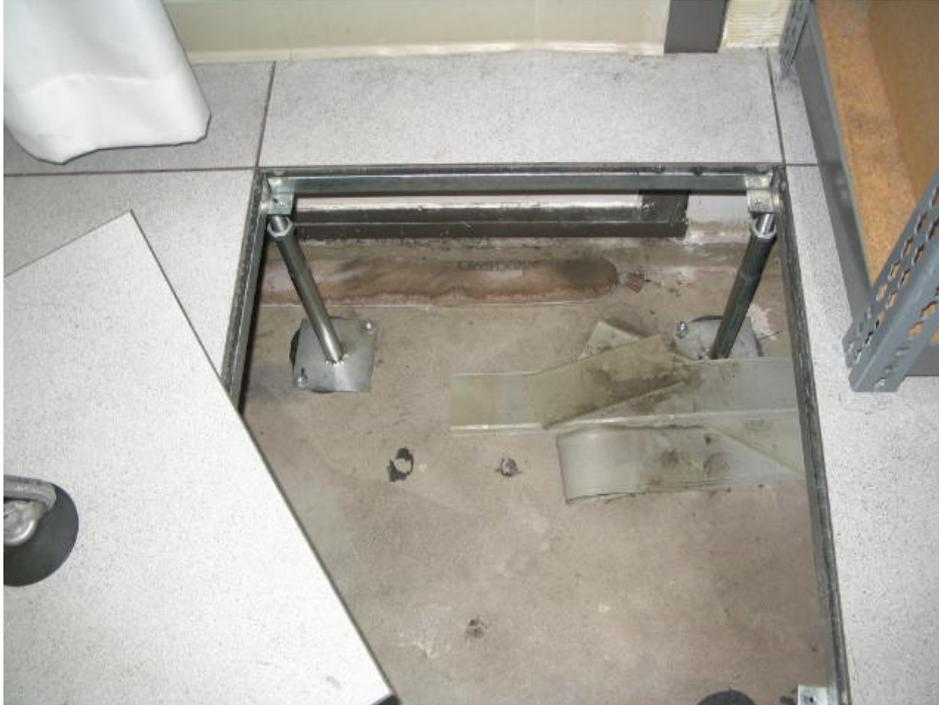
9

Date	Address	Photo Location – Description	Up
07/09/08	450 N Street Sacramento, California	First floor; Print Room 135; southeastern portion of room; looking east and down; view of subfloor area beneath eastern storefront window; showing staining on absorbent sock	↑

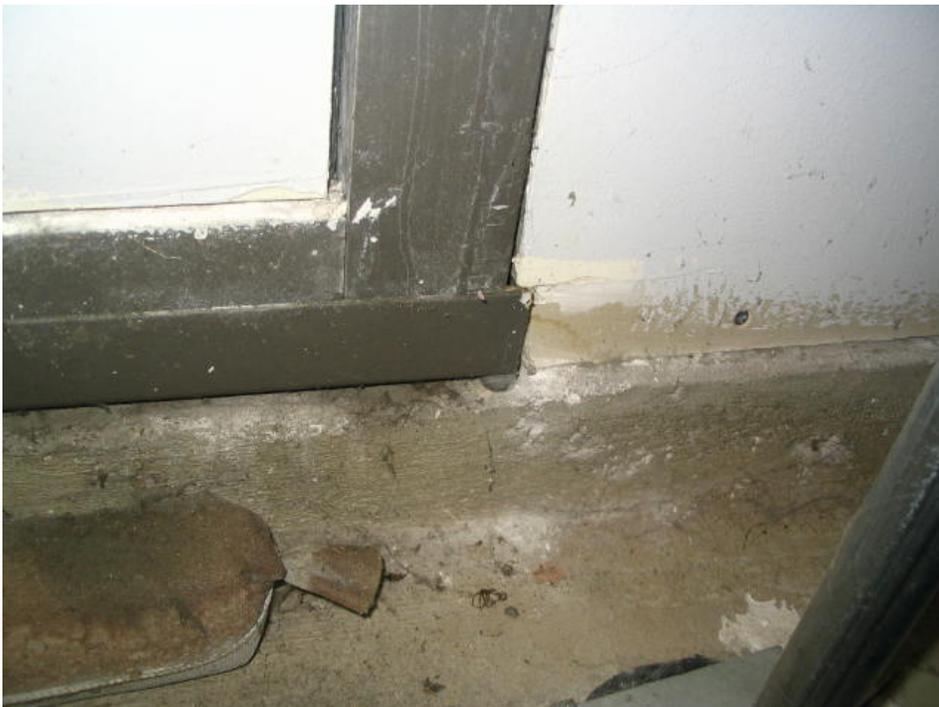
10

Date	Address	Photo Location – Description	Up
07/09/08	450 N Street Sacramento, California	First floor; Print Room 135; southeastern portion; looking east and down; view of subfloor area beneath eastern storefront window; showing water staining on absorbent sock and northern perimeter wall	↑

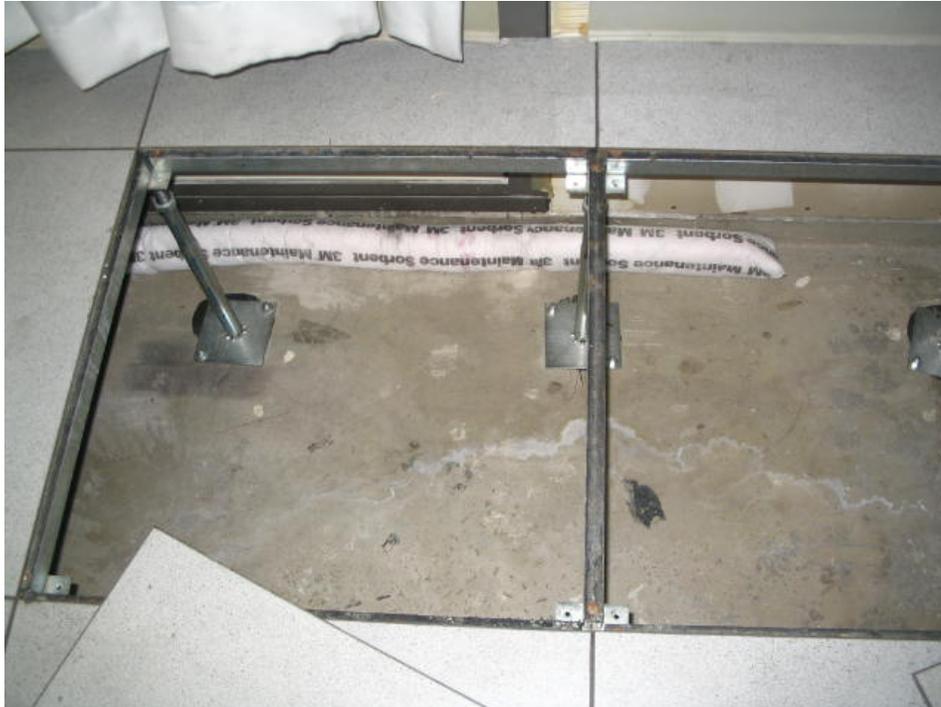
11

Date	Address	Photo Location – Description	Up
07/09/08	450 N Street Sacramento, California	First floor; Print Room 135; southeastern portion of room; looking east and down; view of subfloor area beneath eastern storefront window; showing water staining on absorbent sock and concrete subfloor	↑

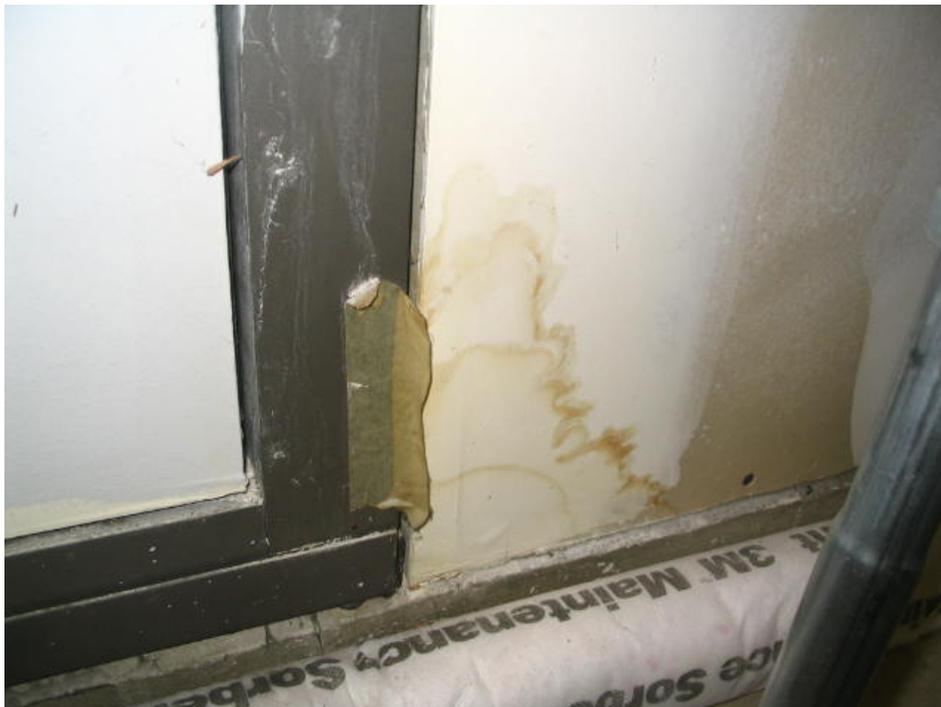
12

Date	Address	Photo Location – Description	Up
07/09/08	450 N Street Sacramento, California	First floor; Print Room 135; southeastern portion of room; looking east and down; view of subfloor area beneath eastern storefront window; showing staining on eastern perimeter wall	↑

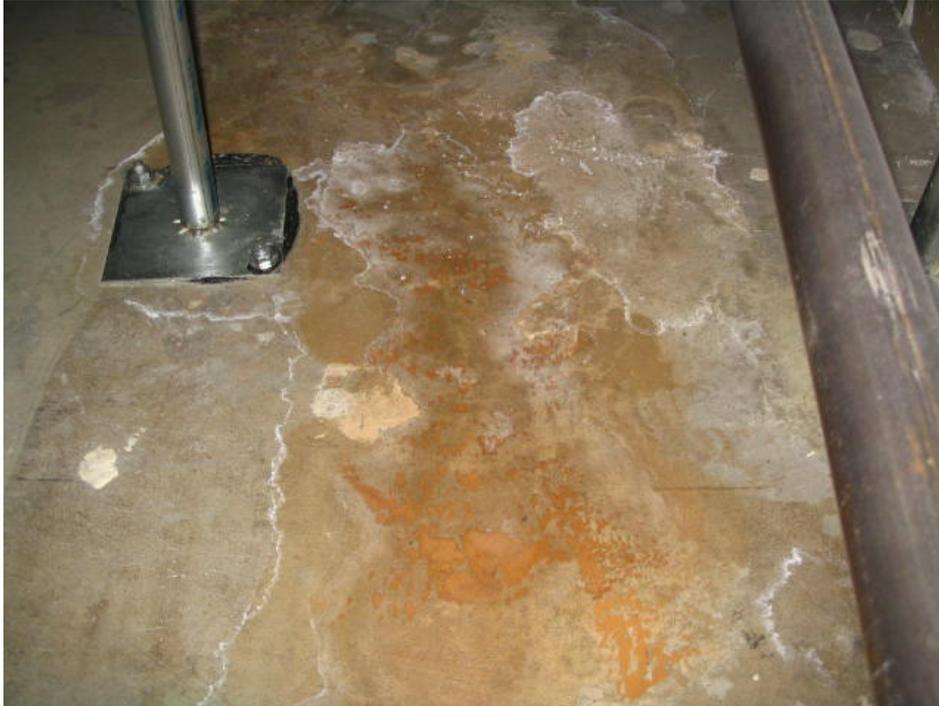
13

Date	Address	Photo Location – Description	Up
07/09/08	450 N Street Sacramento, California	First floor; Print Room 135; southern portion of room; looking down; view of southern portion of subfloor area; showing staining and efflorescence on concrete subfloor	↑
