California State Board of Equalization
450 N Street, Sacramento, California

**Mold Remediation – Second Floor
Closure Report Addendum**

Project No. 2372.02-572

Addendum Date: October 31, 2012

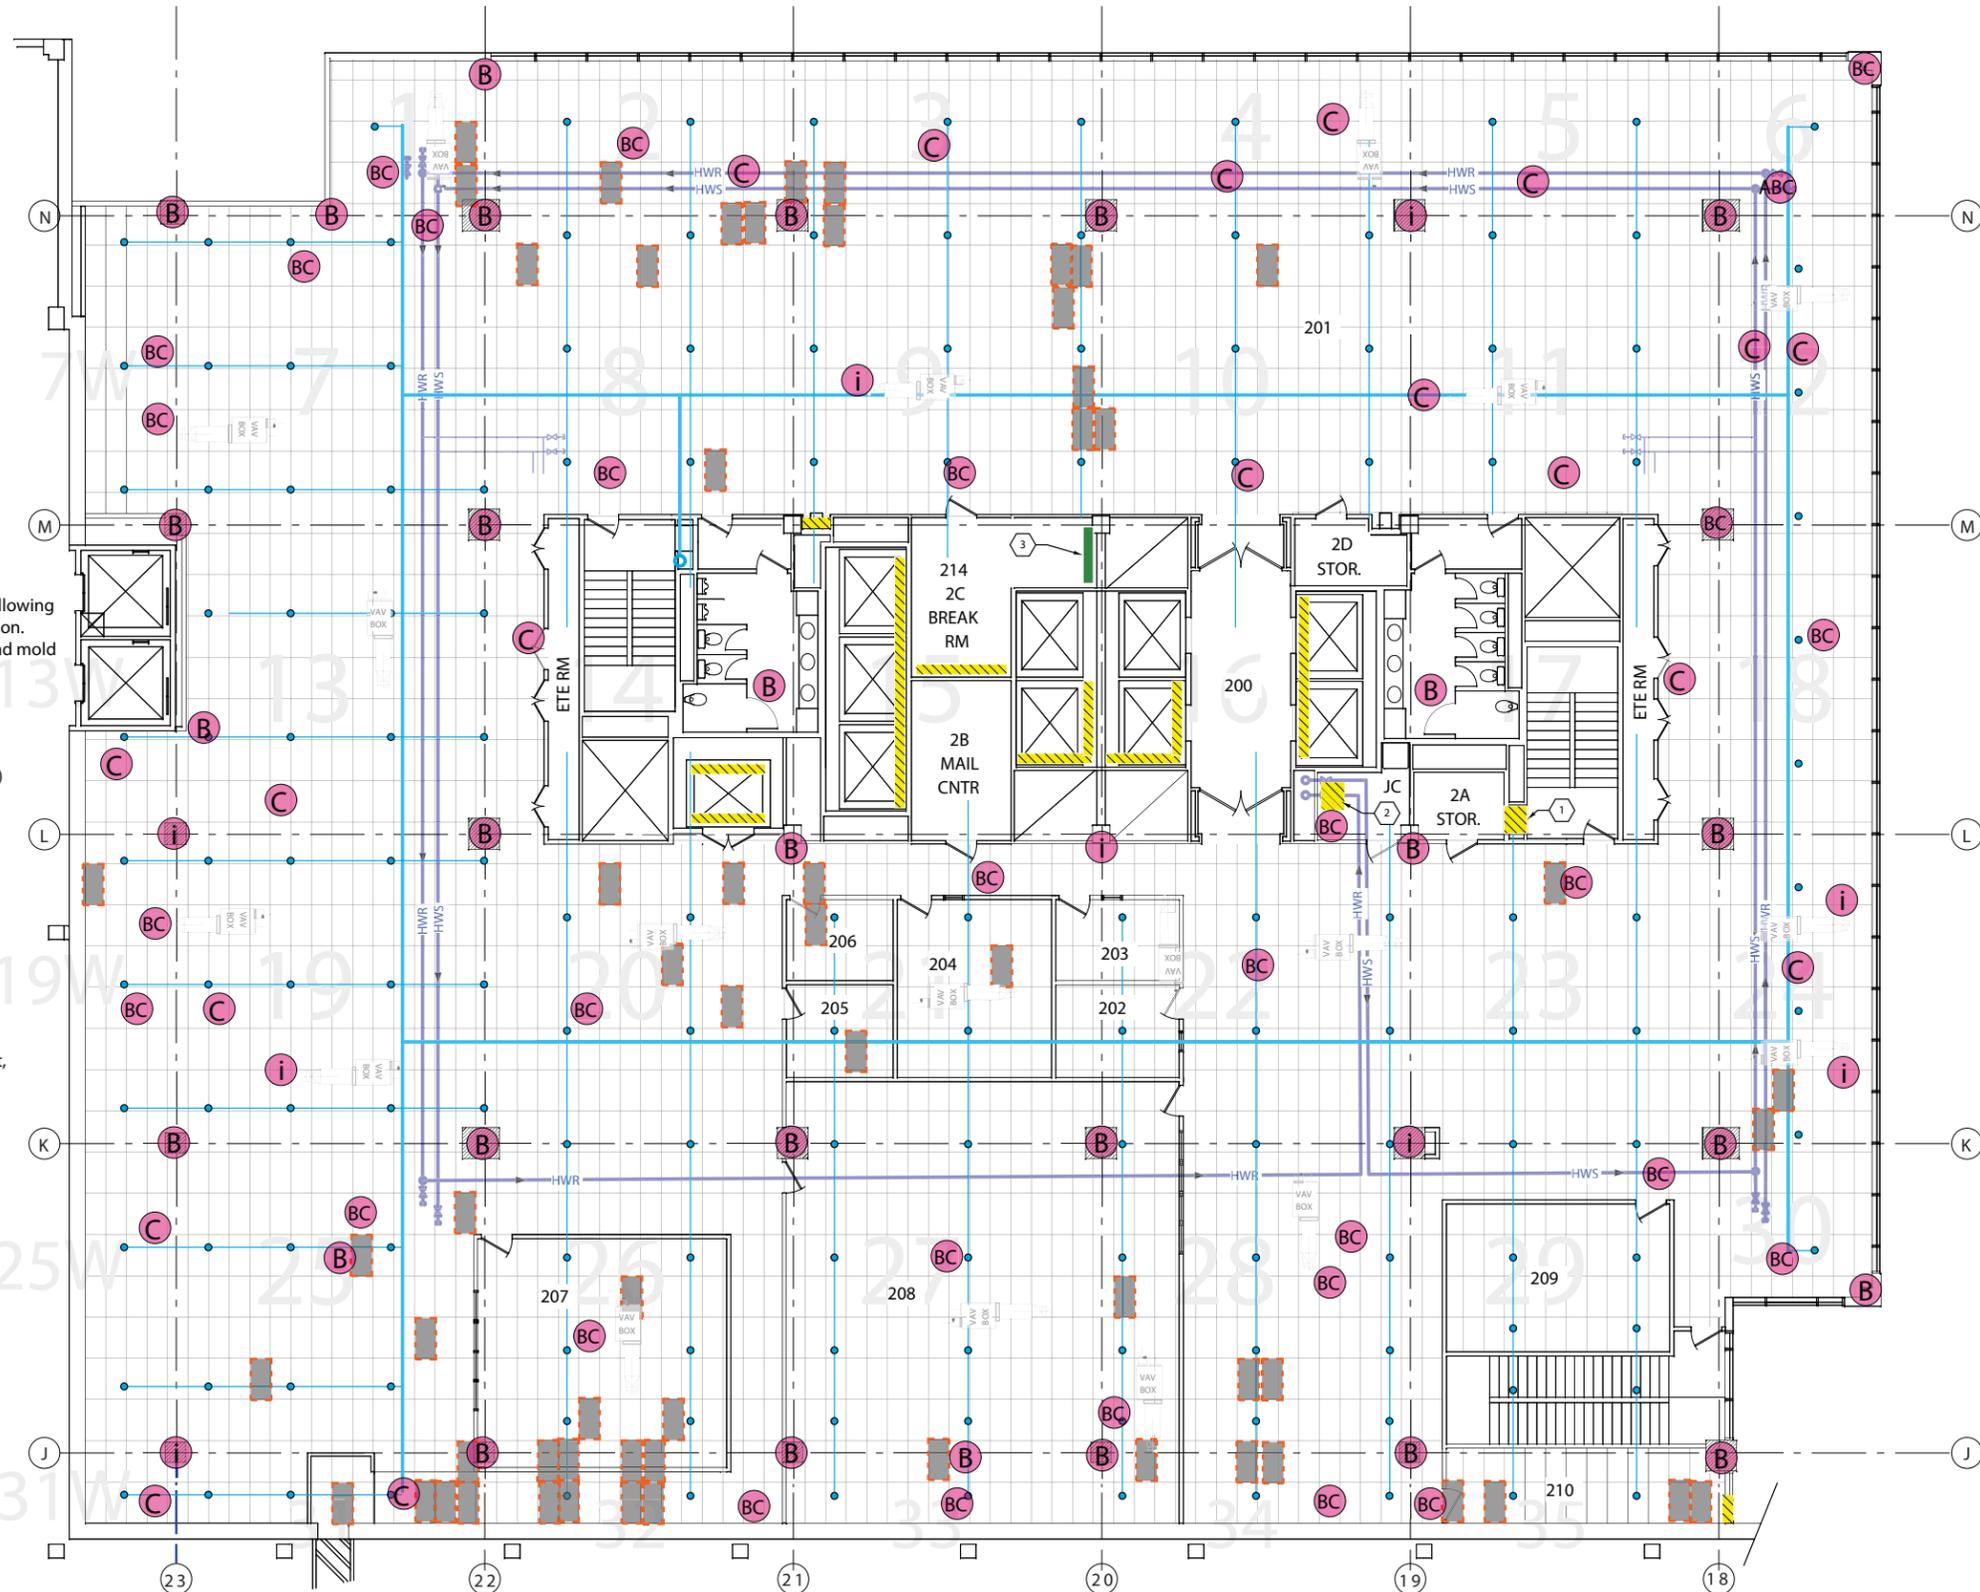
Stairs 3, SE Corner | The exterior concrete panels leaked and caused staining of ceiling tiles and visible mold growth. The damage was investigated and remediated. |

- ① Water stain at standpipe
- ② Stain below pipe
- ③ Visible mold growth 10 sq.ft. above ceiling

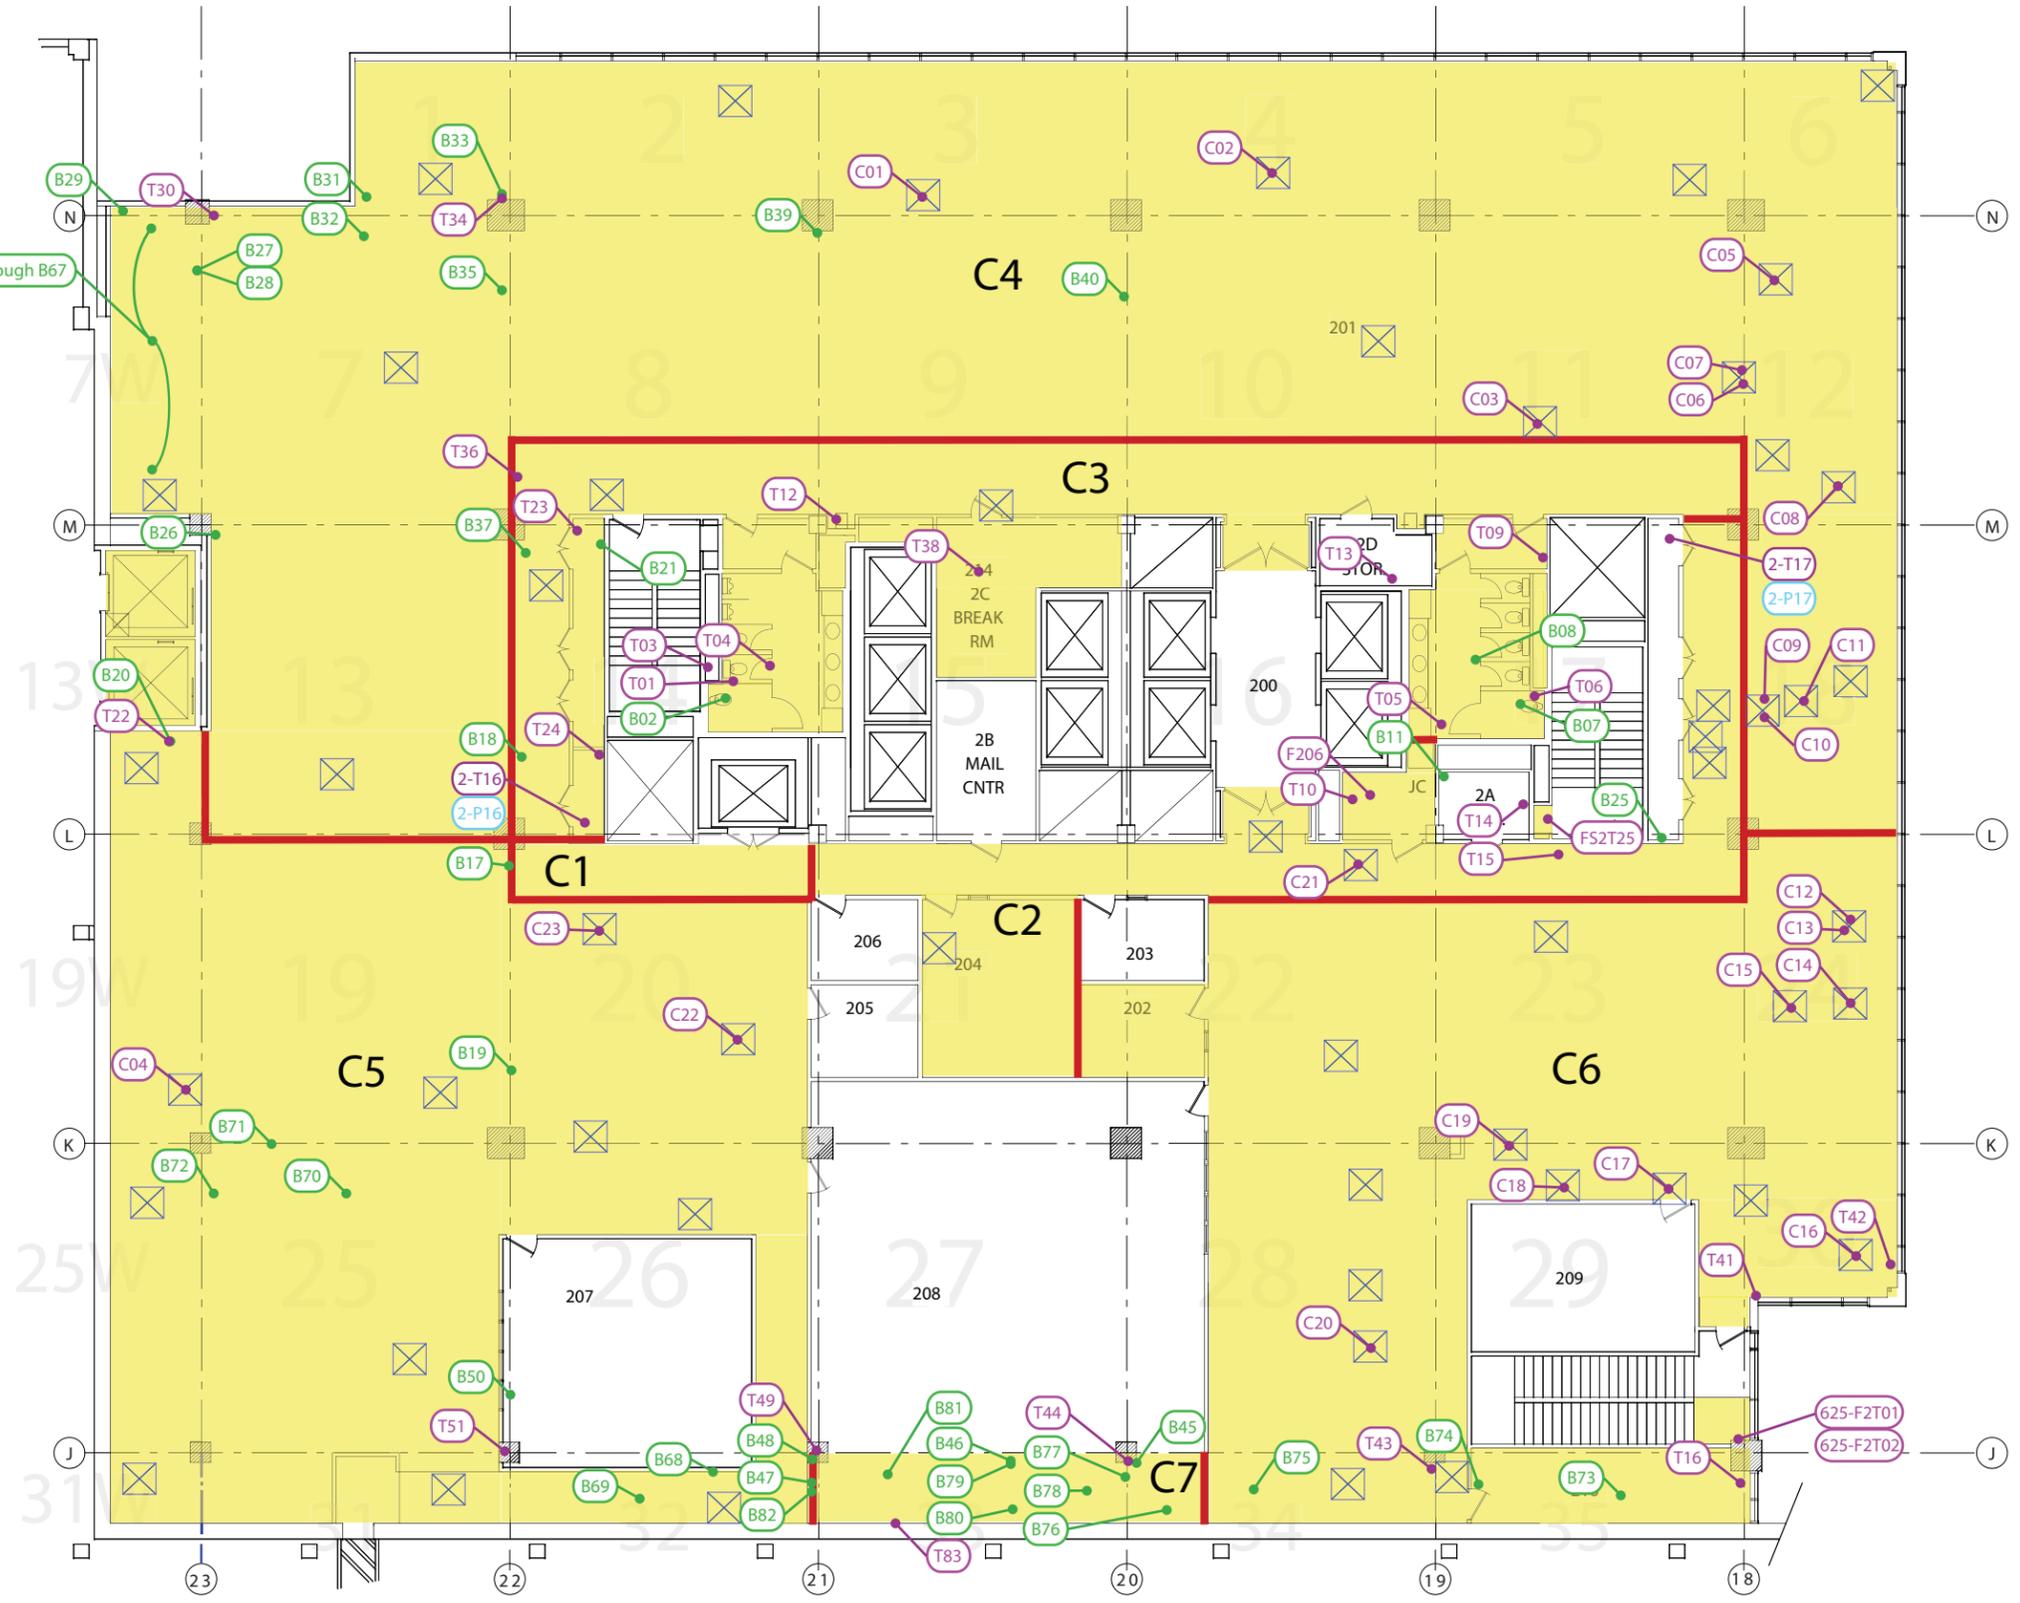
Containment barrier

- 20:30 observe and photo doc Floor 2 stairs 3 stained ceiling tile w/ung observe wall damage and delam cove base - arrange for JLS to change out the ceiling tile and tape cove base
