California State Board of Equalization
450 N Street, Sacramento, California

**Mold Remediation – Third Floor
Closure Report Addendum**

Project No. 2372.02-572

Containment and Sample Locations (Oct 2012)
 Board of Equalization Building, Mold Remediation
 450 N Street, Sacramento, California

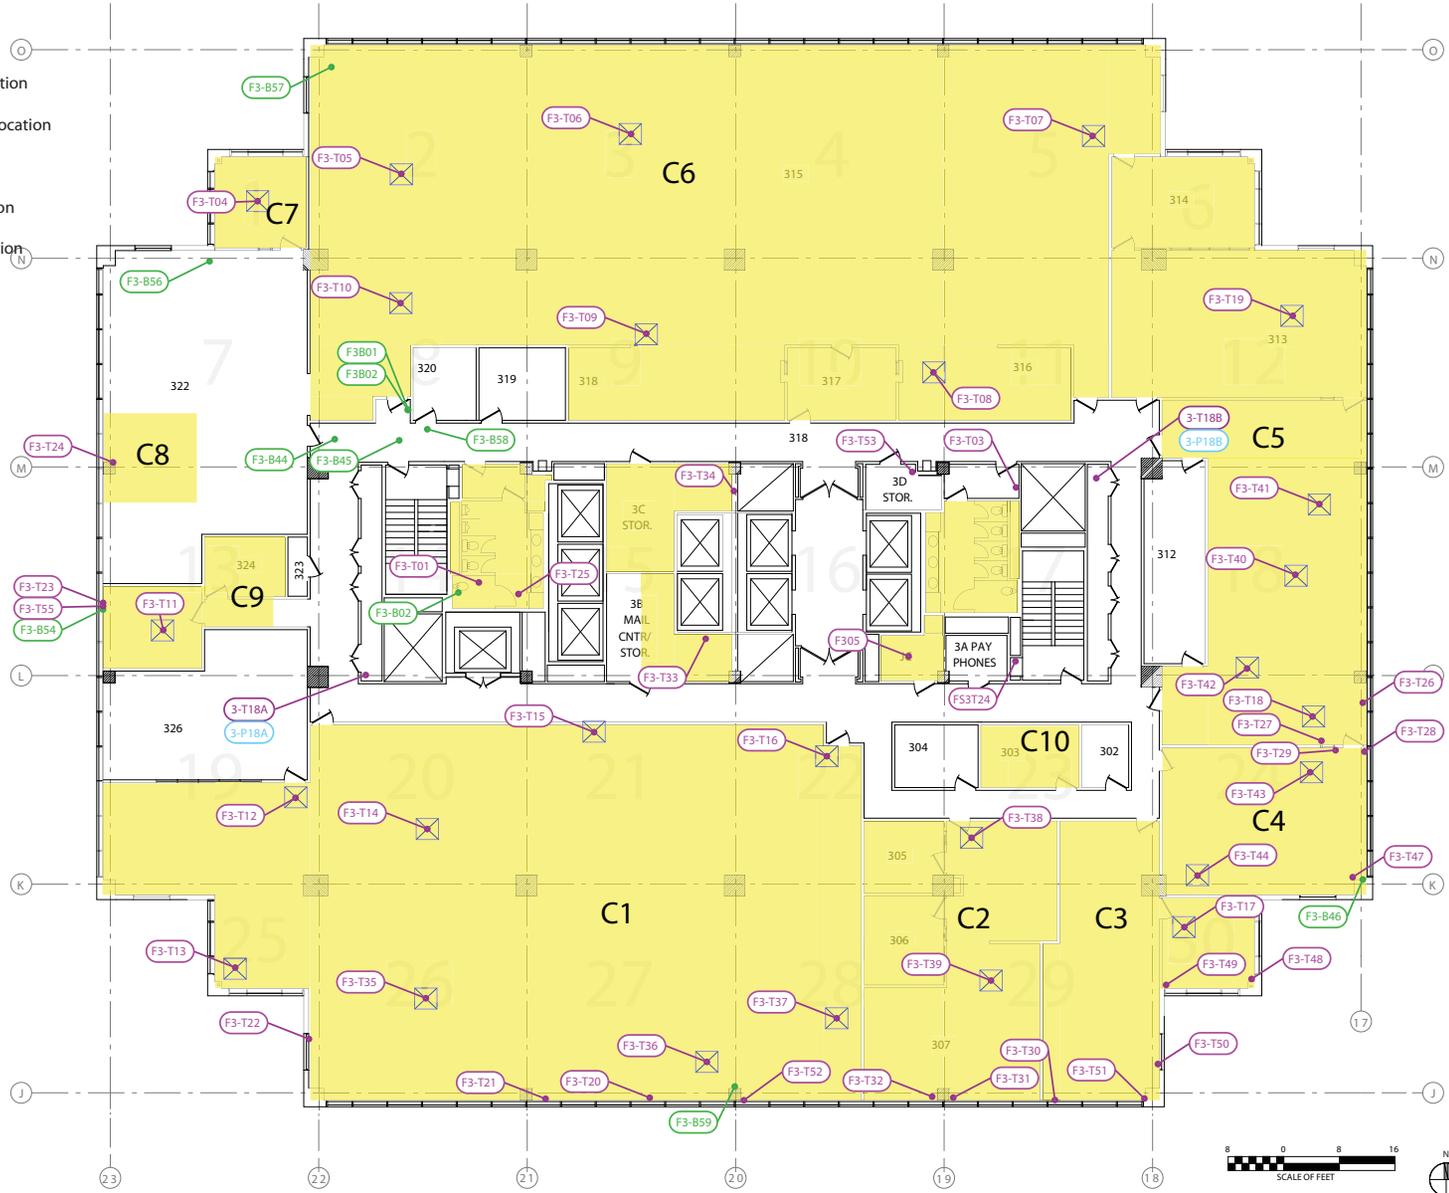
Subsequent to the completion of the closure report, a need for additional investigation and/or remediation activities was identified. Identified areas were subjected to sampling. Using a combination of surface tape lift and/or bulk samples, LCD tested stains on walls and other building materials to determine if the stains were indicative of mold growth. The sample locations are depicted in a revised Figure 2 attached to this addendum.
