BioMax Environmental

November 18th, 2008

**Microbial Assessment and
Mitigation Procedures for 5th and 6th Floor Storage and Electrical Room Areas
Department of General Services Board of Equalization Building
450 N. Street
Sacramento, California**

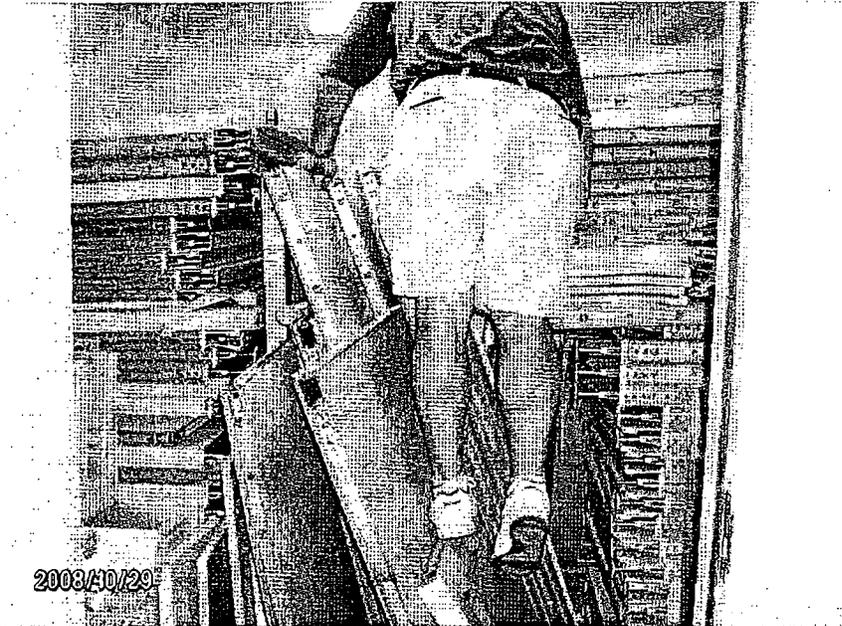
Storage Room 6C – At the time of our 10/29/08 assessment, storage room 6C was observed with excessive quantities of stored cubicle dividers and furniture which significantly limited physical access into the room. Upon inspection of accessible areas, however, BioMax verified the presence of dark colored "smudges" present on the upper wall to the left of the door entry point which had been indicated through interviews with LCD personnel. Although such "smudges" contained evidence of what appeared to be that of physical contact abrasion, BioMax elected to collect a surface sample and airborne SporeTrap sample for confirmatory microbial analysis as a precautionary measure. Utilization of a hand-held moisture meter also indicated normal moisture content present within the accessible structural areas at the time of our assessment.

- 1) Condition of Storage Room 6C wherein extensive quantities of cubicle furniture was stored creating limited access for inspection and sampling during assessment.

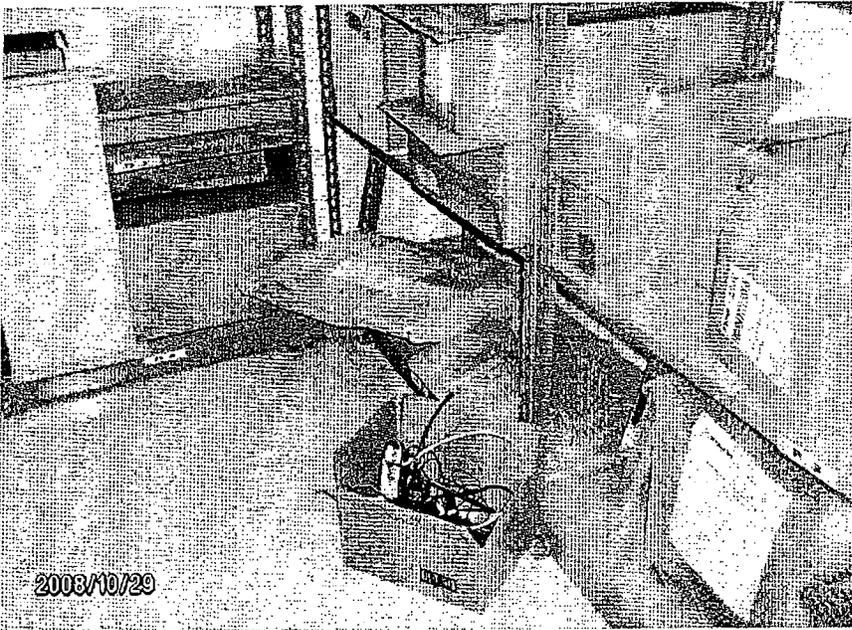
Storage Room 5C – At the time of our 10/29/08 assessment, BioMax inspected the MAP Scanning Room with a shared wall located to the west and adjacent to the noted break room. No visual evidence of mold-like staining was observed present on the shared wall. Utilization of a hand-held moisture meter also indicated normal moisture content present within the wallboard material at the nearest approximate location to the impacted area at the time of our assessment. A single air sample was similarly collected from this accessible area for comparative purposes.

- 3) Image within Storage Room 5C wherein wall-bolted metal framed shelving had covered localized suspect mold-like growth at lower shelf area.

10. Following metal shelving removal, BioMax specifically recommends that all visibly damaged sheetrock materials and impacted sheetrock be removed and wallboard underlayment materials inspected for moisture related damages. As verified through visual inspection, any stained and/or moisture/mold affected interior sheetrock and building materials should be removed, wherever feasible, to the extent of visible staining, at a minimum. Any affected baseboard and floor tile materials shall also be removed and disposed under containment controls for appropriate inspection of subflooring at the direction of the project CIH.

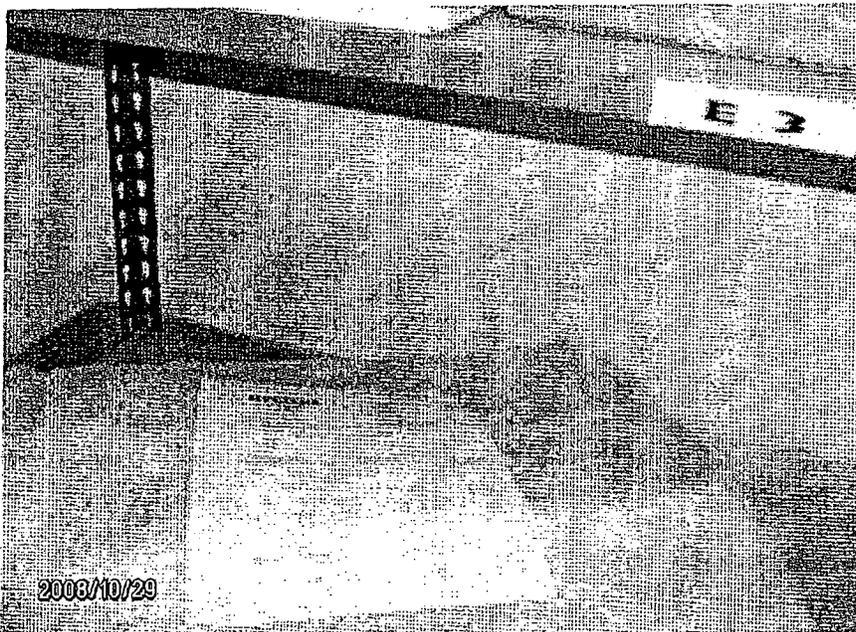
- 4) Close-up image of stained wall surface following removal of office equipment from lower shelf at time of assessment.

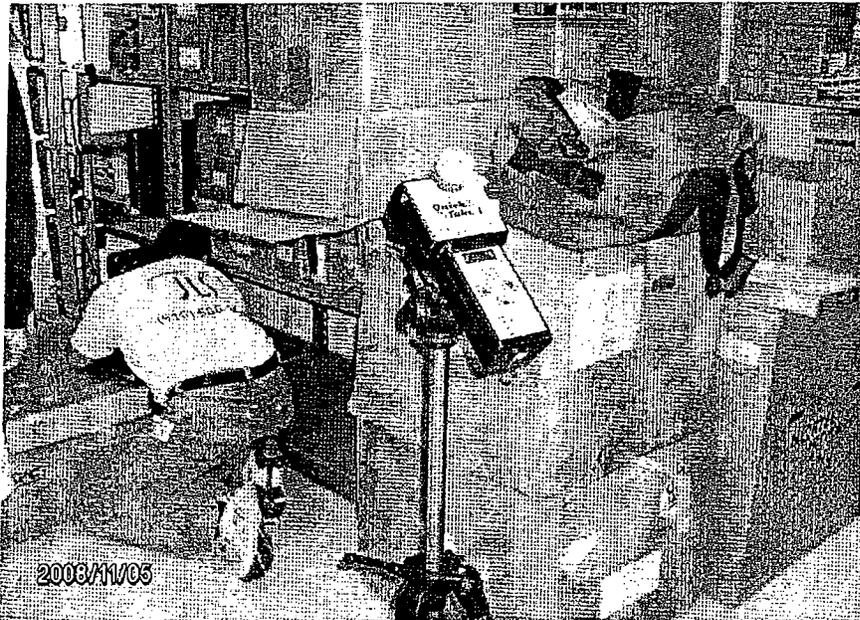
Storage Room 5B – At the time of our follow-up assessment performed on 11/05/08, BioMax identified the presence of mold-like surface staining near the floor level present behind a metal storage rack with shelved computer equipment and supplies. BioMax also noted the presence of what appeared to be “stuffed” paint on the wall to ceiling interface immediately above the mold like staining. Such areas, however, did not contain the presence of staining on sheetrock or paint underlayment surfaces inspected at the time of this assessment. Utilization of a hand-held moisture meter also indicated normal moisture content present within the accessible structural areas at the time of our assessment. A SporeTrap airborne sample was similarly collected from this tenant accessible area for comparative purposes.

7) Image of air sampling and storage materials present within storage room 5B at time of follow-up airborne and surface assessment performed on 11/05/08.

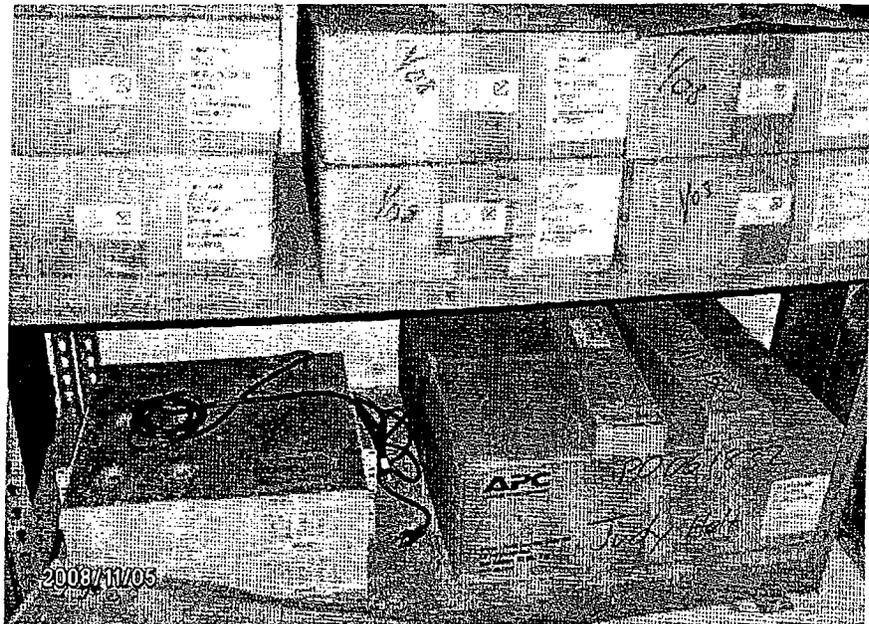
8) Image of stored material covering stained wallboard material within storage Room 5B at time of assessment.
