MJO: 3726

Date: July 13, 2012

Customer: DGS/RESO/BPM

Cast Iron Pipe Fittings Corrosion Analysis

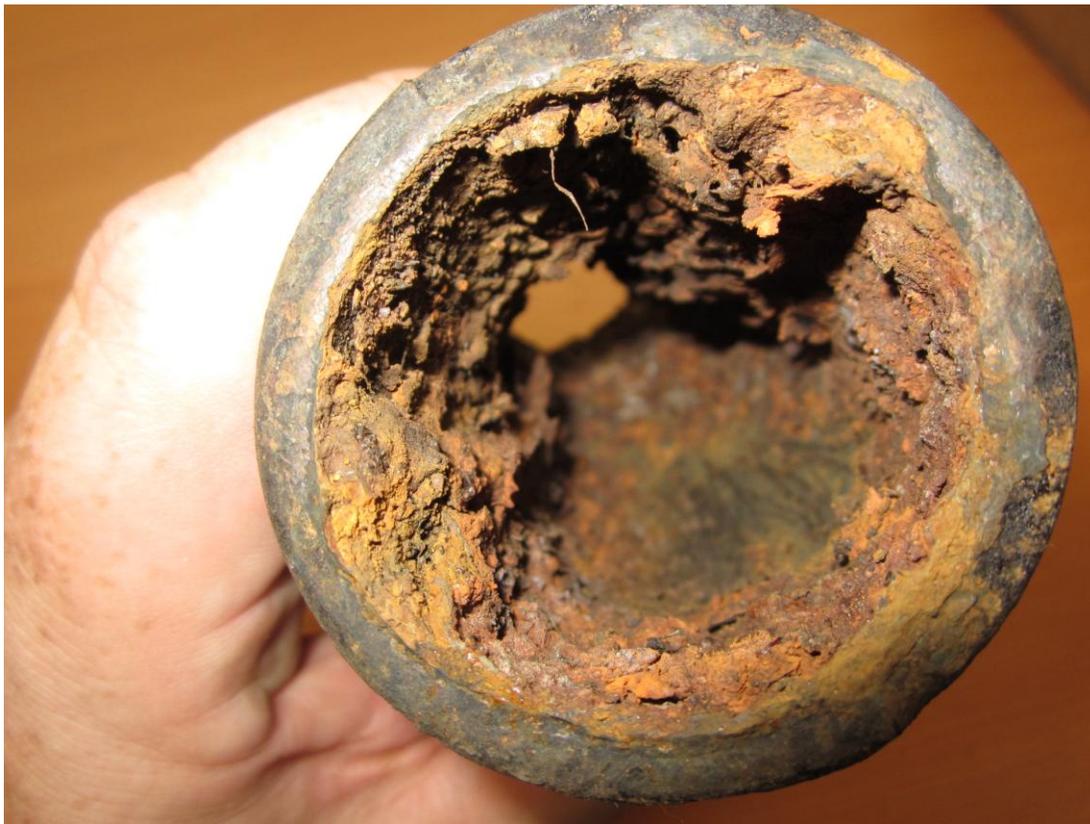
Introduction: Two cast iron pipe fittings from the 4th floor sanitary line of 450 North St. (Suite 1200), Sacramento, CA 95814, were submitted to MTL for corrosion analysis. Sample #1 was a 1/8th Bend and Sample #2 was a Tee. Both exhibited extensive corrosion from the inside out (See Figures 1 & 2 below) however the Tee was the worse case having to be delivered in two pieces.

Figure 1 – Inside of 1/8th bend fitting (Sample 1).

Alloy selection – White cast iron is immune to graphitic corrosion although it is susceptible to other forms.

Control of the environment – water traps could reduce or eliminate corrosion gases, raising the pH (via alkaline drain cleaners) is an inexpensive approach.

Use of sacrificial anode cathodic protection or impressed current cathodic protection.

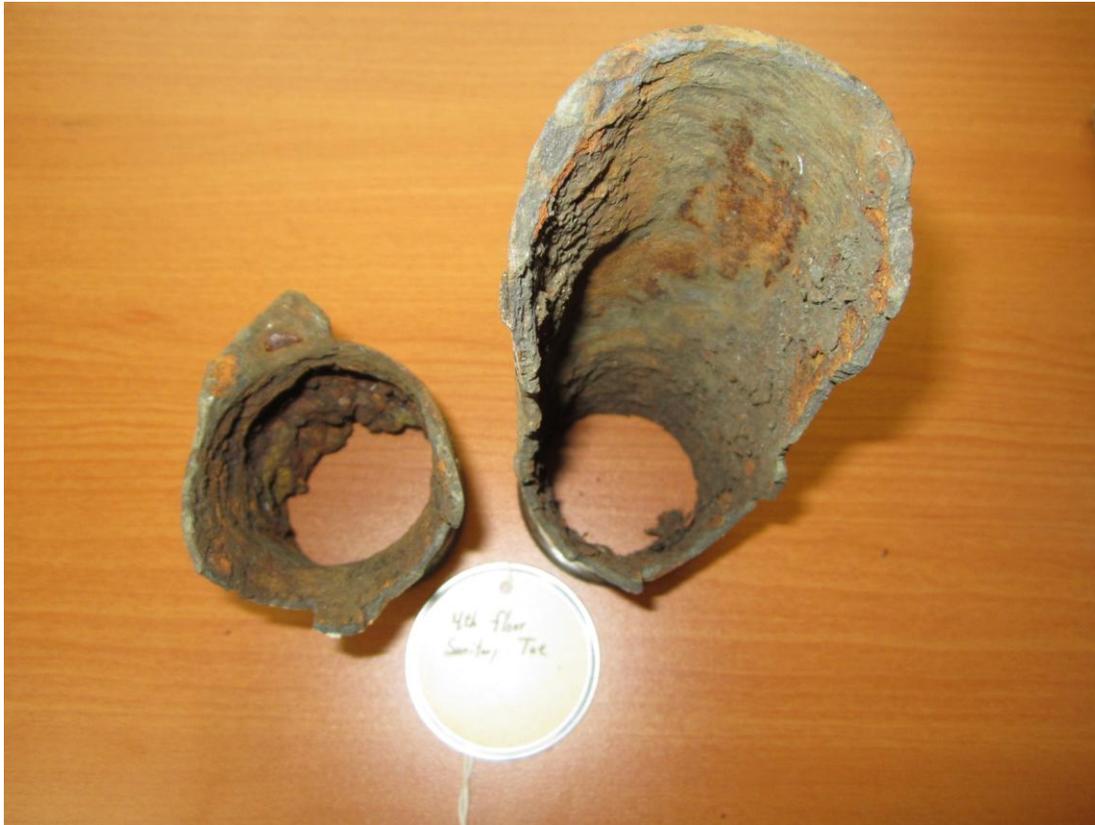
Figure 2 – Sample 2 – Fourth floor Tee.

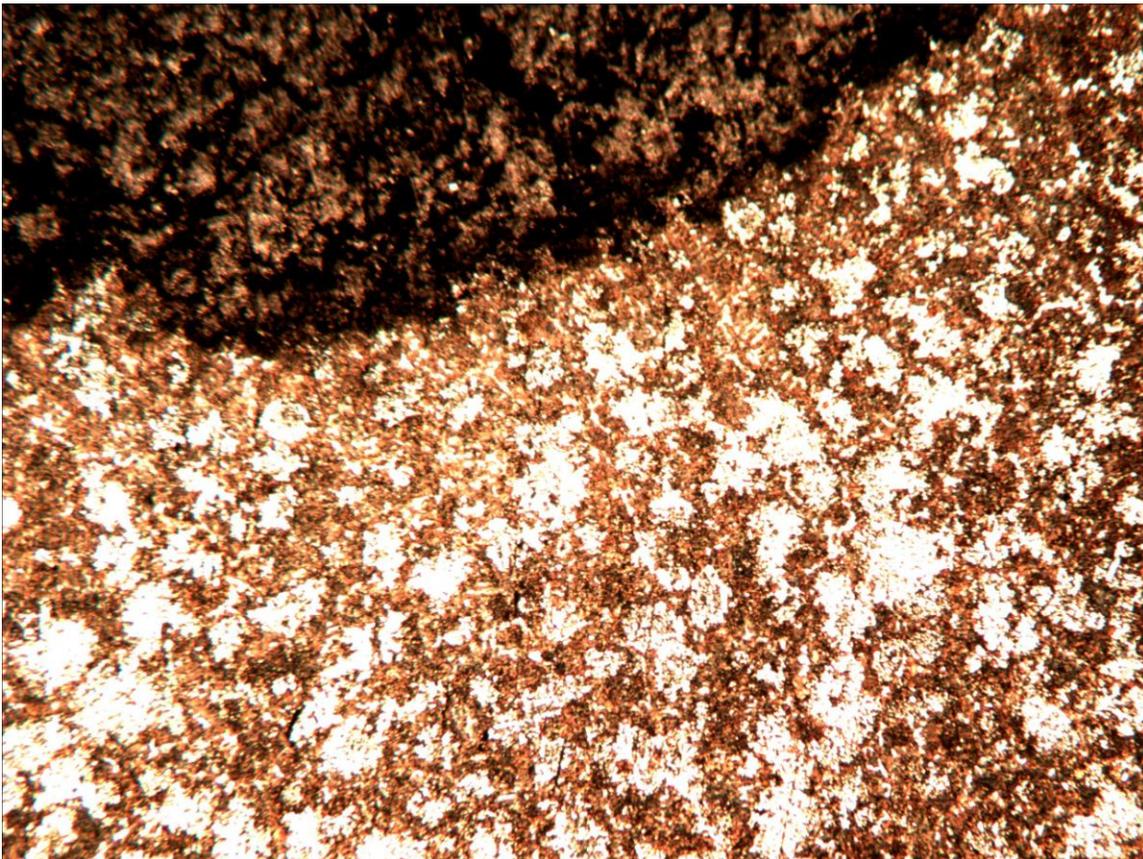
A sample from each fitting was sectioned out and mounted in cross-section in epoxy. The cross-section was polished down to 4000 grit then etched using nital solution. Both of the samples displayed an intact layer of brittle graphite and corrosion products. This layer is indicative of graphitic corrosion in gray iron in which the iron matrix is selectively leached away, leaving a porous mass of graphite.

Figure 3 – Sample 1 at 100x. Black at top left is an intact porous layer of corrosion product & graphite. “Brighter” material is compromised base metal that has not yet been completely leached away.

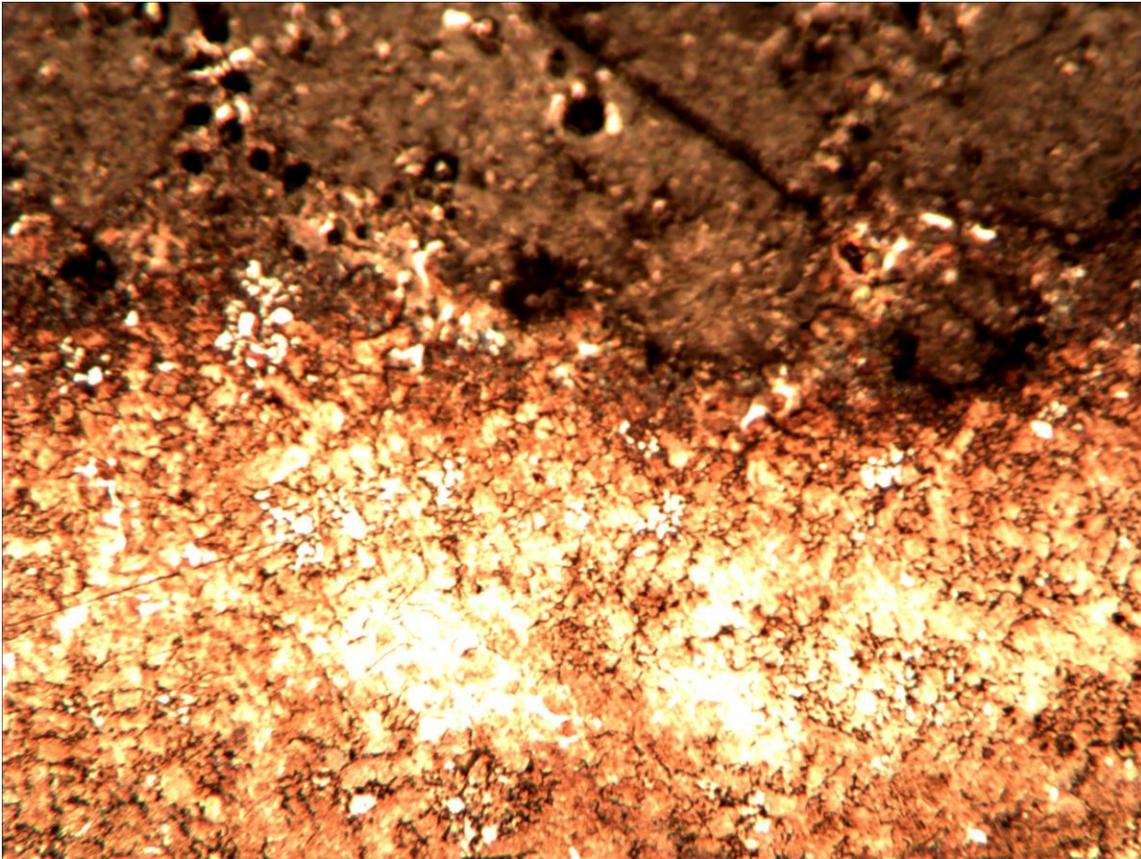
Figure 4 – Sample 2 at 200x. Close-up of the graphite (top)/ compromised metal interface.
