Appendix B
Daily Logs

LaCroix Davis LLC
Building & Environmental Forensics

Client	**Department of General Services (DGS)**	Contractor: **JLS Environmental**	Day ✓ Swing 22 Weekend/Holiday 22
Project	**Board of Equalization (BOE)**	Location(s):	Floor all Floor 22 Floor 1 Floor
Building	**450 N Street, Sacramento CA**	Compound(s) of Concern	Mold Kitchen ACM LBP Other VCT all
LCD Project #	**2372.0** 2 **-572; SOW** 5.0	**Description:** Kitchen	
LCD Project #	**2372.0** 2 **-572; SOW** 4.0	**Description:** VCT all rooms	
LCD Project #	**2372.0** 2 **-572; SOW** 5.0	**Description:** 22 - mail room 22B copy room 2222

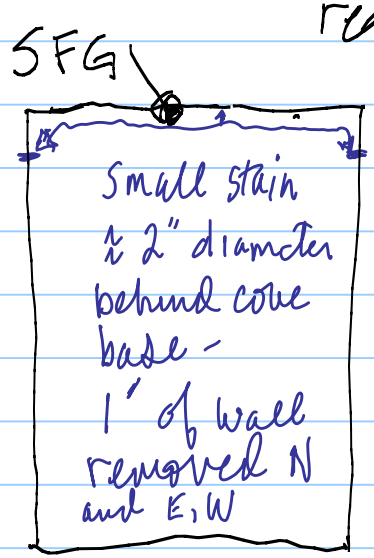
15:30 1708 VCT removal continues - slow progress
17A N wall 1° layer removed 1'↑ No stains on 2° layer
17B St walls 1° layer removed 4"↑ No stains on 2° layer
1712 Bottom trim and VCT removal completed
ready for adhesive removal (Grinding tomorrow)

Both rooms ready for adhesive removal Saturday.

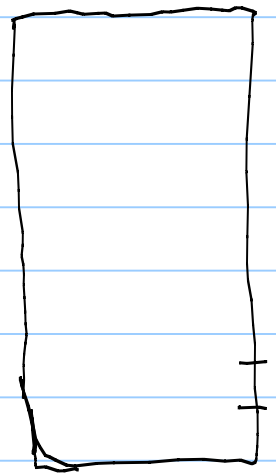
1712

No issues
GB trimmed ≈ 1/2"
VCT removed

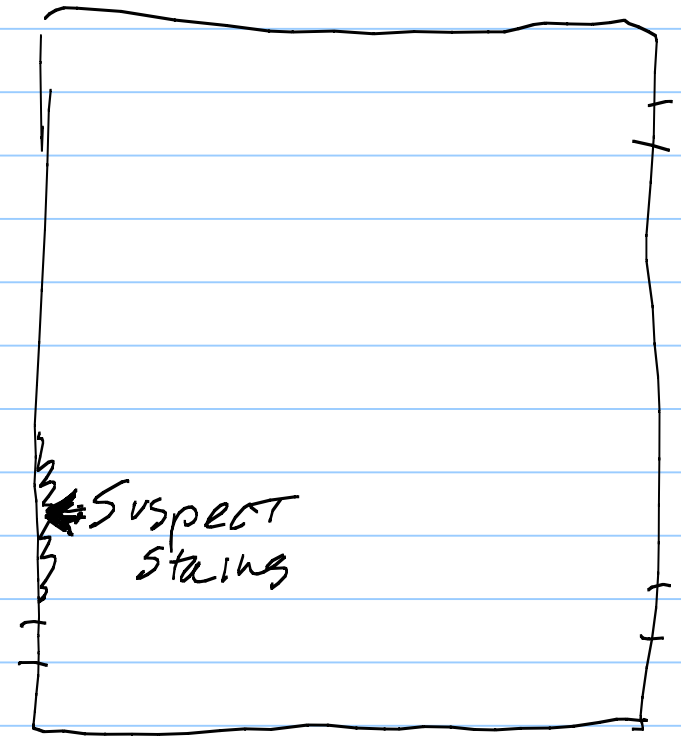
1708

all VCT removed
all GB trimmed ≈ 1/2"

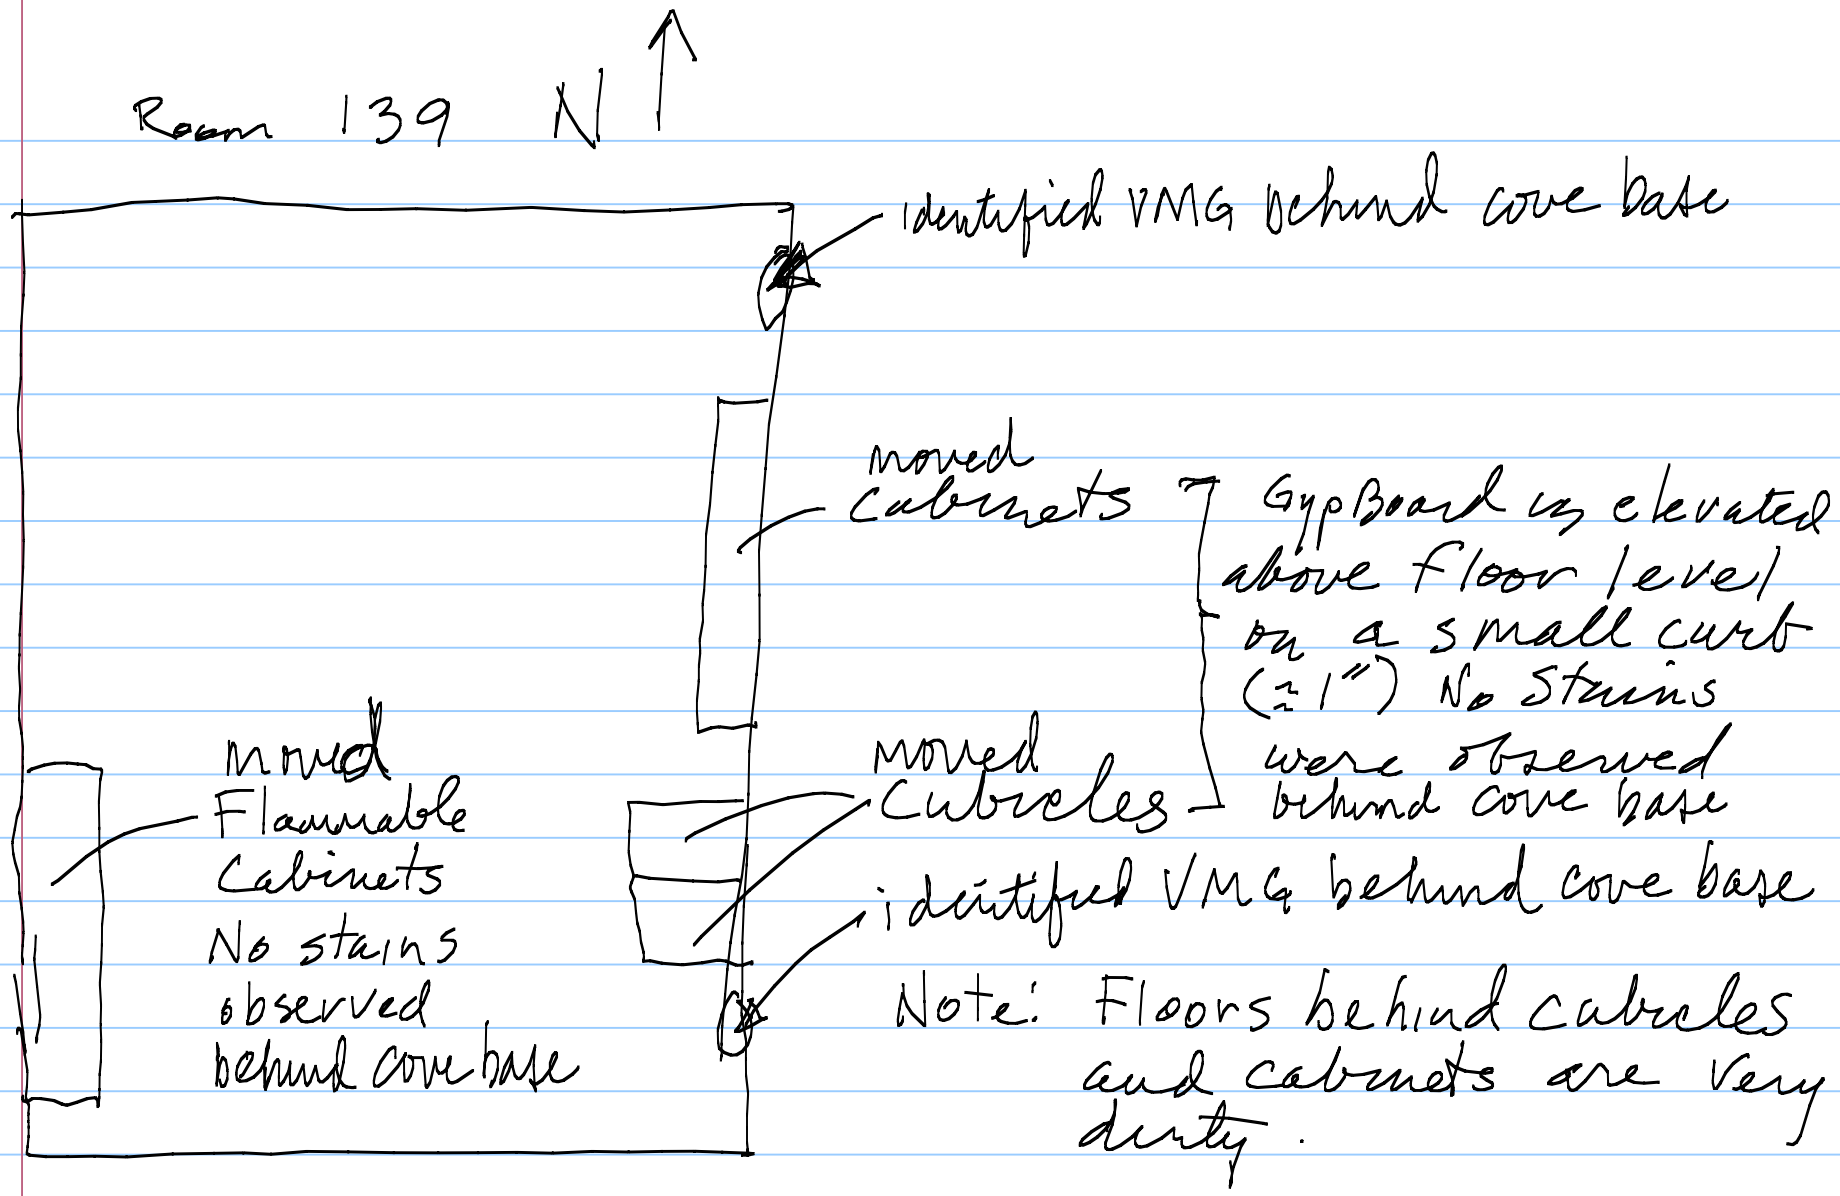
Room 139 N

identified VMG behind cove base
moved cabinets
GypBoard is elevated above floor level on a small curb (≈1") No stains were observed behind cove base
moved Cubicles
identified VMG behind cove base
moved Flammable Cabinets
No stains observed behind cove base
Note: Floors behind cubicles and cabinets are very dirty.

Floor 1 139 Replace Cove base behind combustible cabinets and move cabinets back to wall

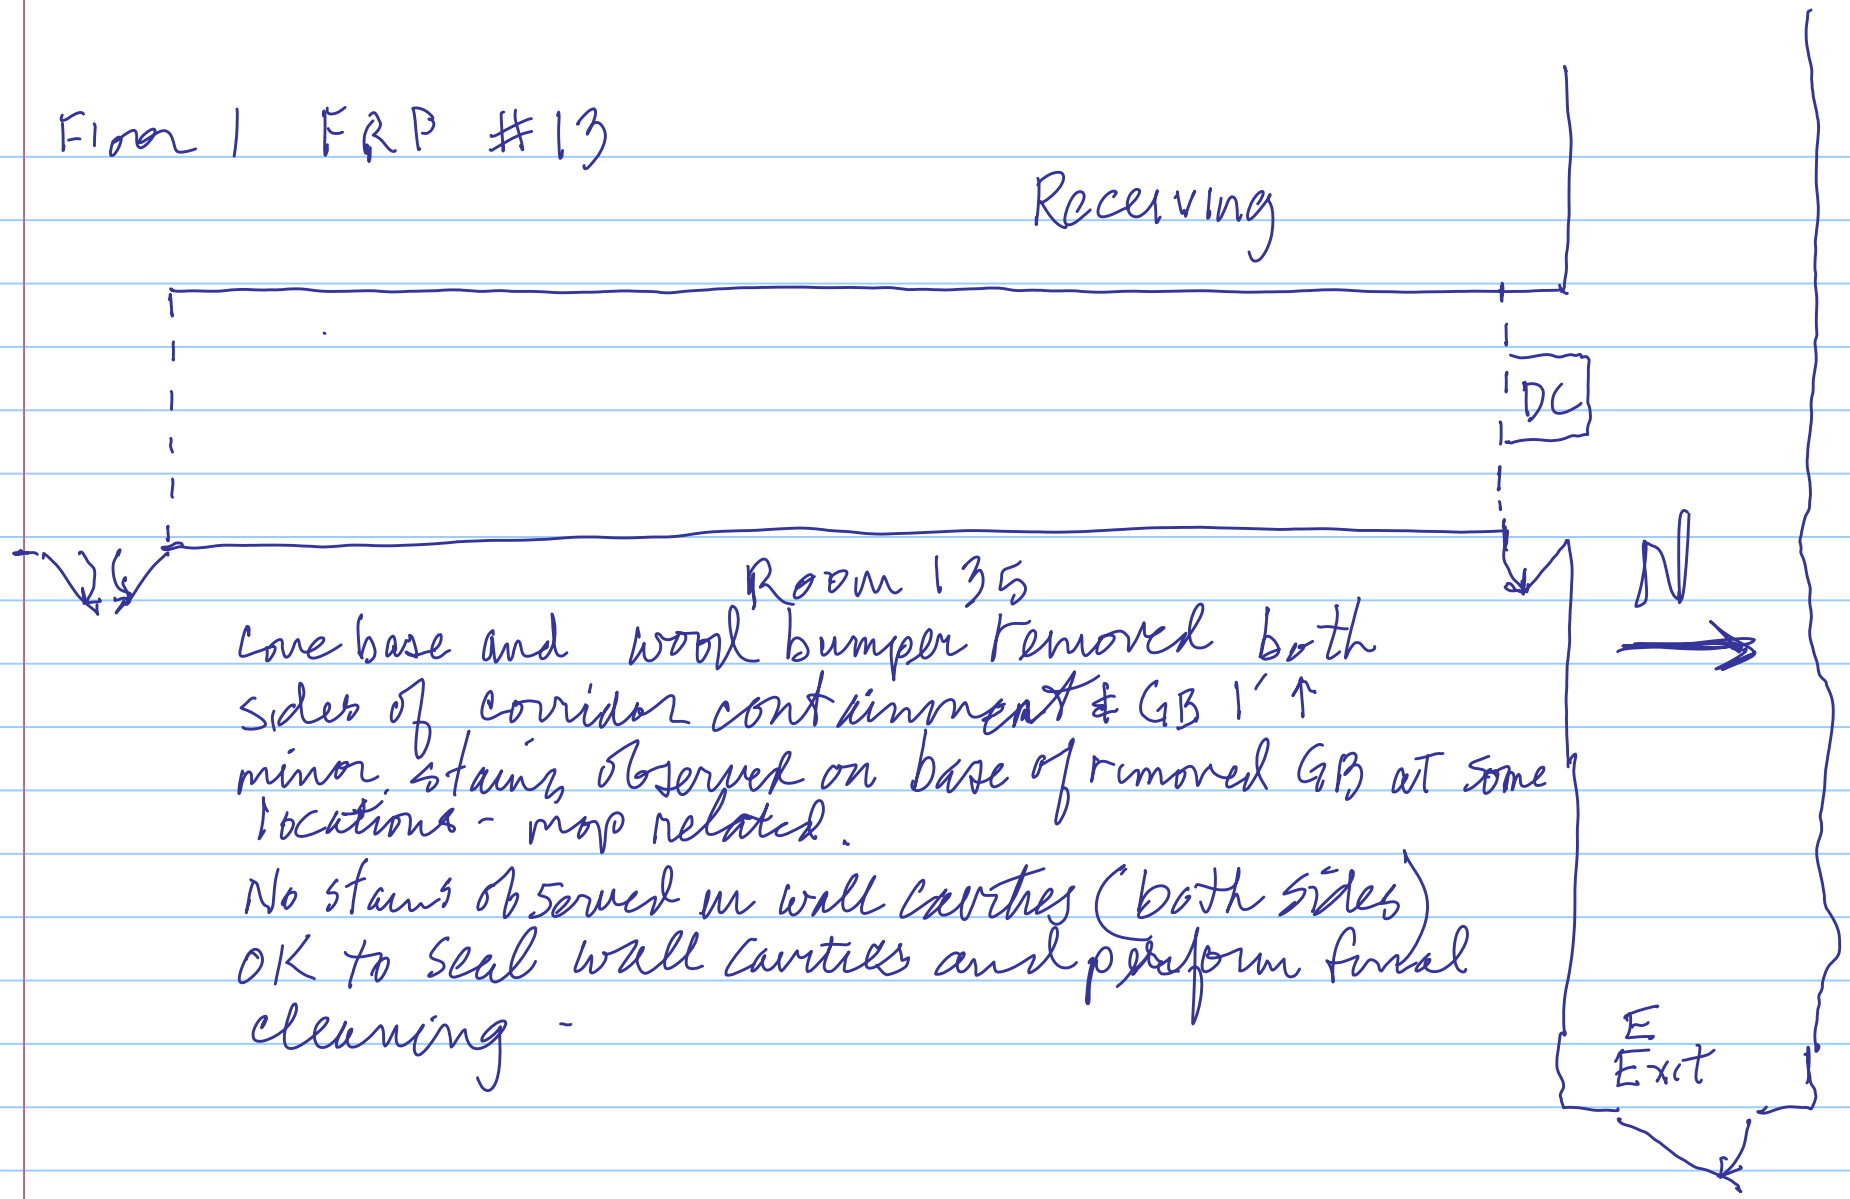
Floor 1 FRP #13

Cove base and wood bumper removed both sides of corridor containment & GB 1' ↑
minor stains observed on base of removed GB at some locations - mop related.
No stains observed in wall cavities (both sides)
OK to seal wall cavities and perform final cleaning -

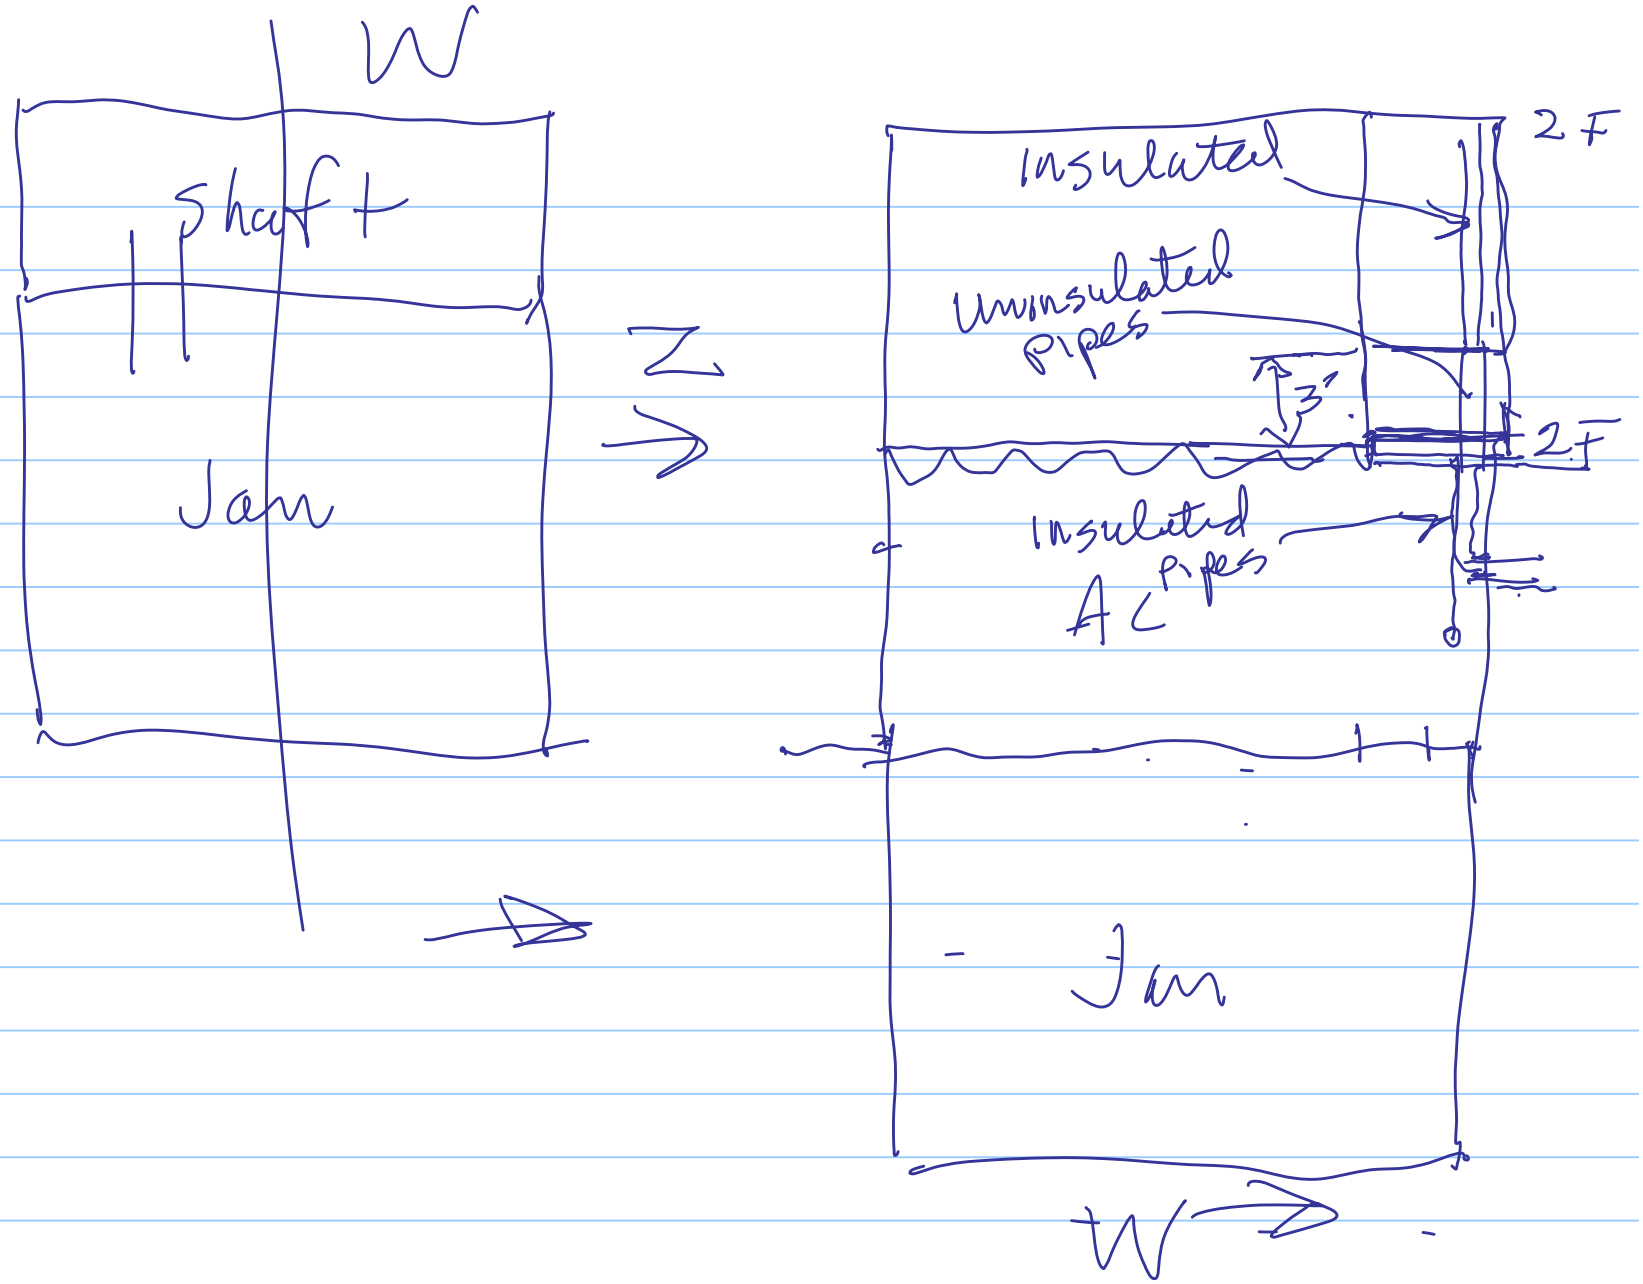
- containment of Janitor Rooms.
- remove deck (GB 2 layers 5/8" + 1 layer 1" Green Shaft)
- turn pressure on & observe (Domestic Water)
  No leaks observed but there is condensation on 2 other uninsulated lines above deck
- Brice comments that piping look ok - they will have JLS

W
shaft
Jam
Z
insulated
2F
uninsulated pipes
3"
2F
insulated pipes
AC
Jam
W

① insulate the pipes above deck (in the pipe shaft)
② leave pipe uninsulated below the deck to observe conditions
③ reinstall deck GB layers and GB wall on Floor 2
④ detail clean all surfaces in both Janitor Rooms
⑤ Air Quality testing by LCD & HTI Sat. AM

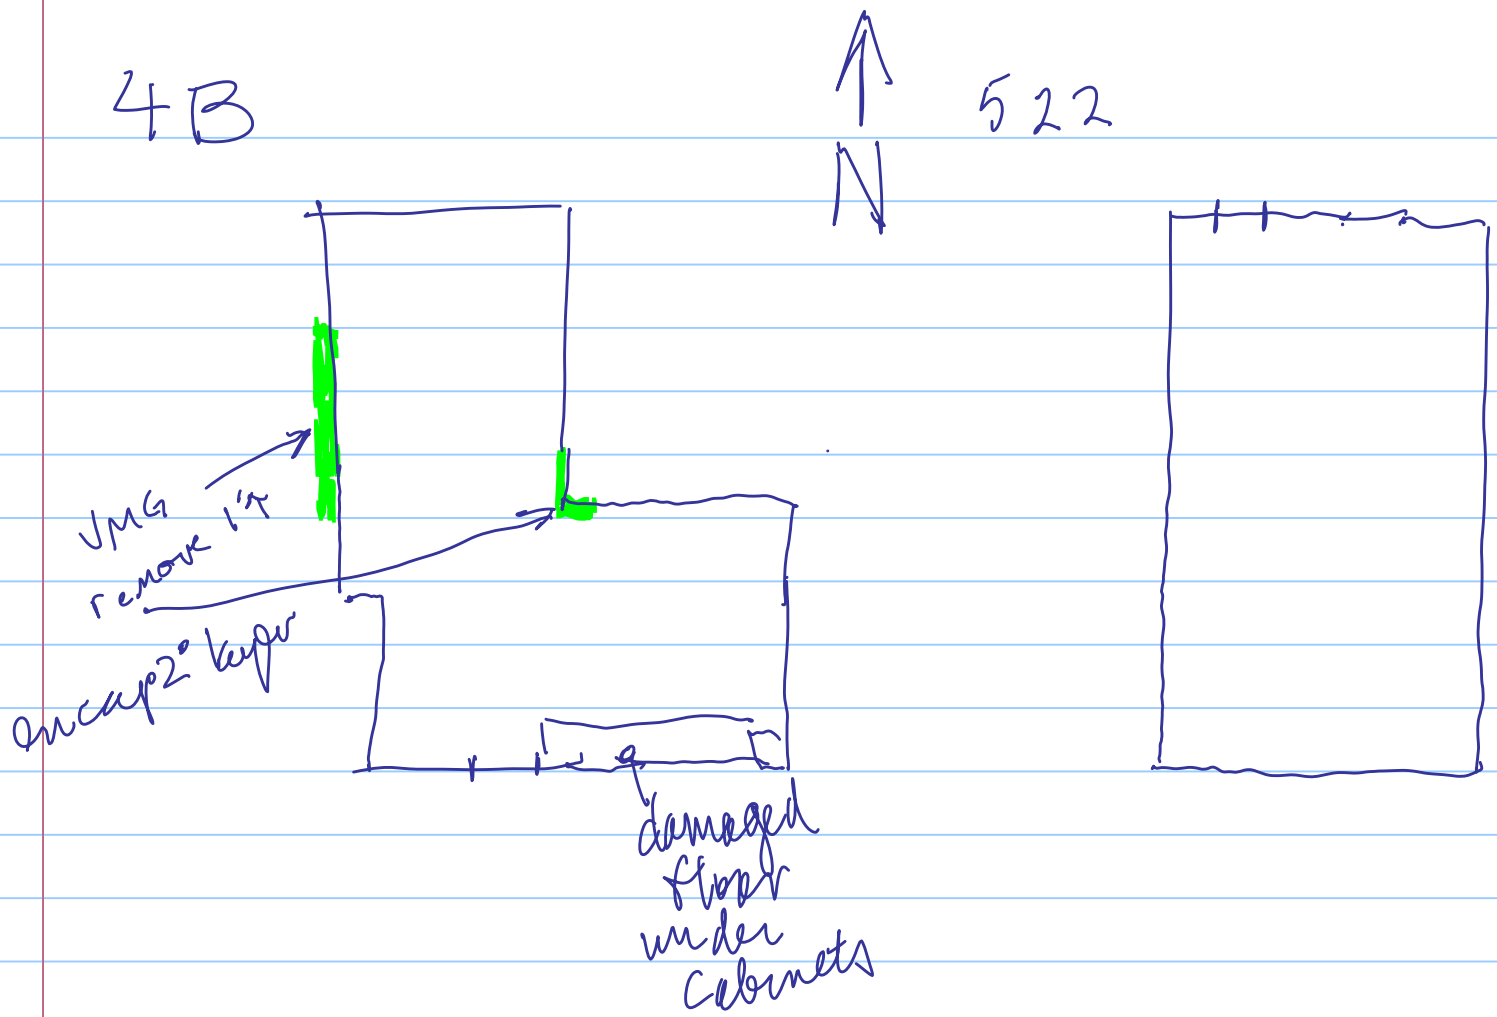
6B – No issues – 3 Rusty screws
6C – No issues
522 – No Issues
4B – VMG West wall at Coveback + Very stained + cupped floor at shelving

4B
N
522
JMG remove 1'x
encap 2° layer
damaged floor under cabinets

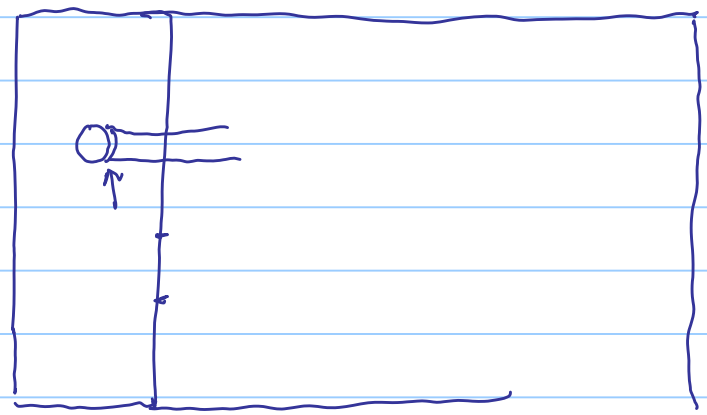
6 Janitor - Leak

Leak observed at Dom H_2O riser at T to PRV
JLS notified J. Armstrong - J. Beesley is coming
to bldg to shut down dom H_2O

discuss engineering controls w/ HTI for pipe
repair effort.

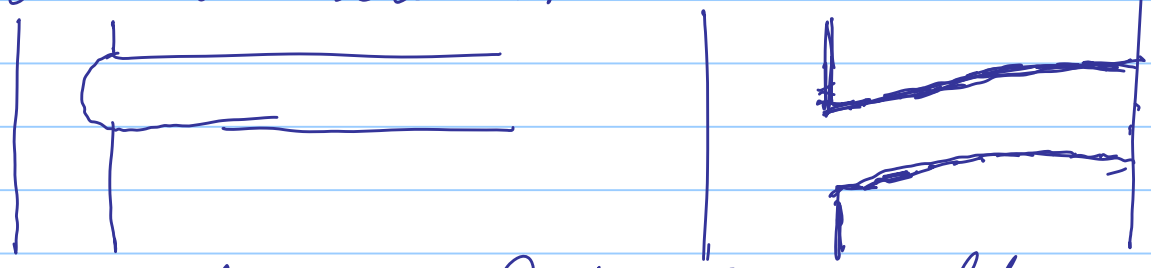
JLS continues adhesive removal 4, 5, 6
6B, 6C, 522, 4B
perform clearance testing Floor 1 containments w/ HTI
COC & deliver to lab
arrange lab for Sunday AM & PM
14:15 - review lab results - Pass - relay to JLS
collect VOC samples Floor 6 & 5
Repair completed Floor 6 janitor Room -
Reactivate Domestic Water 14:25 - Fail

drain system and attempt to repair
2nd attempt fails - the crack gets larger
each time
7:00 JLS will regroup and attempt to repair pipe
Sunday AM
set up testing schedule w/ HTI - 6:00 AM

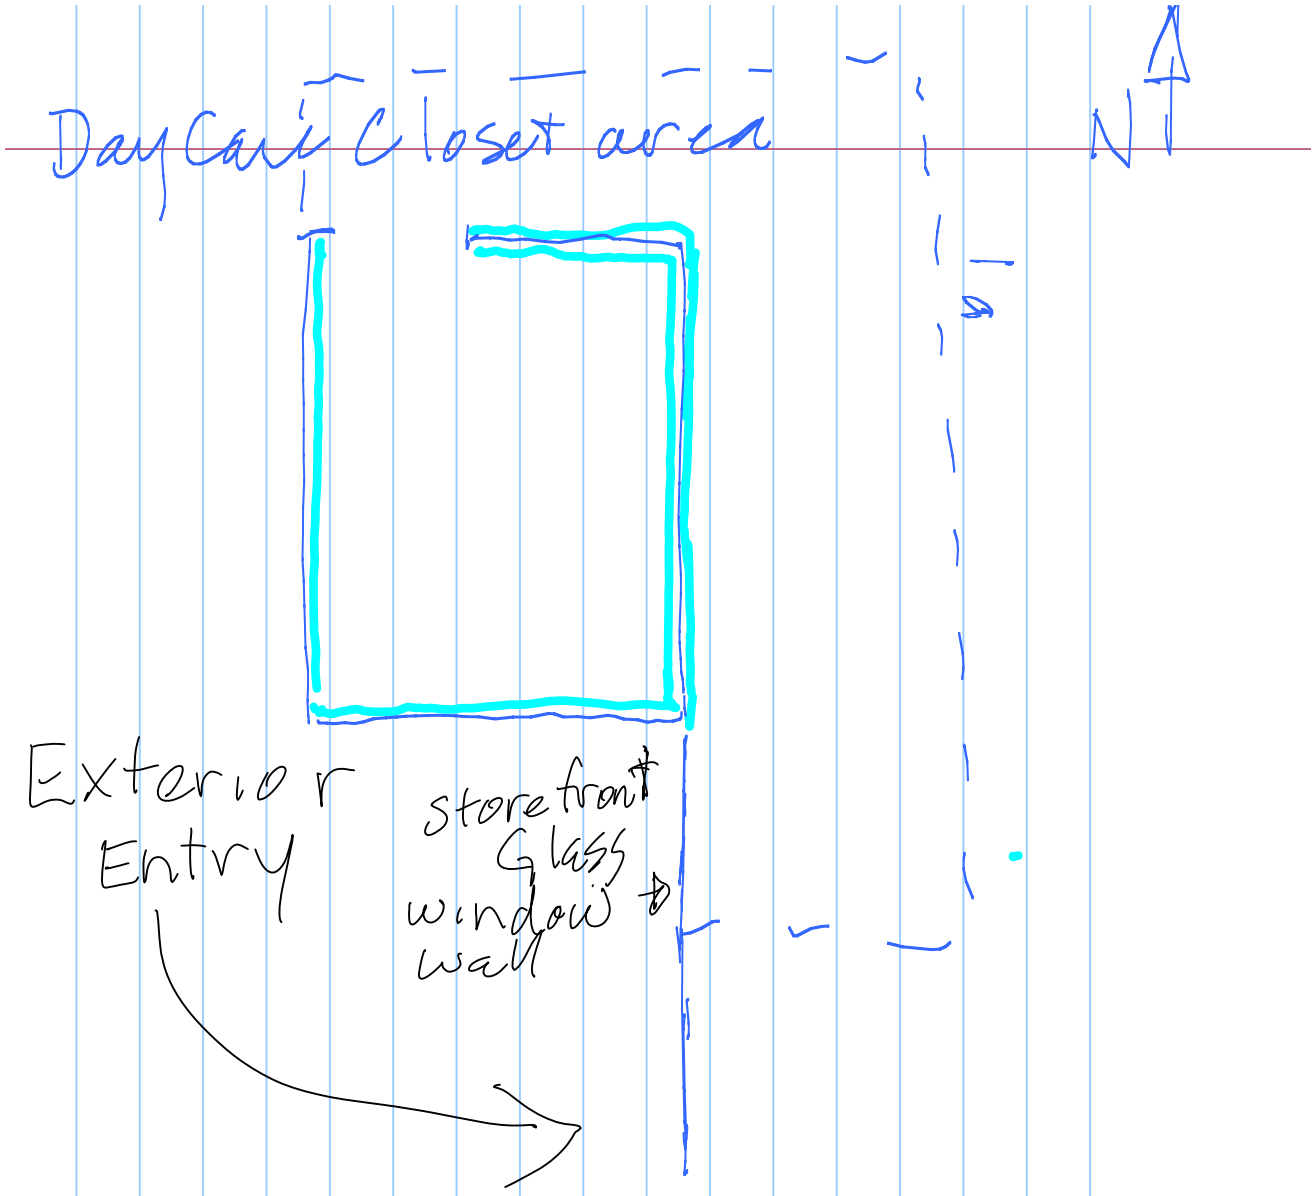
22:00 M. Hoy on-site for status report
F1 DayCare #1b ready for cleanup & loadout
F1 DayCare area #2 ready for visual inspection
22:15 2' removed around entire area - No Stains on opposite side of framing
22:30 F1 DayCare #1a removal underway - removal of 2' entire area as cove base inspection in closet vmg observed.

Daycare Closet area
N
Exterior Entry
storefront Glass window wall

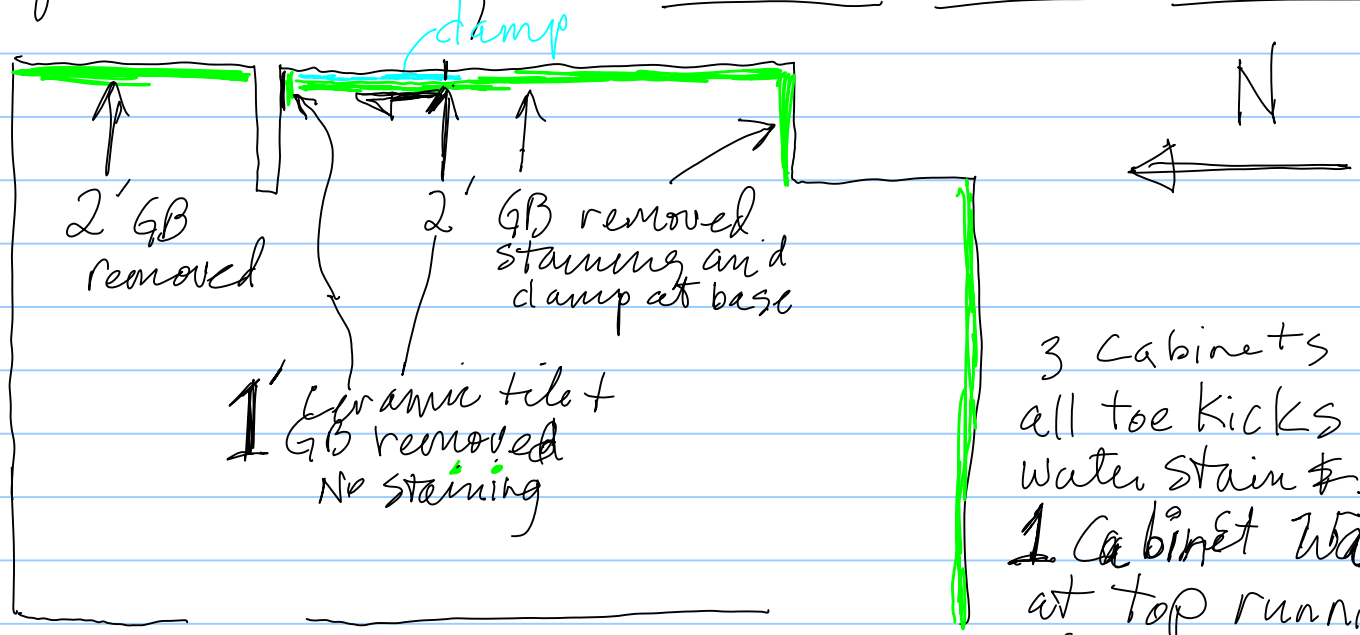
3 cabinets removed all toe kicks have water stain & SFG

1 Cabinet Water stain at top running down the back.

1 cabinet Bottom is very moldy. it will be wrapped & removed from Containment.

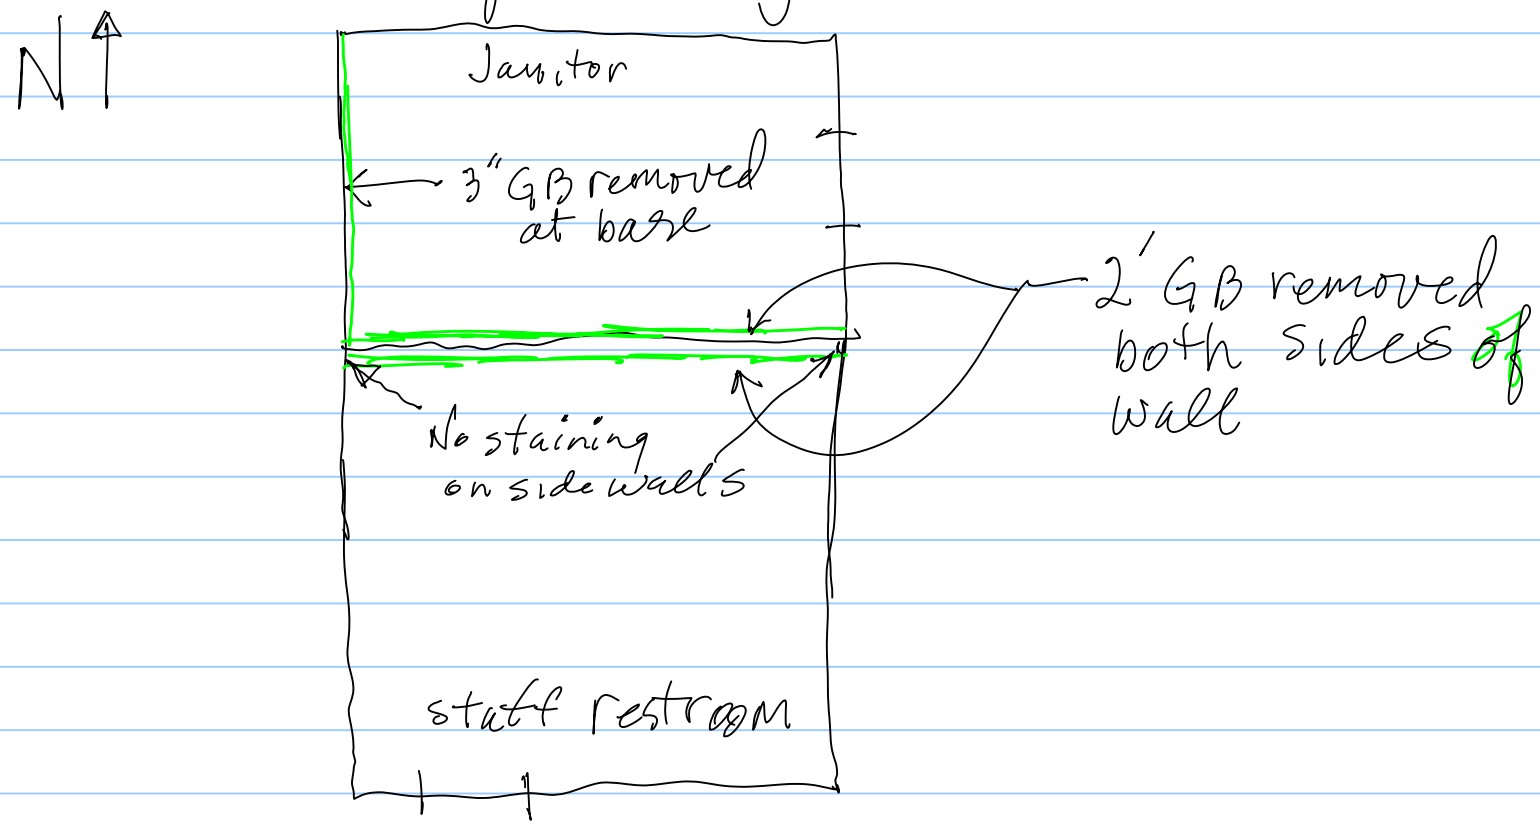
23:00 Removal begins Day Care Staff Restroom & Janitor
