December 30th, 2008

Post Mitigation Assessment Report
Department of General Services
Board of Equalization Building, 450 N. Street
Break Room 1103
Sacramento, California

Attachment A: Digital Images
December 17th, 2008
BOE Building Break Room 1103
450 N. Street, Sacramento, CA

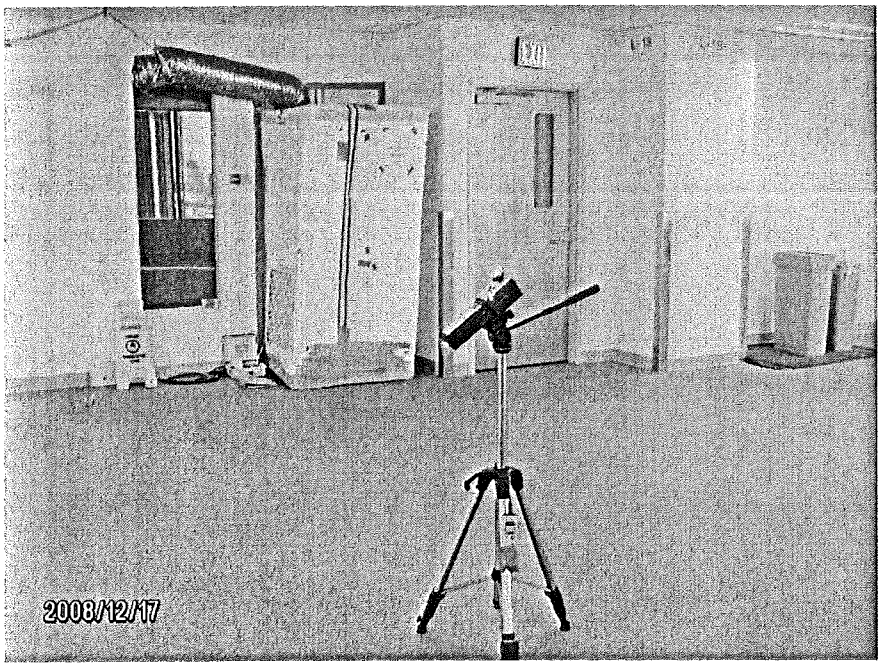
1) Image within adjacent vacated hallway working space of 11th floor near 1103 Break Room Area at time of assessment.

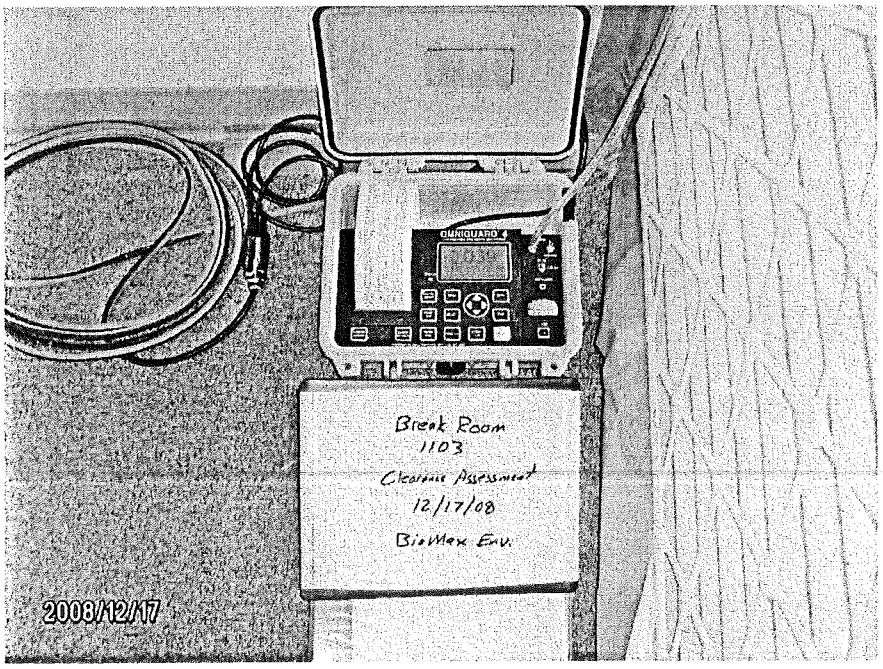
2) Image of Break Room 1103 pressure data logging equipment as viewed from adjacent hallway (outside containment) at time of clearance assessment.

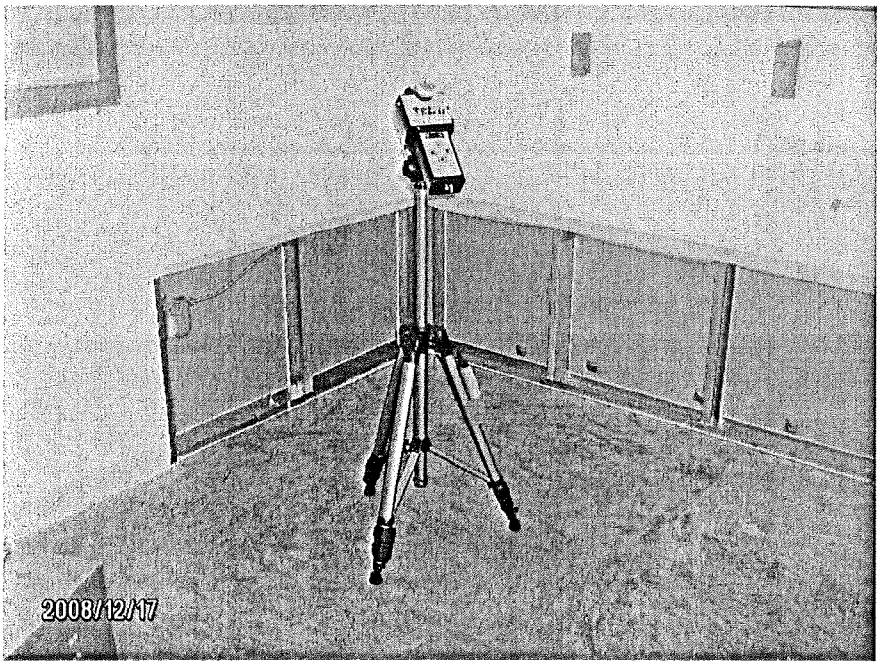
3) Image of air sampling equipment and exposed wall cavities within Break Room 1103 containment structures at time of assessment.

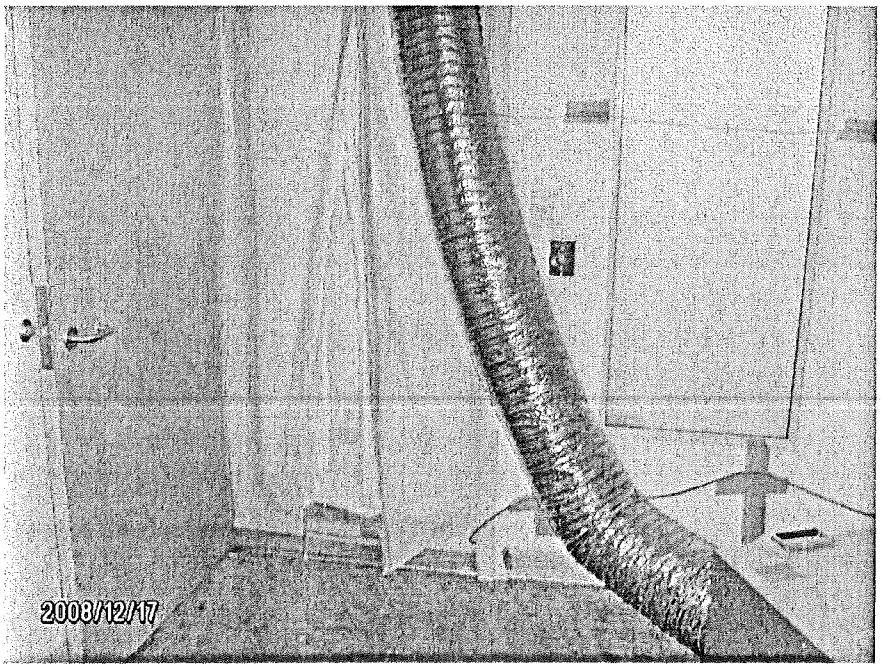
4) Image of air handling equipment and entry chamber as viewed from interior of Break Room 1103 containment.

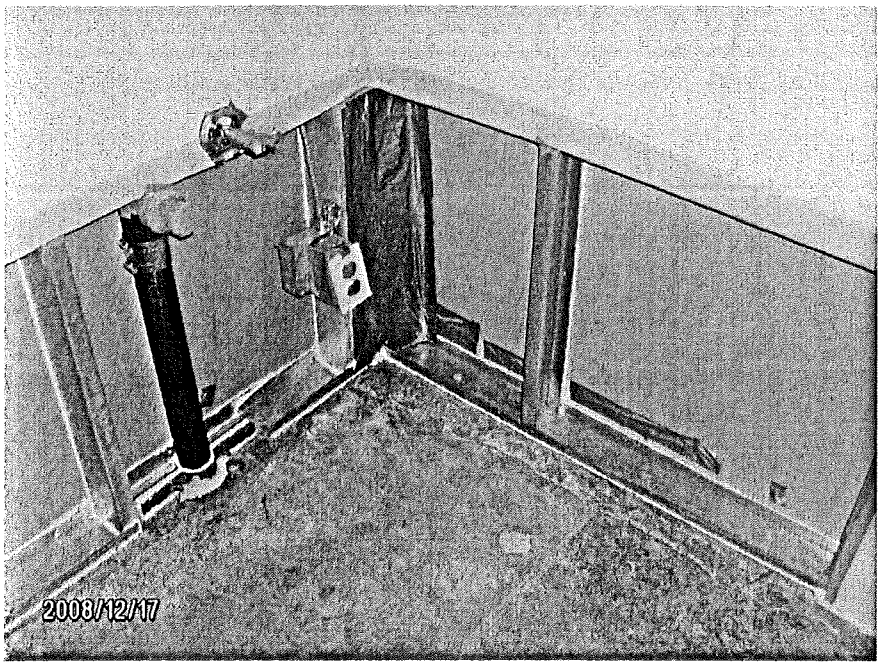
5) Additional image of exposed wall material removal within interior containment of Break Room 1103 at time of assessment.

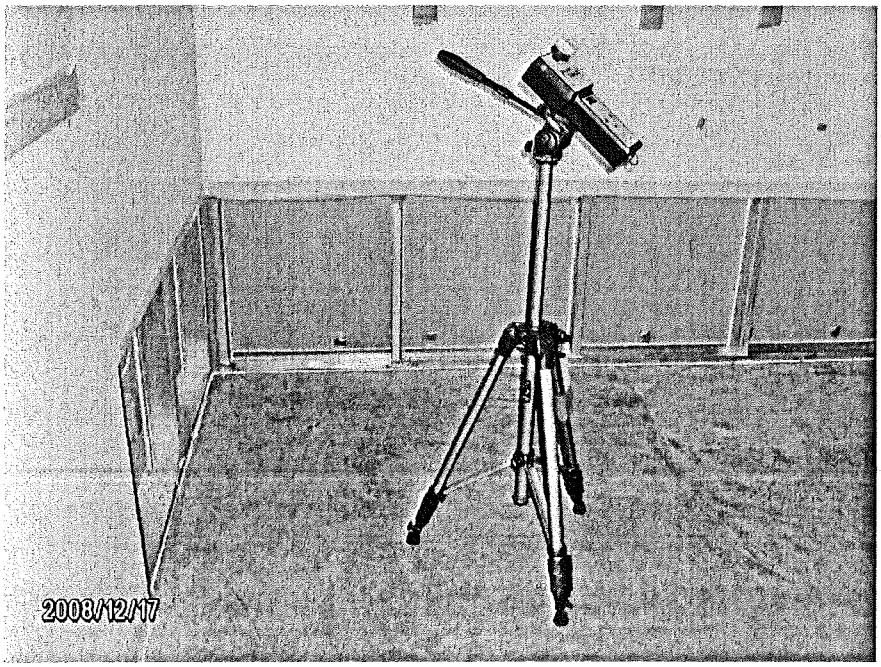
6) Additional image of air sampling equipment and wallboard removal delineation within break room 1103 area at time of assessment.

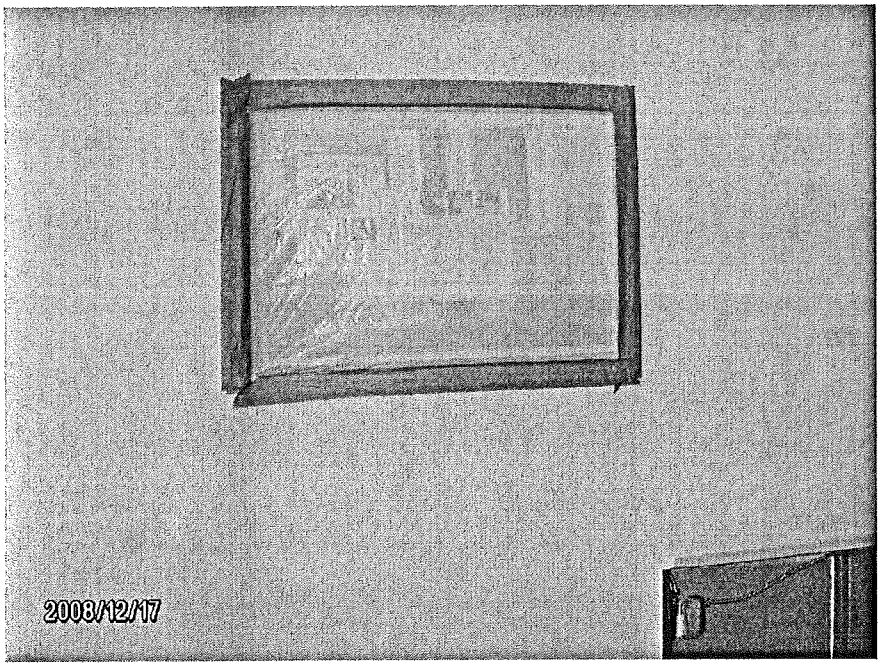
7) Close up image of exposed critical containment covering placed over tenant postings within Break Room 1103 at time of assessment.

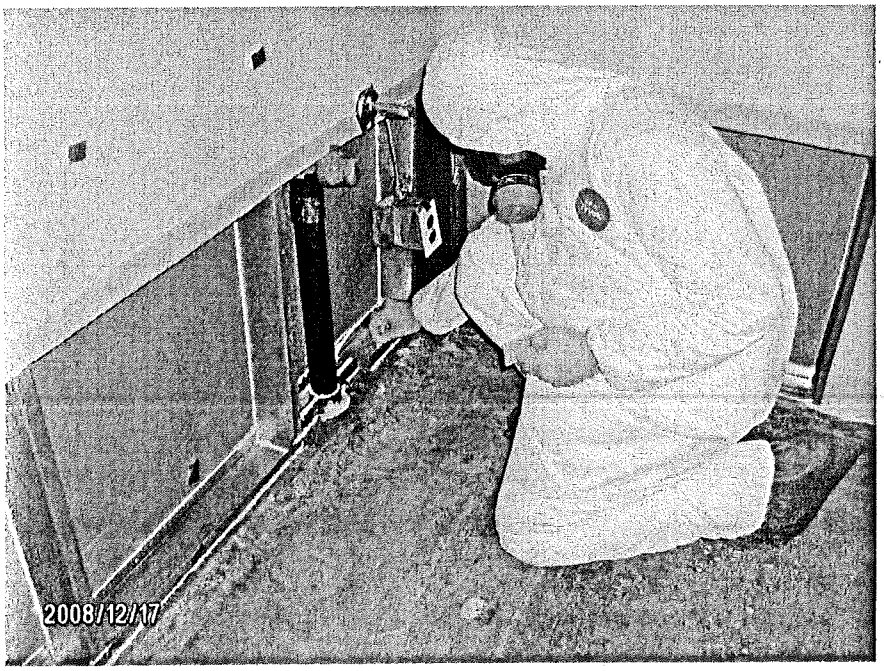
8) Image of exposed metal wall framing where HTI technician (Larry) collects surface tape lift sample at time of assessment.

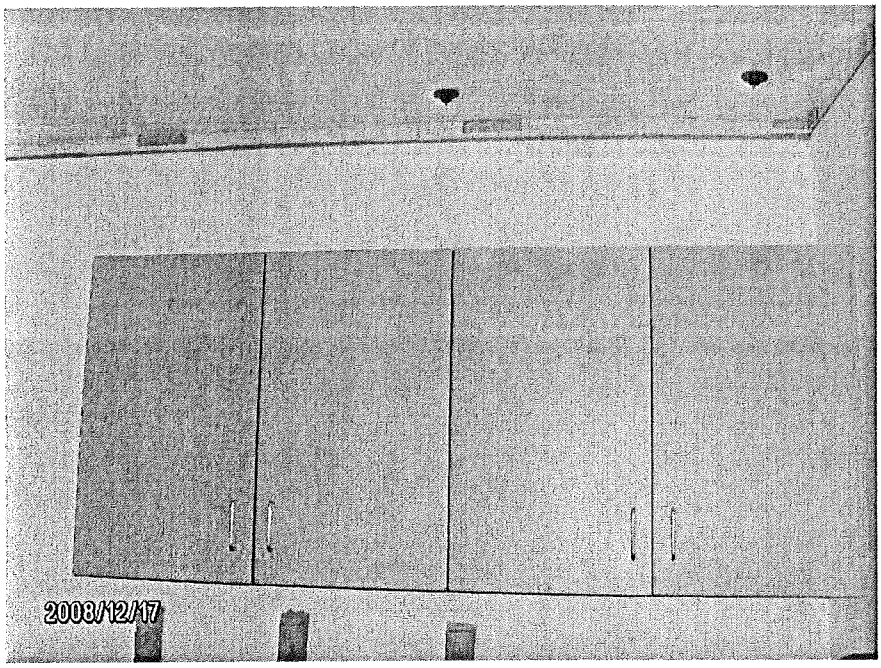
9) Image within Break Room 1103 containment viewing ceiling and wall posting barrier plastic maintained by JLS for duration of mitigative effort.

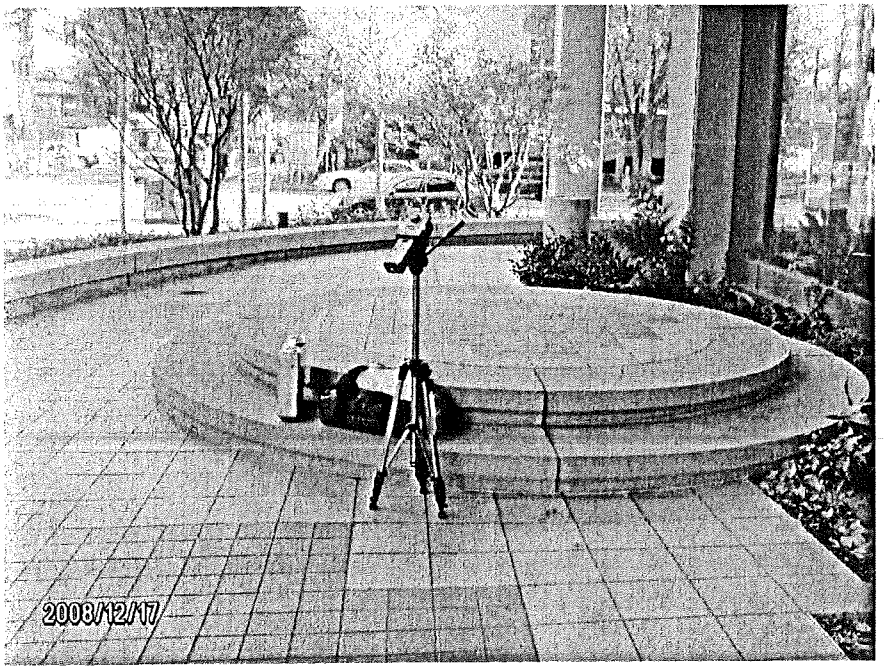
10) Image of ambient air sample location and equipment utilized at conclusion of interior sample collection.
