January 22nd, 2010

**Post Mitigation Assessment Report**
**Department of General Services**
**Break Room 1409 and Adjacent Rooms 1408 and 1410**
**Board of Equalization Building, 450 N. Street**
**Sacramento, California**

March 20th, 2009
BOE Building Break Room 1409, Employee Lounge 1410, and Quiet Room 1408
450 N Street, Sacramento, CA

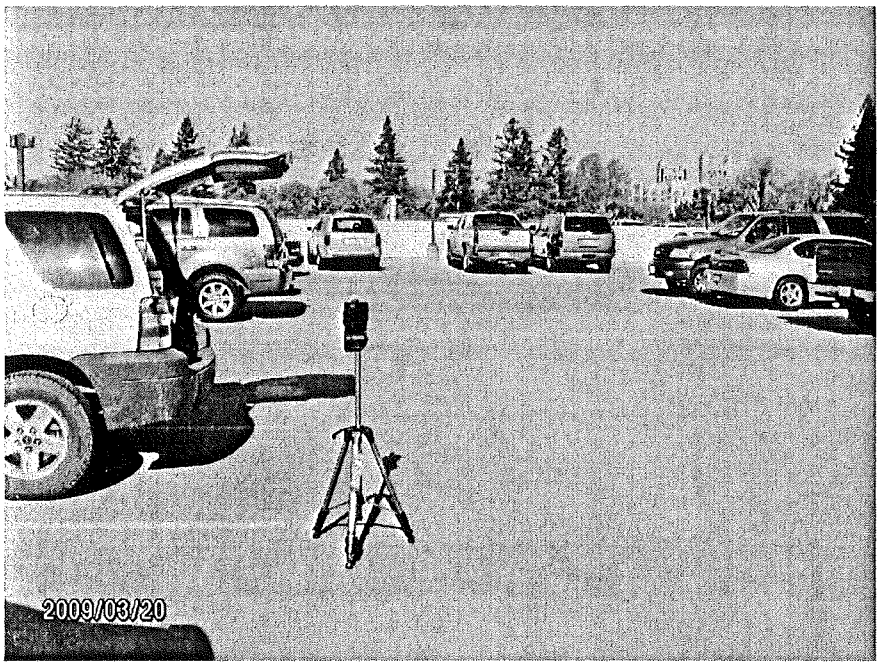
1) Image of ambient air sampling performed on Garage Rooftop prior to interior sampling within BOE Building located at 450 N Street, Sacramento, California.

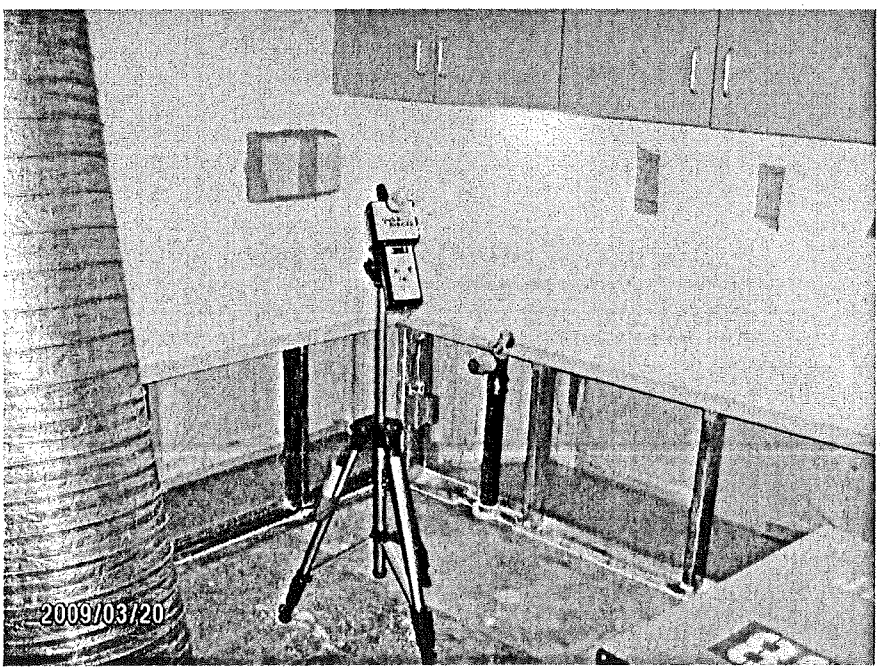
2) Image of air sampling performed within Break Room 1409 and adjacent rooms 1408 and 1410 (mini "Pop Out" containments) as noted at time of clearance assessment.

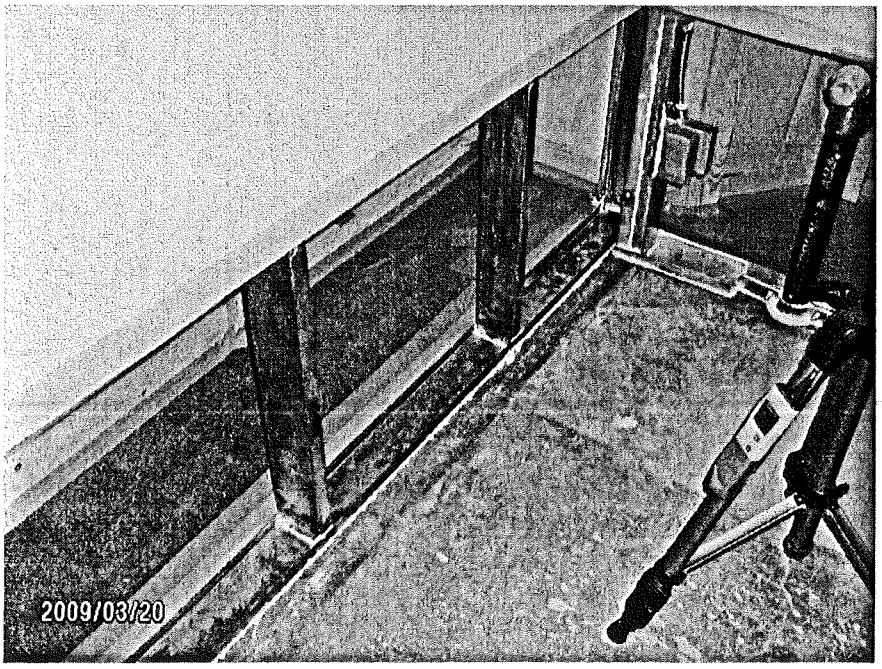
4) Image of air sampling equipment and wallboard removal delineation within Break Room 1409 area at time of assessment.

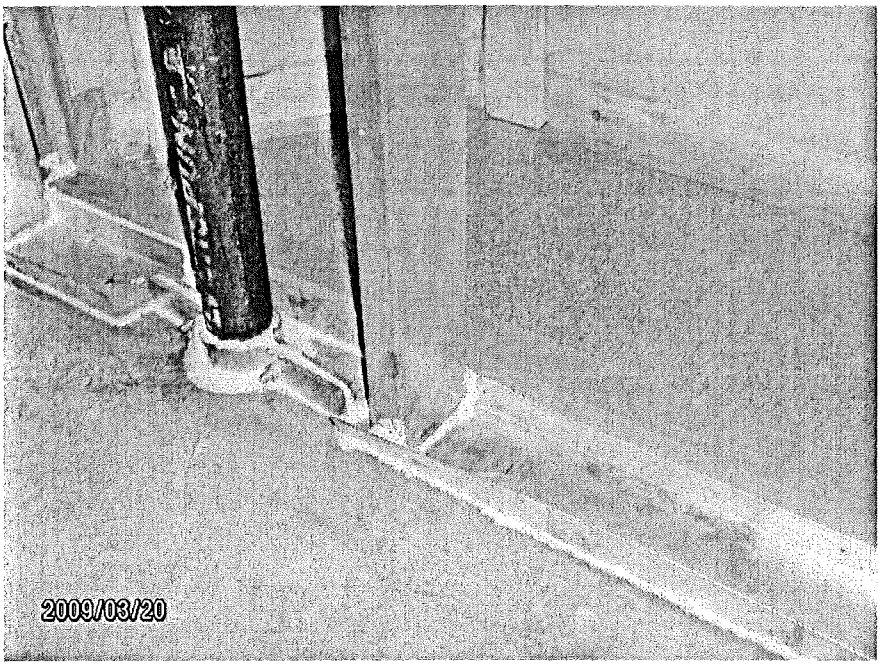
6. As verified during these assessment activities, all identified affected interior wallboard building materials had been removed from each of the noted interior areas exposing interior wall cavity framing (metal) and underlayment wallboard siding materials present within each of the impacted areas. Upon post mitigation inspection, all remaining exposed building materials located within the break room areas exhibited no significant staining and/or

5) Close-up image of exposed wall framing systems and wallboard interior cavities within Break Room 1409 at time of clearance assessment.

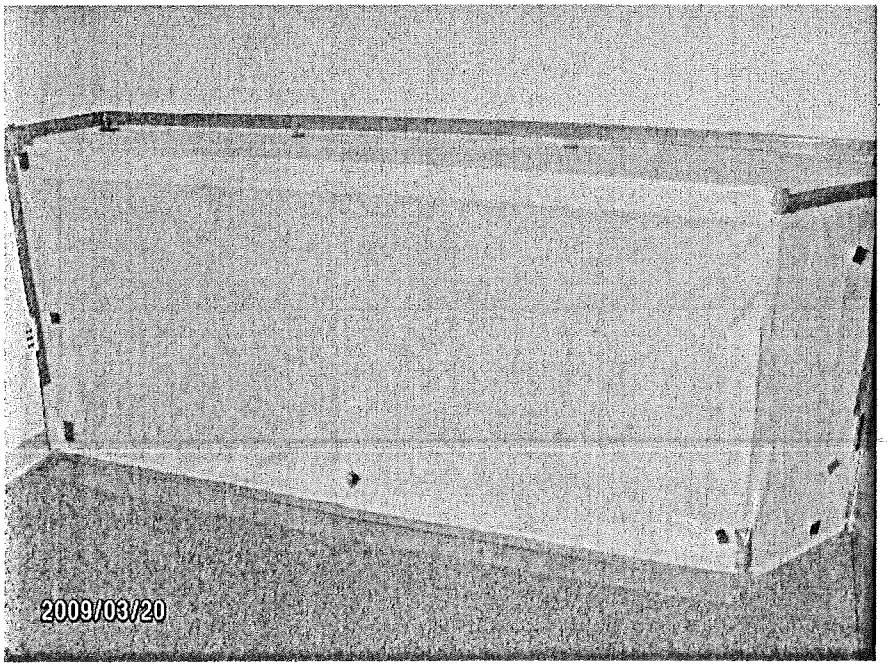
7. Adjacent area mini containment "Pop Out" containments were observed under acceptable negative pressure within the Employee Lounge (1410) and Quiet Room (1408) areas at the time of this assessment activity. Due to the limited size of such areas, acceptable access for inspection was performed from the primary Break Room area only as was the only access into the noted structures at this time.

6) Image of mini containment "Pop Out" constructed within adjacent Quiet Room (1408) constructed as needed to remove affected wallboard materials adjacent to Break Room 1409.

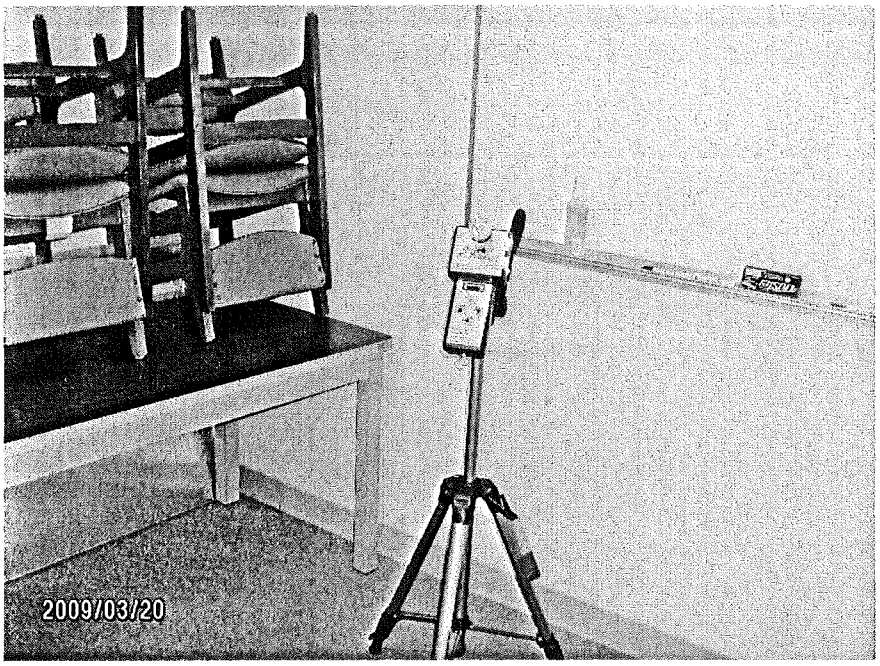
7) Image of air sampling performed within adjacent room (Quiet Room 1408) at time of assessment.

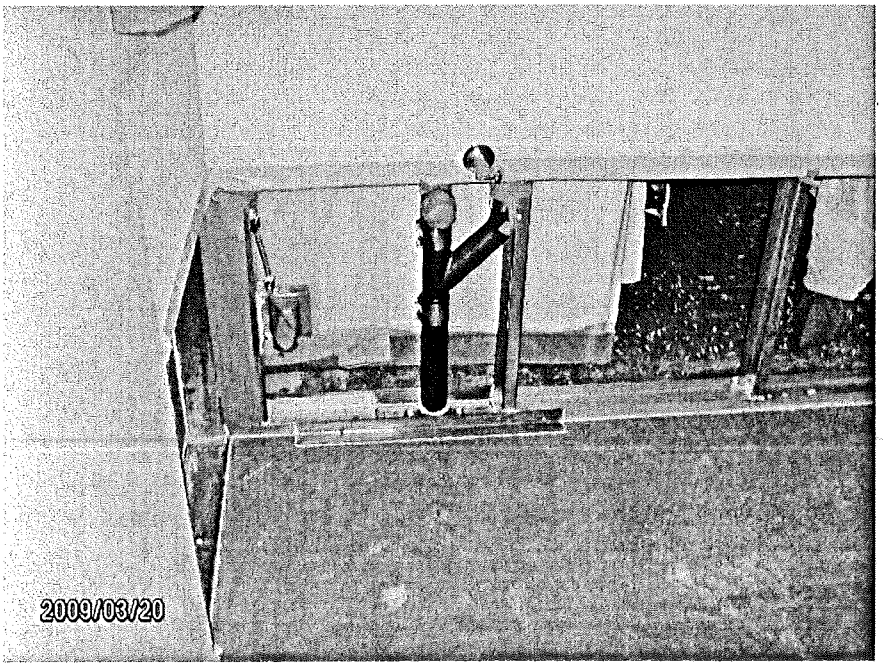
8) Image of wall removal delineation performed within Break Room 1409 as viewed from Employee Lounge 1410.

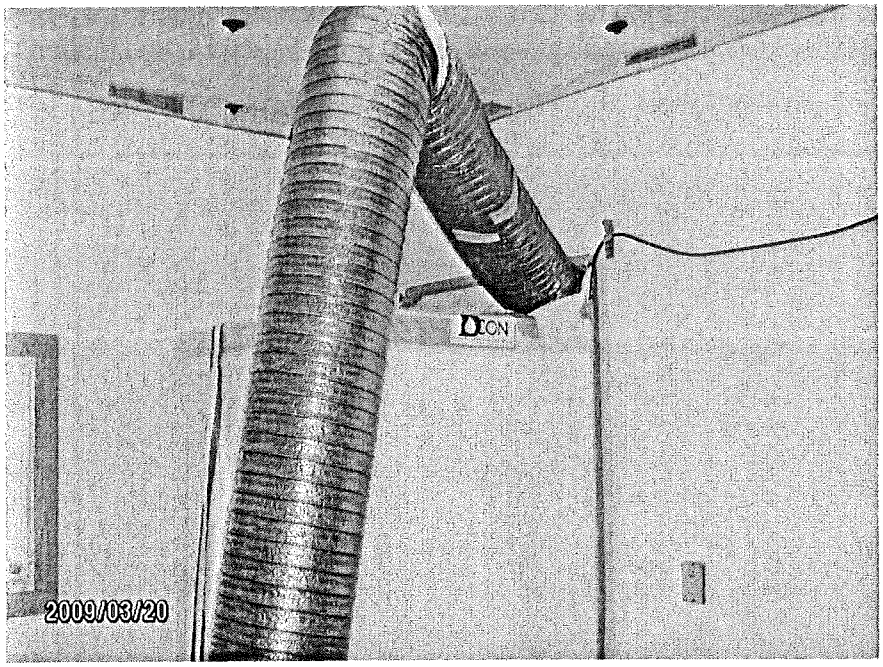
3) Image of pressure monitoring equipment located within hallway of Break Room 1409 at time of assessment. Acceptable air pressure differential (negative pressure) recorded at negative -0.038 inches.

9) Image of containment entry chamber and flex exhaust hosing associated with the barrier controls present within Break Room 1409 at the time of assessment.

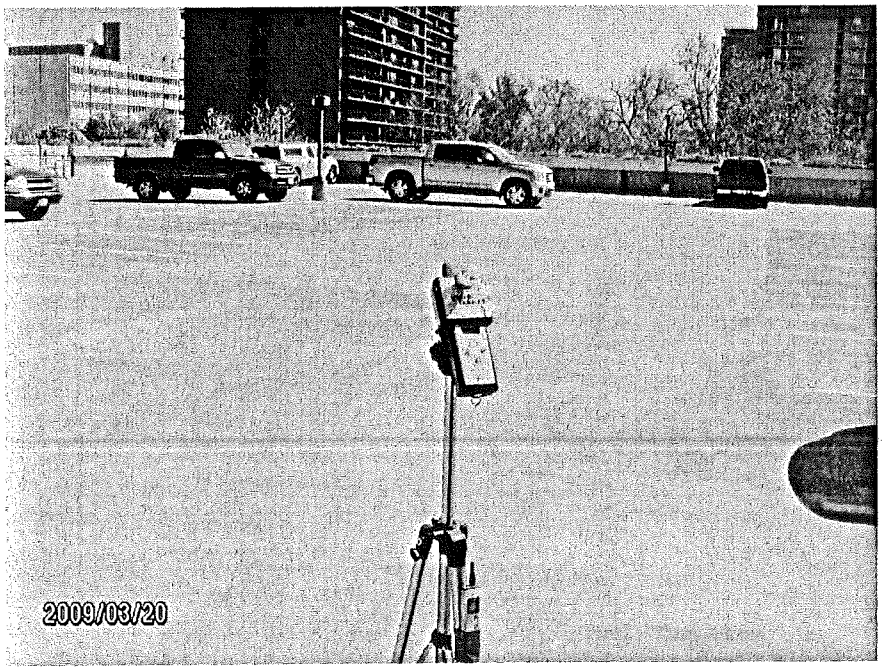
10) Ambient rooftop sampling performed post interior sampling as part of required at time of assessment.
