BioMax Environmental
Environmental Consulting and Industrial Hygiene Services

January 20th, 2010

Post Mitigation Assessment Report
Department of General Services
Break Rooms 1719 and 136
Board of Equalization Building, 450 N. Street
Sacramento, California

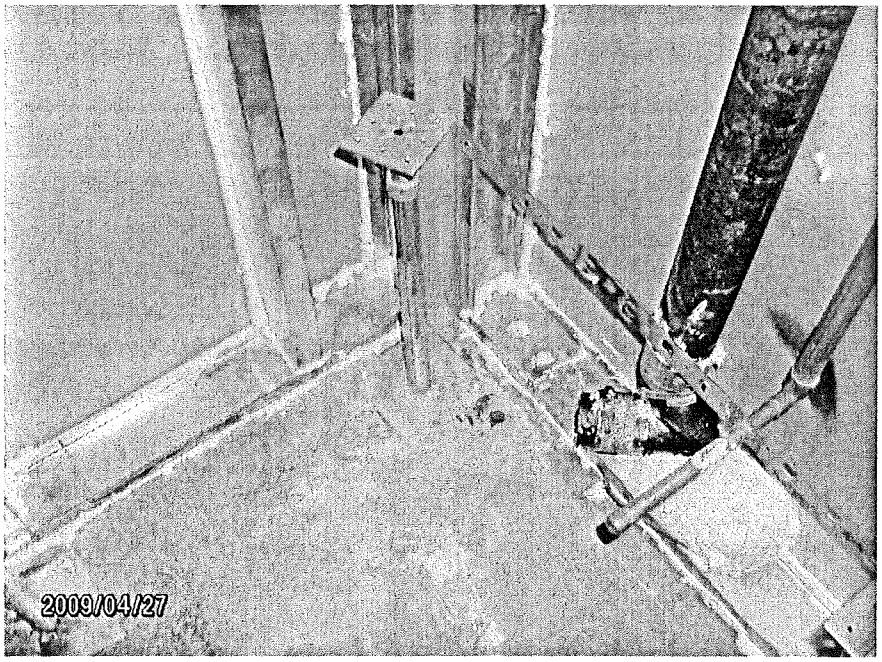
8) Image of air sampling activity and wall removal delineation performed within Break Room 136 as part of the overall mitigative action.

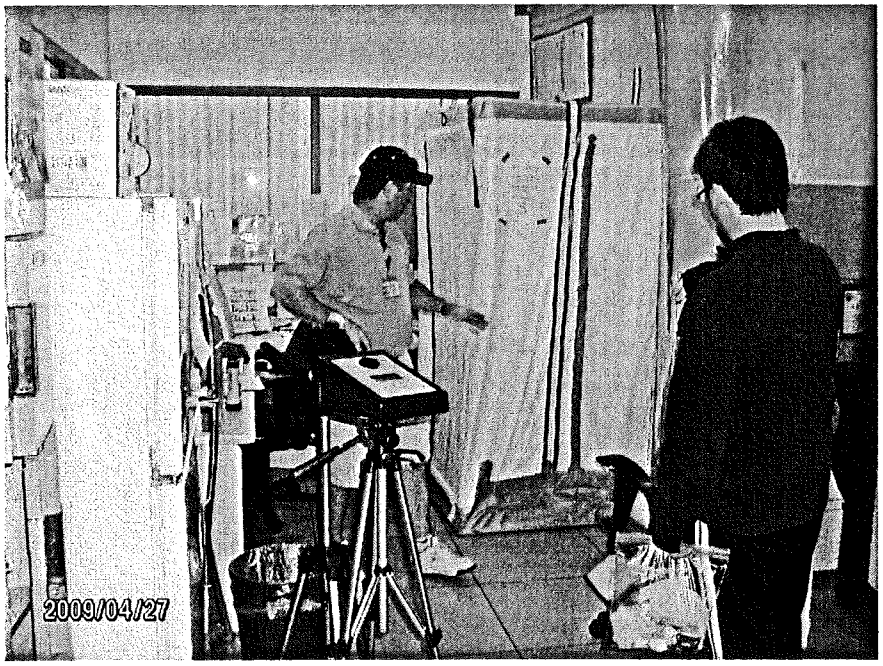
10) Image of adjacent occupancy of DGS workers present near Break Room 136. Air sample also collected in this "occupied" area for comparative purposes.
