January 11th, 2010

Post Mitigation Assessment Report
Department of General Services
Break Rooms 2008 and 1915
Board of Equalization Building, 450 N. Street
Sacramento, California

Attachment A: Digital Images
January 30th, 2009
BOE Building Break Rooms 2008 and 1915
450 N Street, Sacramento, CA

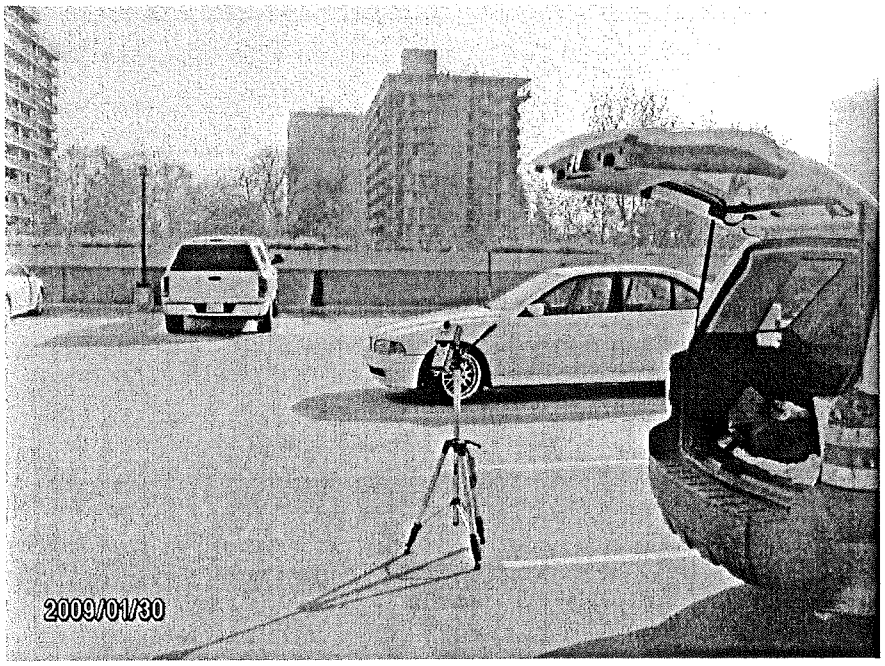
1) Image of ambient air sampling performed on garage rooftop location prior to interior sampling at 450 N Street, Sacramento, California.

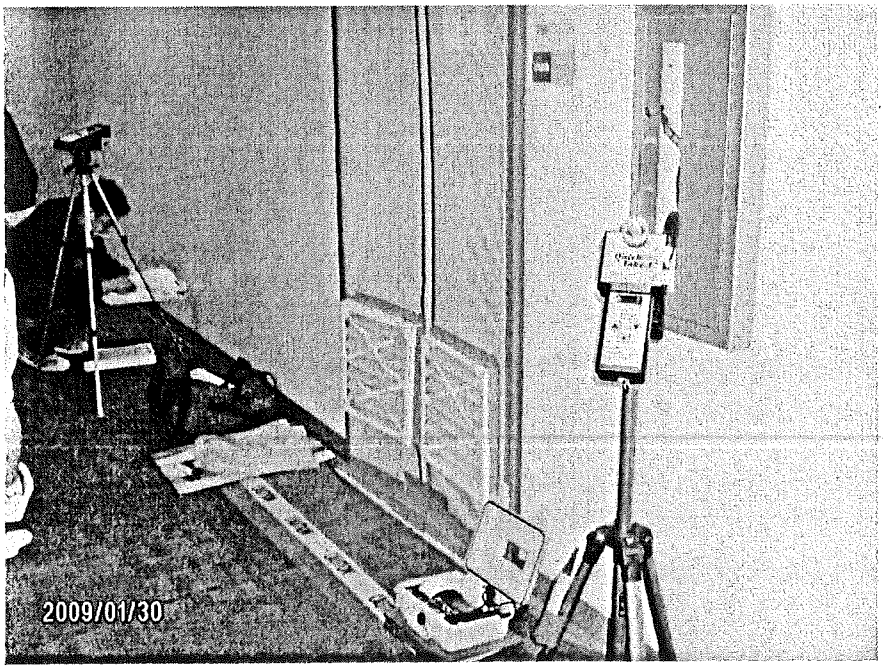
2) Image of tenant occupied hallway air sampling and Break Room 2008 containment entrance area at time of clearance assessment.

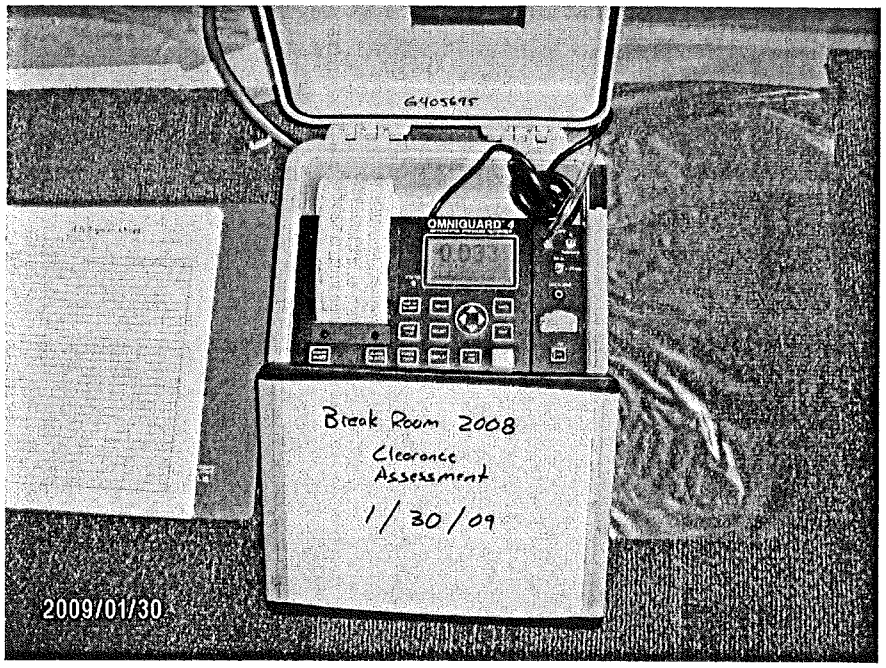
3) Image of pressure monitoring equipment located within hallway of Break Room 2008 at time of assessment. Air pressure differential (negative pressure) recorded at negative 0.033.

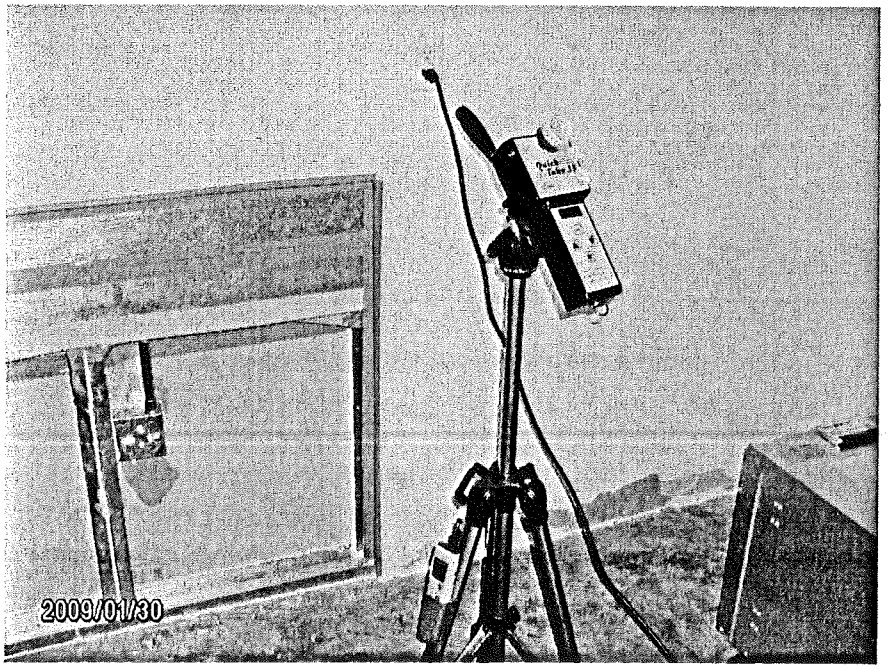
4) Image of air sampling equipment and wallboard removal delineation within Break Room 2008 area at time of assessment.

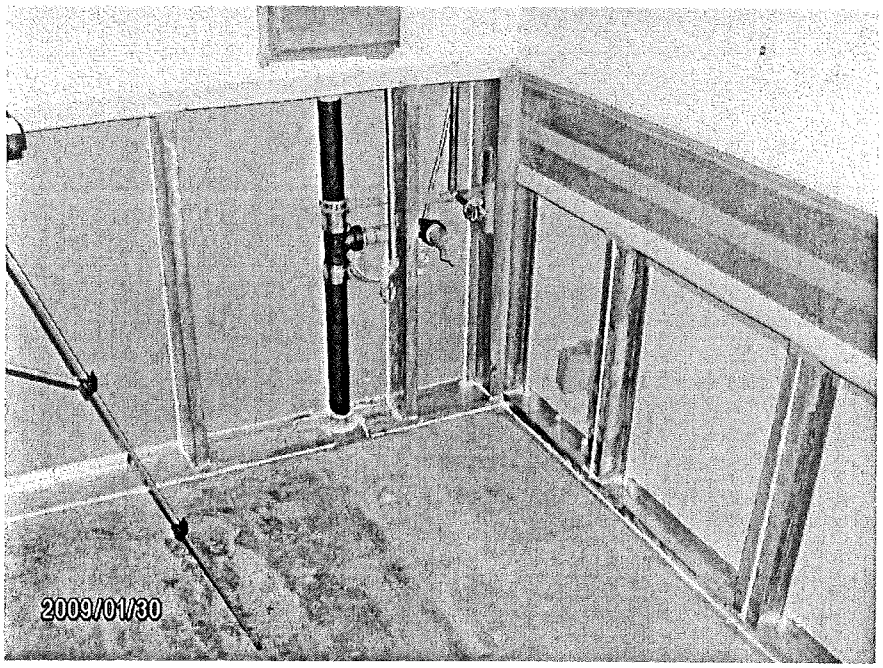
5) Close-up image of exposed wall framing systems and wallboard interior cavities within Break Room 2008 at time of clearance assessment.

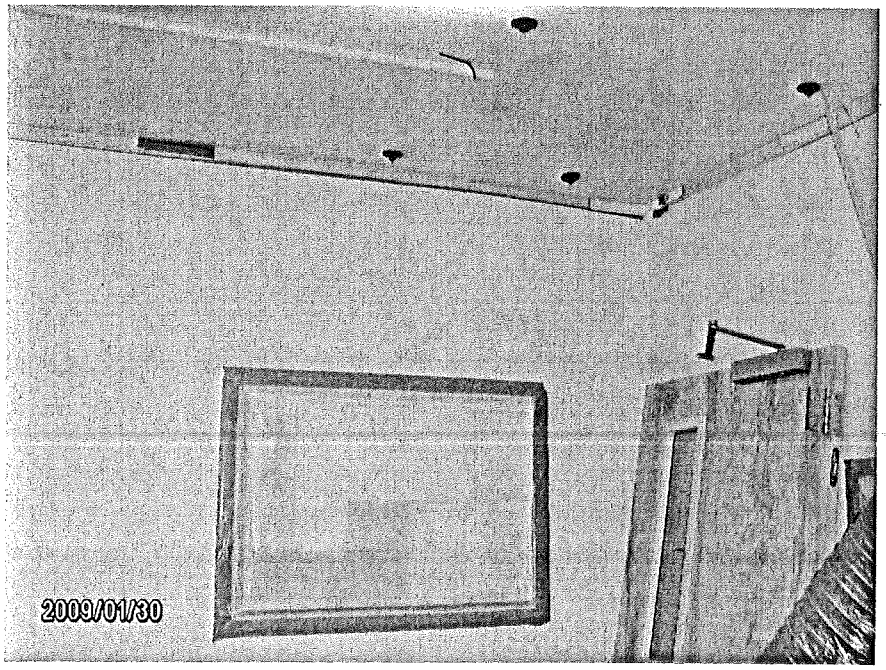
6) Image of ceiling and wall furnishing containment barriers present within Break Room 2008 containment at time of assessment.

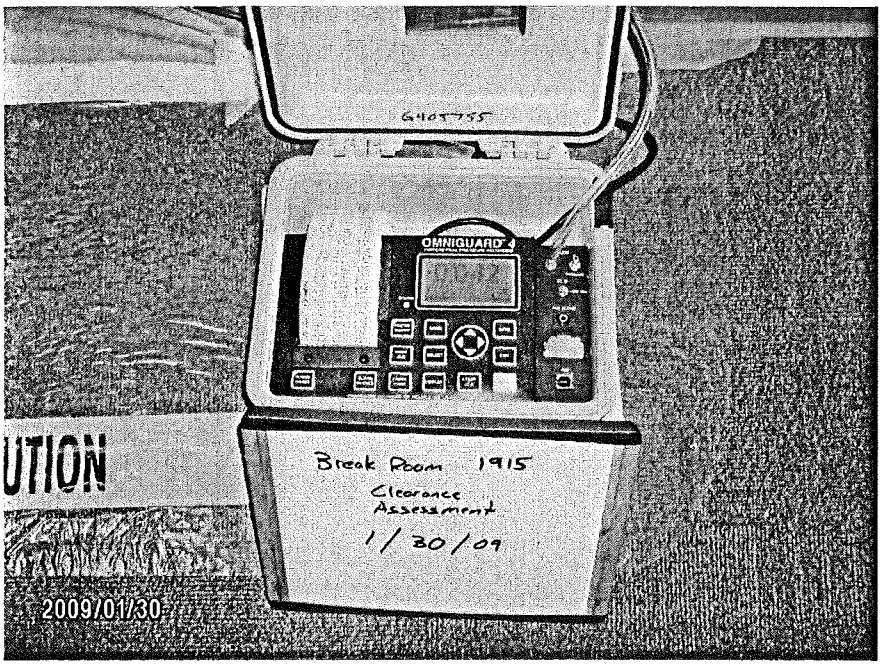
7) Close up image of pressure data logging manometer located at exterior of break Room 1915 indicating negative 0.042 at time of assessment.

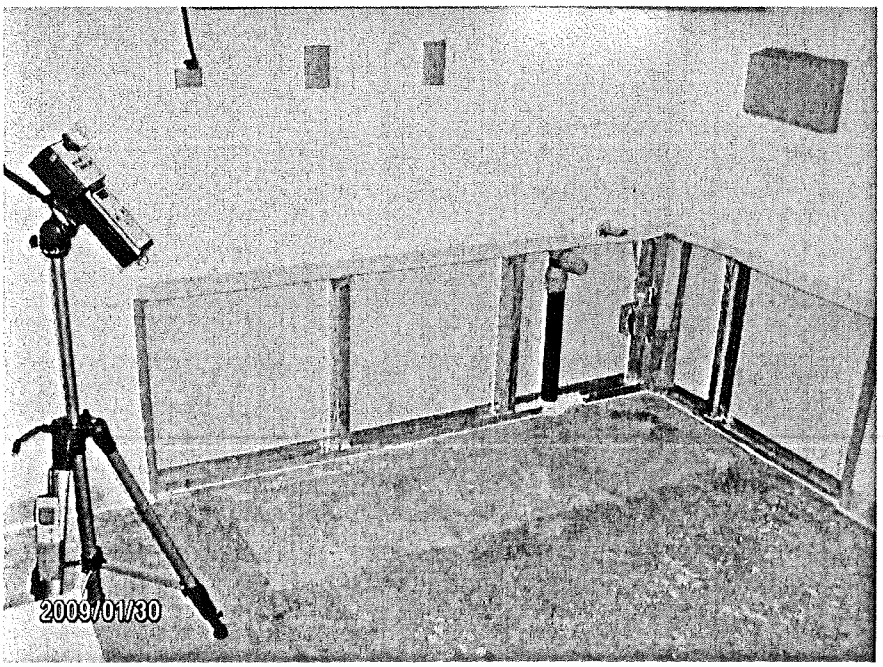
8) Image of air sampling activity and wall removal delineation performed within Break Room 1915 as part of the overall mitigative action.

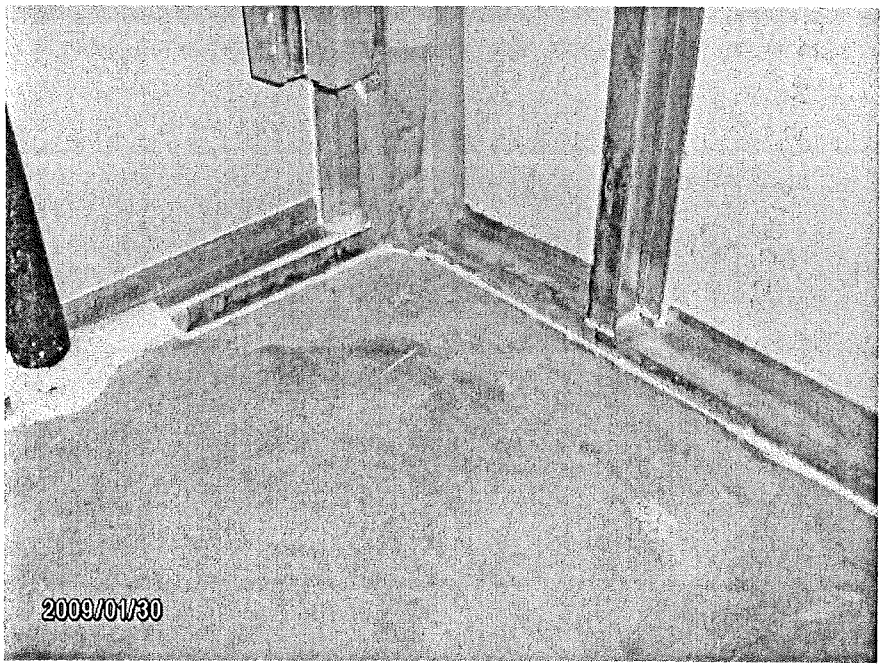
9) Close-up image of exposed wall cavity as viewed from within Break Room 1915 containment at time of assessment.

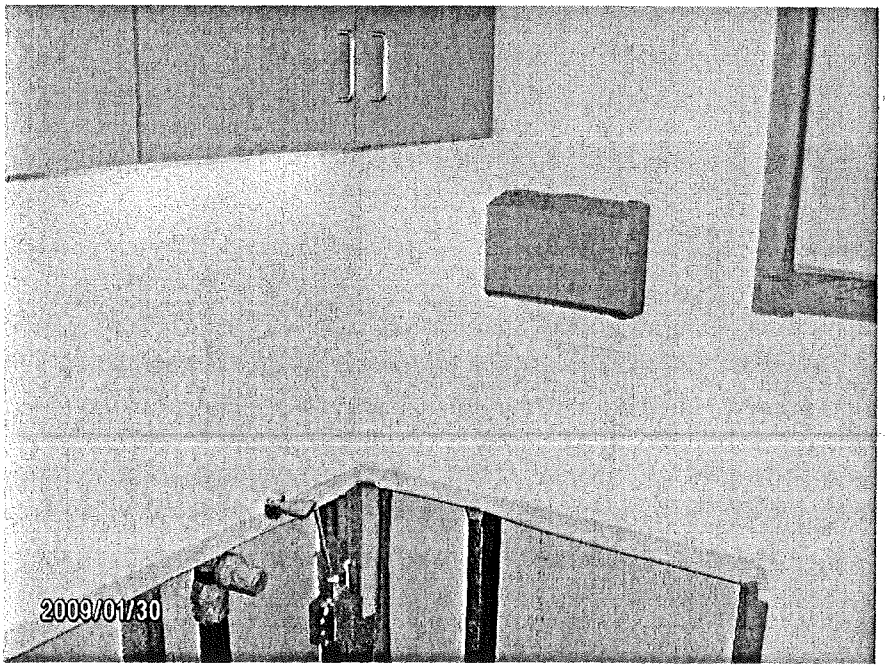
10) Close up image of wall furnishings present within Break Room 1915 containment at time of assessment.

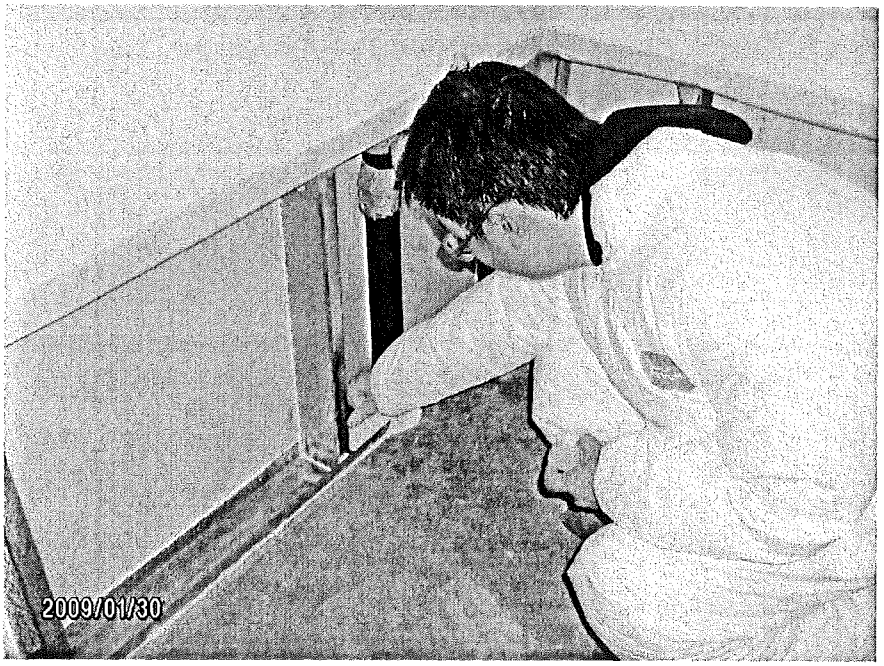
11) Image of HTI technician collecting surface tape sample on exposed wall cavity within Break Room 1915. Noted single gloved hand during collection of sample.

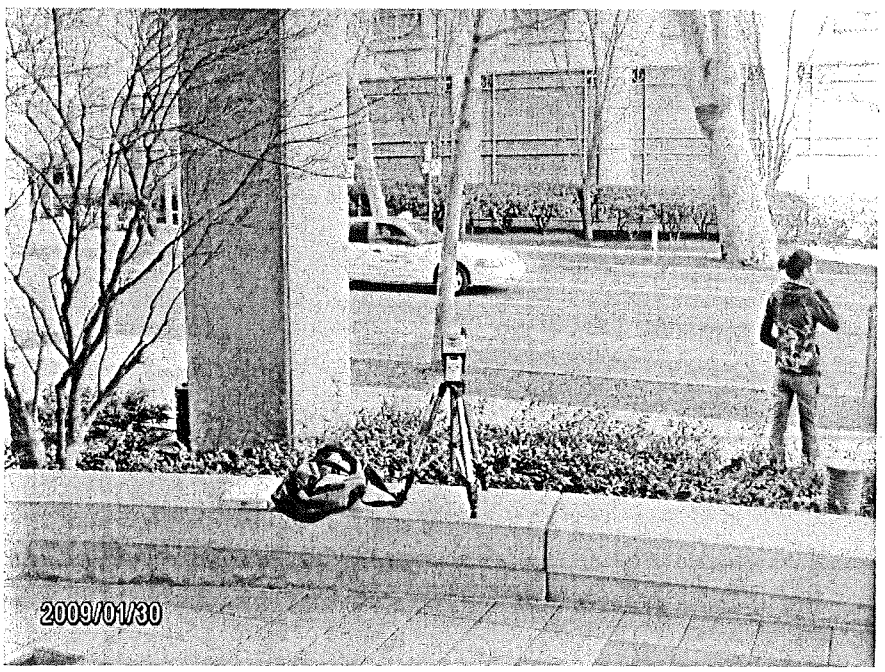
12) Image of ambient air sampling activity performed at outside location near main entrance to BOE building at conclusion of assessment.
