Post Mitigation Assessment Report
Department of General Services
Break Room 905
Board of Equalization Building, 450 N. Street
Sacramento, California

Attachment A: Digital Images
May 8th, 2009
BOE Building Break Room 905
450 N. Street, Sacramento, CA

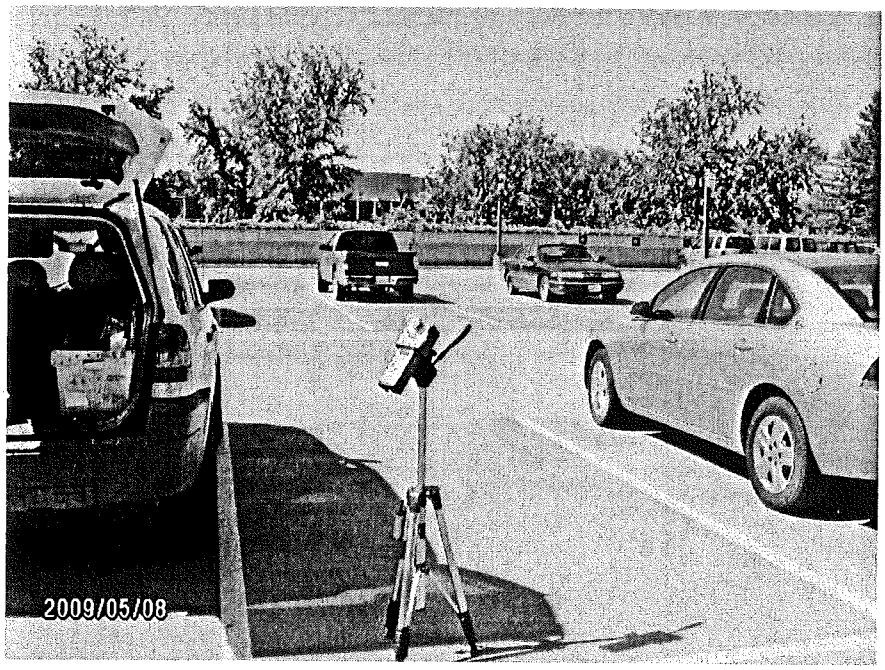
1) Image of ambient air sampling performed on garage rooftop location prior to interior sampling at 450 N Street, Sacramento, California.

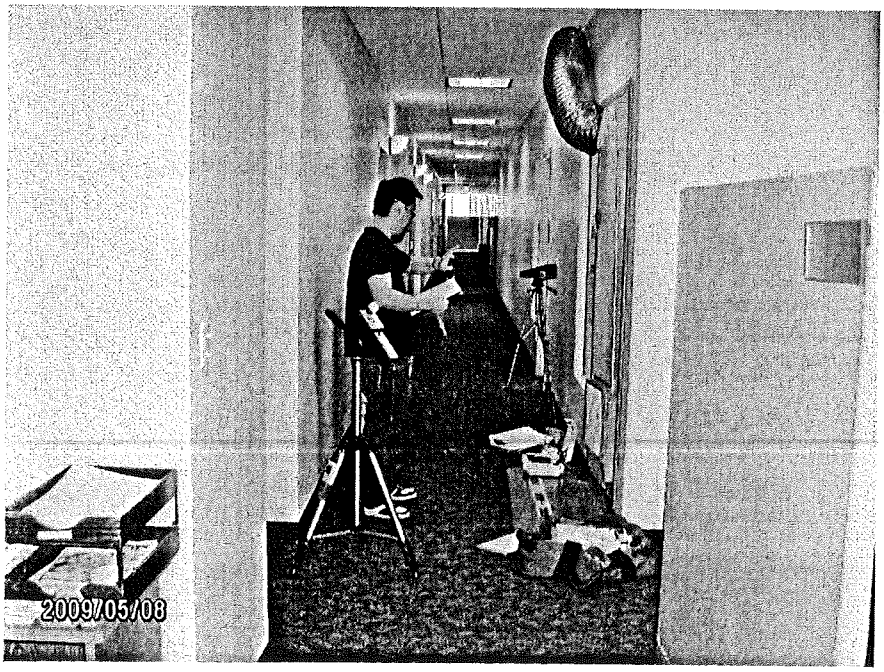
2) Image of tenant occupied hallway air sampling and Break Room 905 containment entrance area at time of clearance assessment.

3) Image of pressure monitoring equipment located within hallway of Break Room 905 at time of assessment. Air pressure differential (negative pressure) recorded at - 0.035 inches.

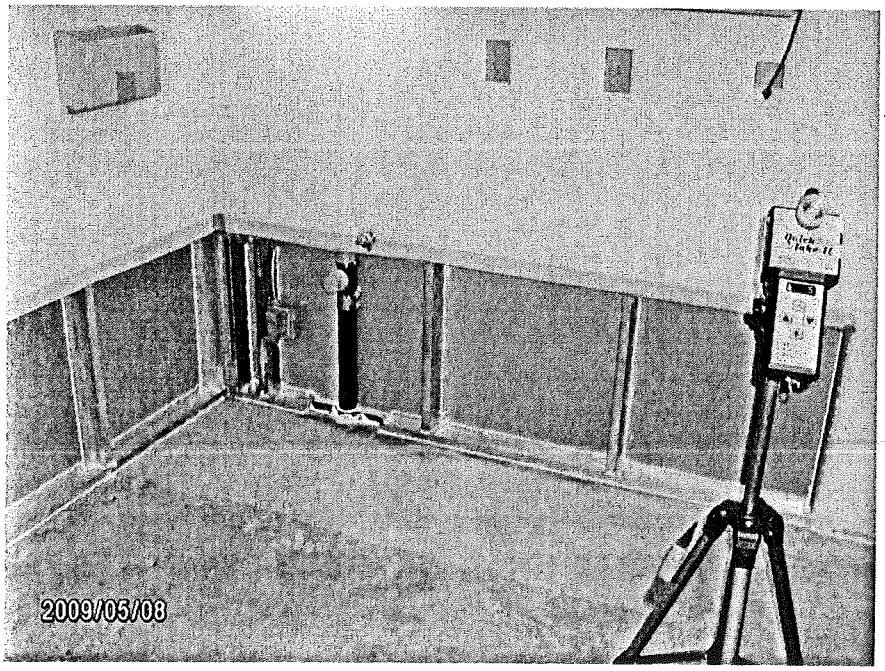
4) Image of air sampling equipment and baseboard removal delineation within Break Room 905 area at time of assessment.

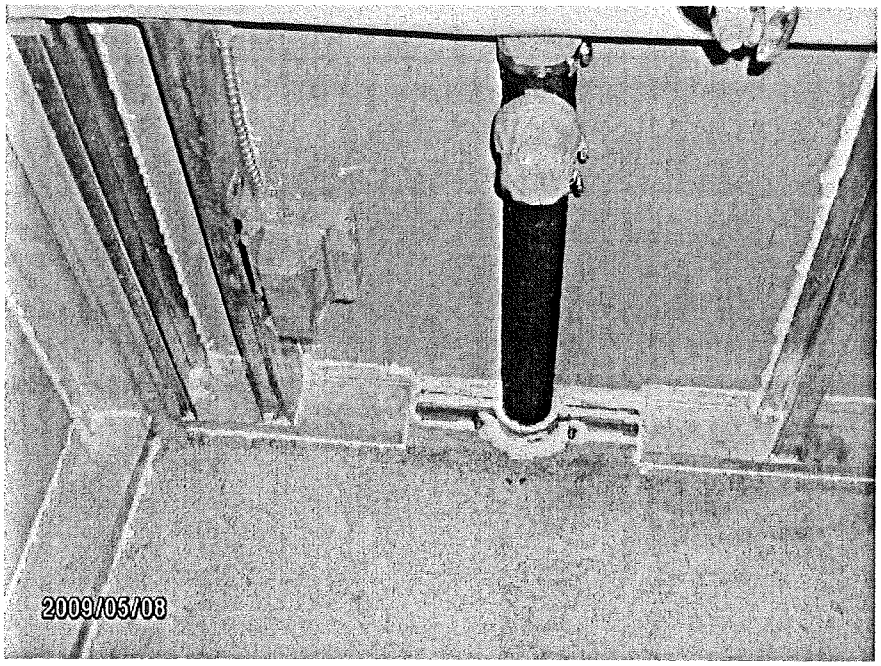
6. As verified during these assessment activities, all identified affected interior wallboard building materials had been removed from each of the noted interior areas exposing interior wall cavity framing (metal) and underlayment wallboard siding materials present within each of the impacted areas. Upon post mitigation inspection, all remaining exposed building materials located within the break room areas exhibited no significant staining and/or

5) Close-up image of exposed wall framing systems and wallboard interior cavities within Break Room 905 at time of clearance assessment.

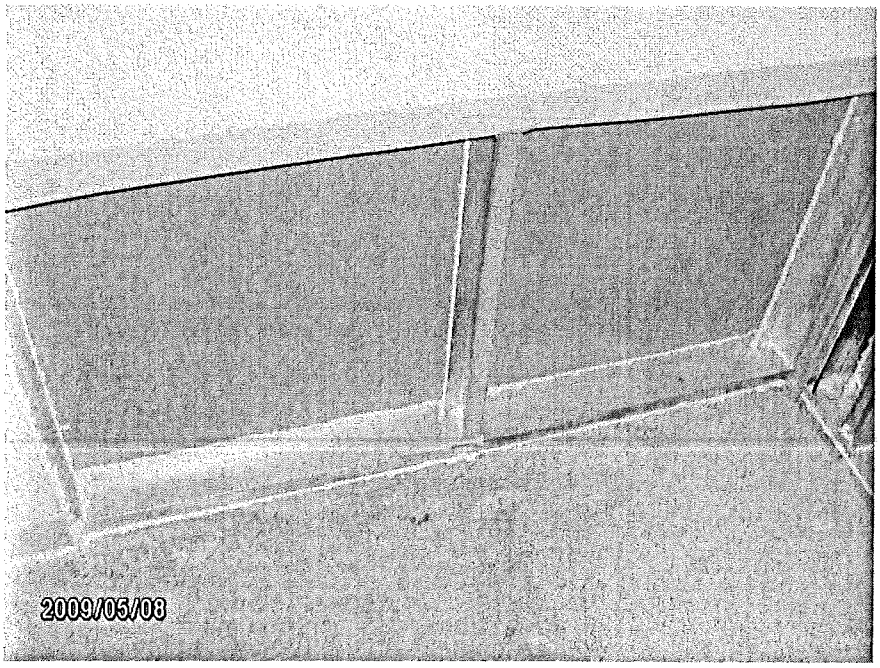
6) Additional close-up image of wallboard removal delineation performed within Break Room 905 containment at time of assessment.

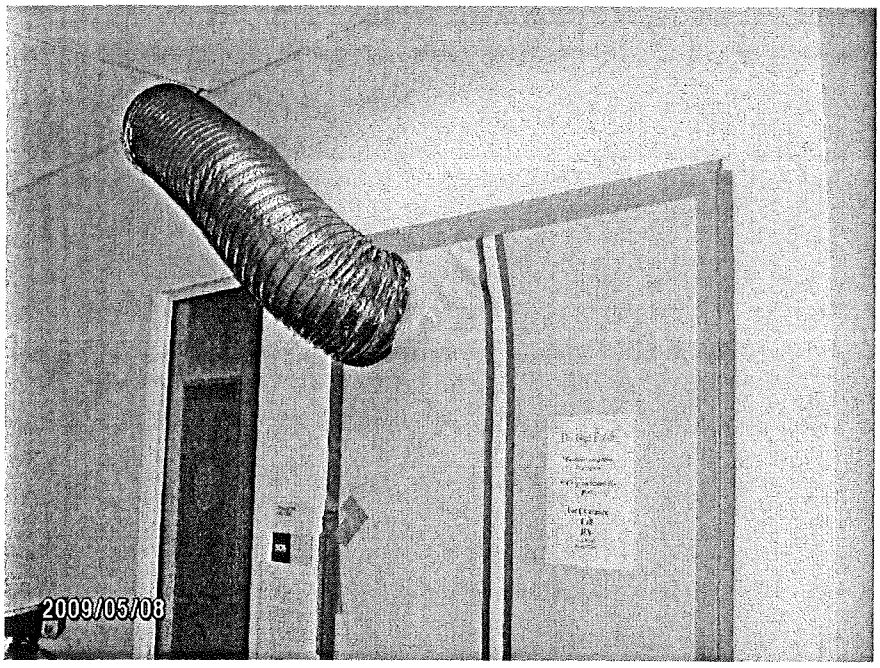
7) Image of entry chamber and construction of HEPA filtered exhaust ducting into hallway at containment of Break Room 905 at time of assessment.

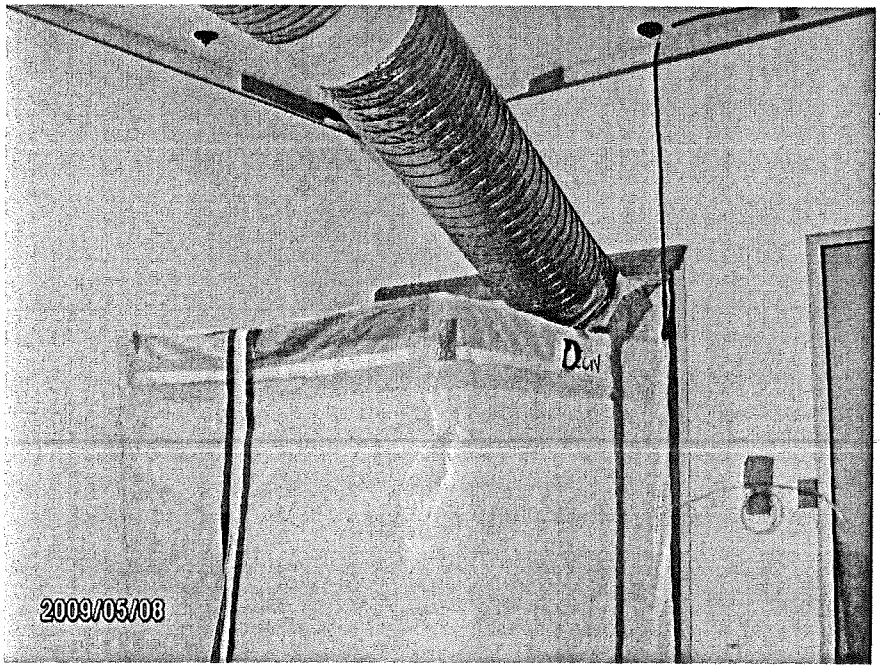
8) Image of entry chamber and construction of HEPA filtered exhaust ducting within containment of Break Room 905 at time of assessment.
