February 4th, 2010

Post Mitigation Assessment Report
Department of General Services
Break Room 910
Board of Equalization Building, 450 N. Street
Sacramento, California

Attachment A: Digital Images
February 18th, 2009
BOE Building Break Room 910
450 N. Street, Sacramento, CA

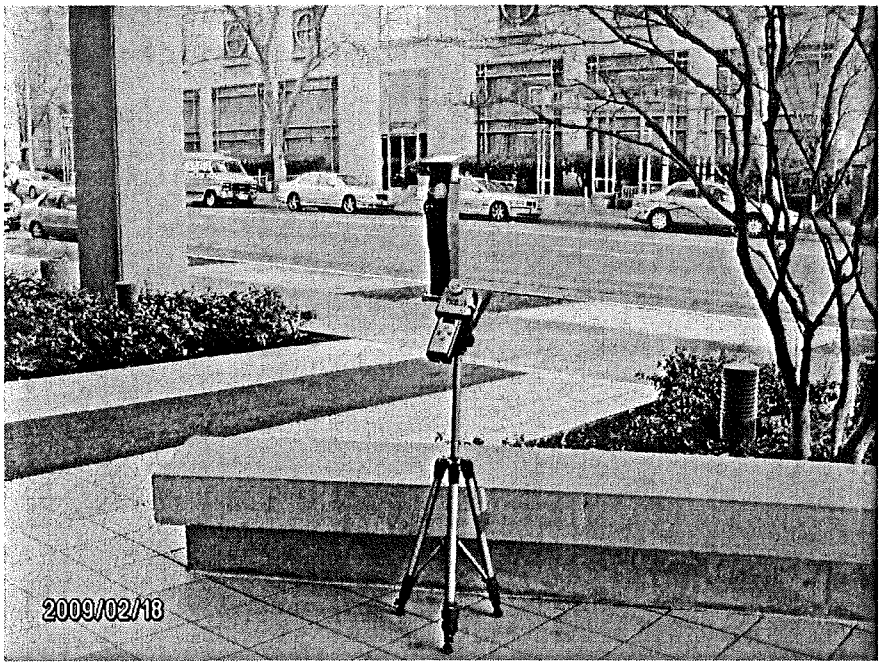
1) Image of ambient air sampling performed at main level entry location prior to interior sampling at 450 N Street, Sacramento, California.

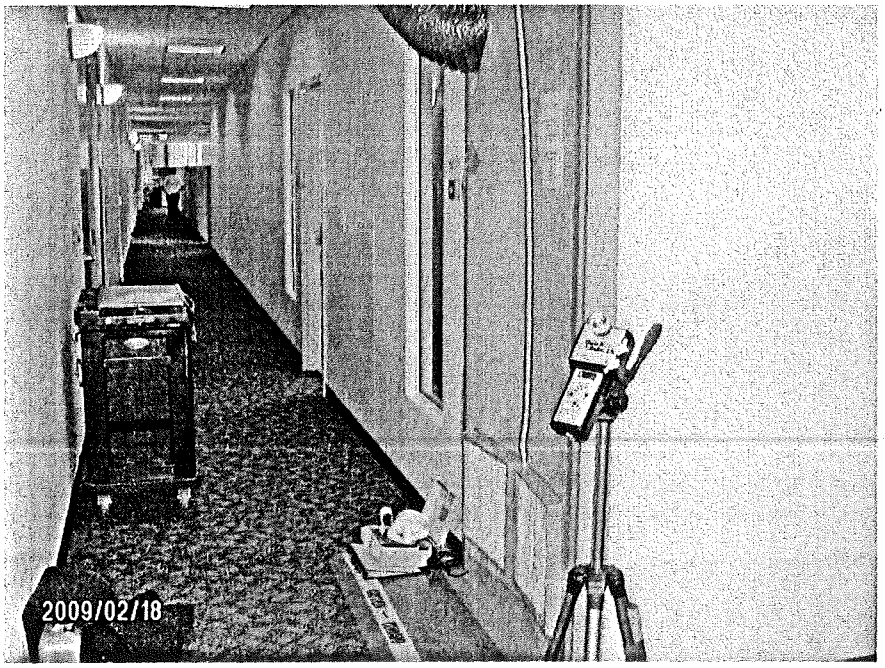
2) Image of tenant occupied hallway air sampling area near Break Room 910 containment entrance area at time of clearance assessment.

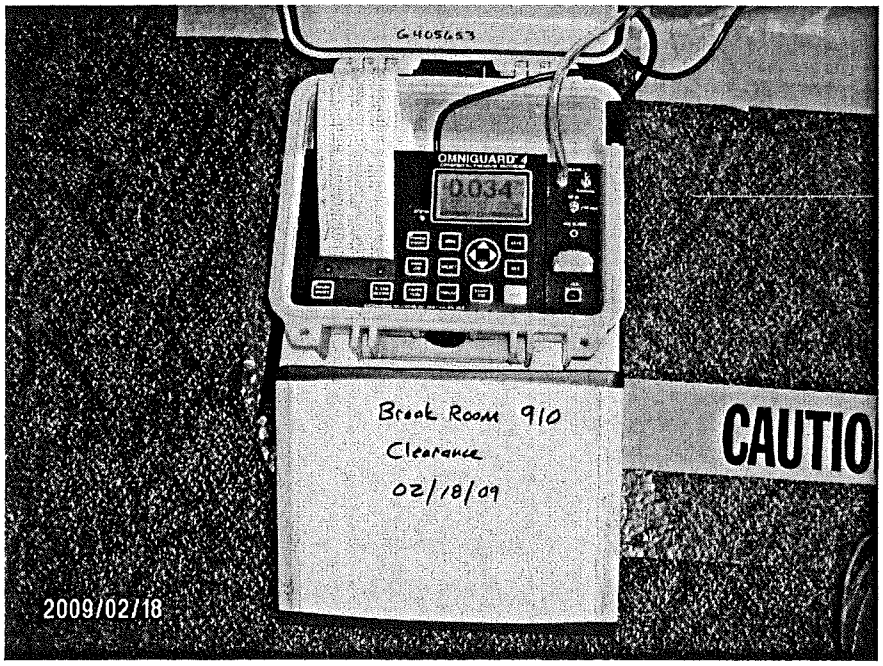
4. The establishment of zippered plastic entry barriers at the doorway entrance to the noted break room containments were observed and verified under appropriate posting and negative pressure differential at the time of this post mitigation assessment. Worker and equipment entry and exit chambers comprised of a series of zippered plastic access doorways were also observed attached to the noted containment barrier system consistent with BioMax's previously noted and approved mitigation protocols.

3) Image of pressure monitoring equipment located within hallway of Break Room 910 at time of assessment. Air pressure differential (negative pressure) recorded at - 0.034 inches.

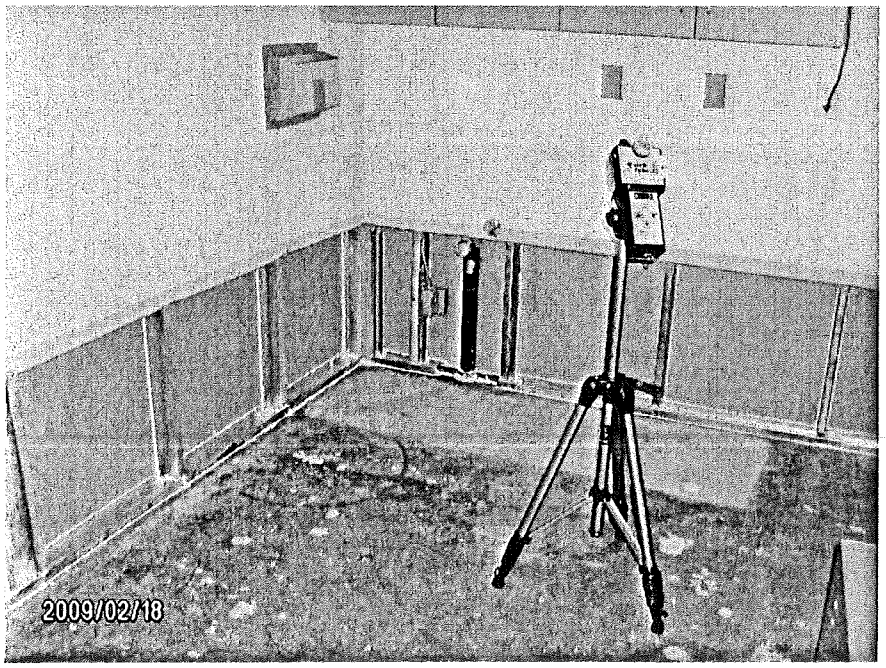
4) Image of air sampling equipment and baseboard removal delineation within Break Room 910 area at time of assessment.

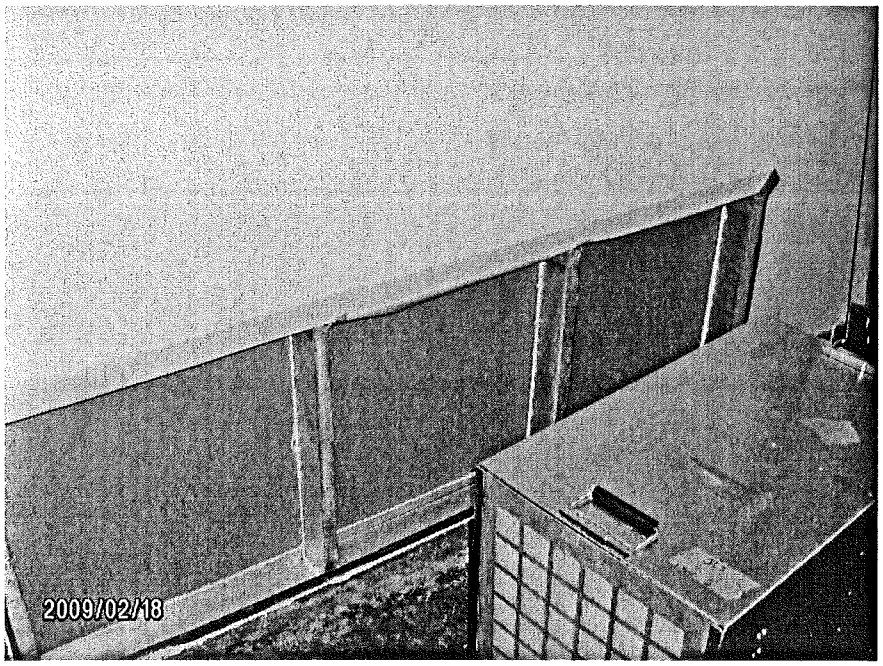
6. As verified during these assessment activities, all identified affected interior wallboard building materials had been removed from each of the noted interior areas exposing interior wall cavity framing (metal) and underlayment wallboard siding materials present within the impacted area. Upon post mitigation inspection, all remaining exposed building materials located within the break room area exhibited no significant staining and/or elevated mold

growth following the completion of prescribed physical material removal and chemical decontamination procedures performed by JLS.

5) Close-up image of exposed wall framing systems and wallboard interior cavities within Break Room 910 at time of clearance assessment.

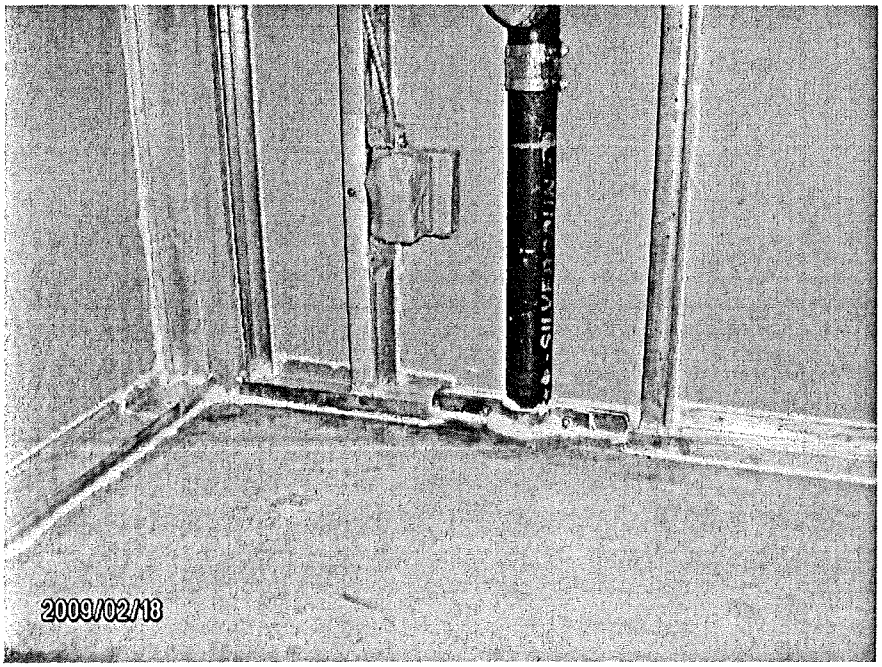
6) Additional close-up image of wallboard removal delineation performed within Break Room 910 containment at time of assessment.

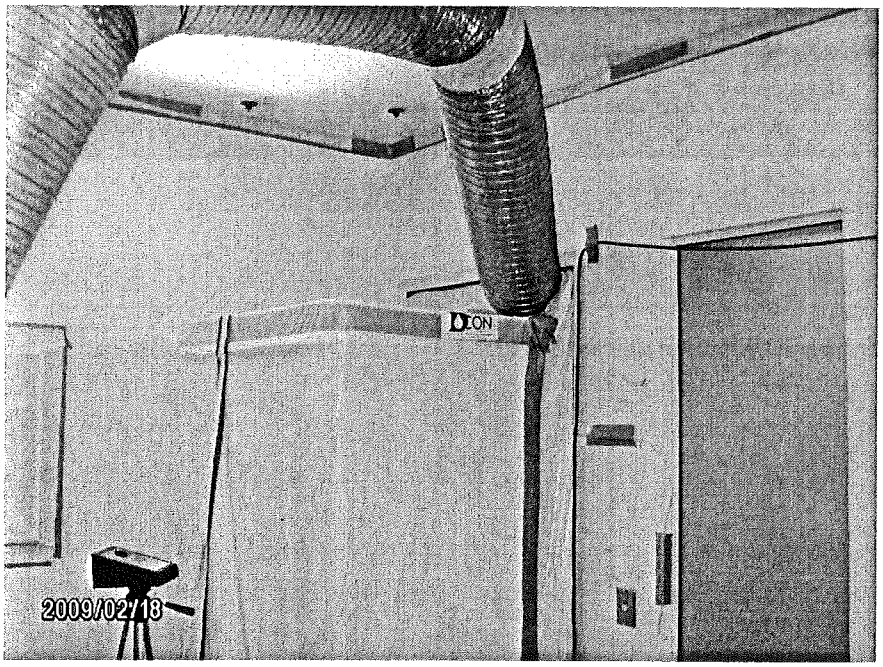
7) Image of entry chamber and construction of HEPA filtered exhaust ducting within containment of Break Room 910 at time of assessment.

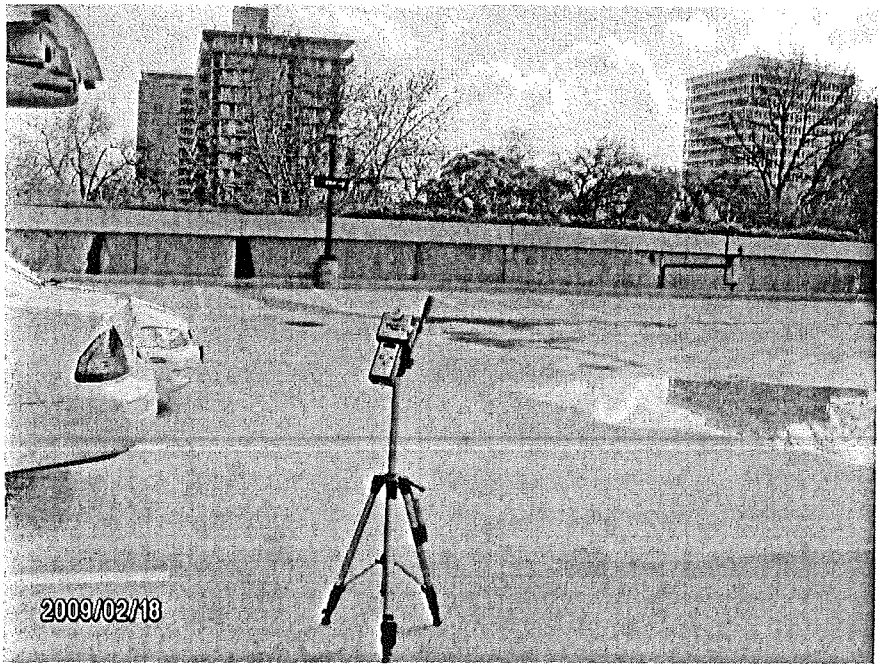
8) Image of ambient air sampling performed on garage rooftop location following the collection of interior microbial samples at time of assessment.
