BioMax Environmental
Environmental Consulting and Industrial Hygiene Services

January 26th, 2010

Post Mitigation Assessment Report
Department of General Services
Break Rooms 617, 507, 406, and 304
Board of Equalization Building, 450 N. Street
Sacramento, California

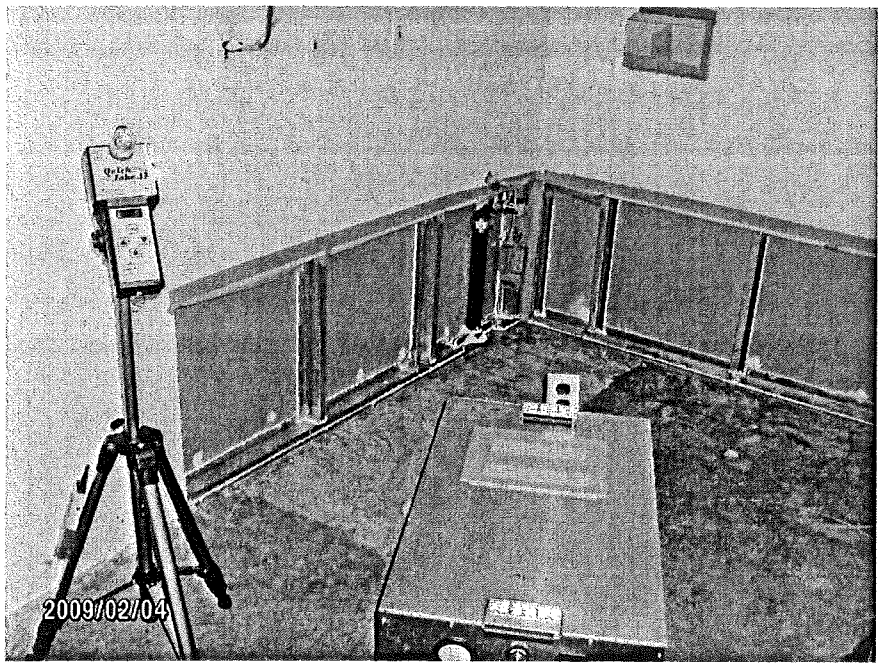
8) Image of wall removal delineation performed within Break Room 406 as part of the mitigative effort.

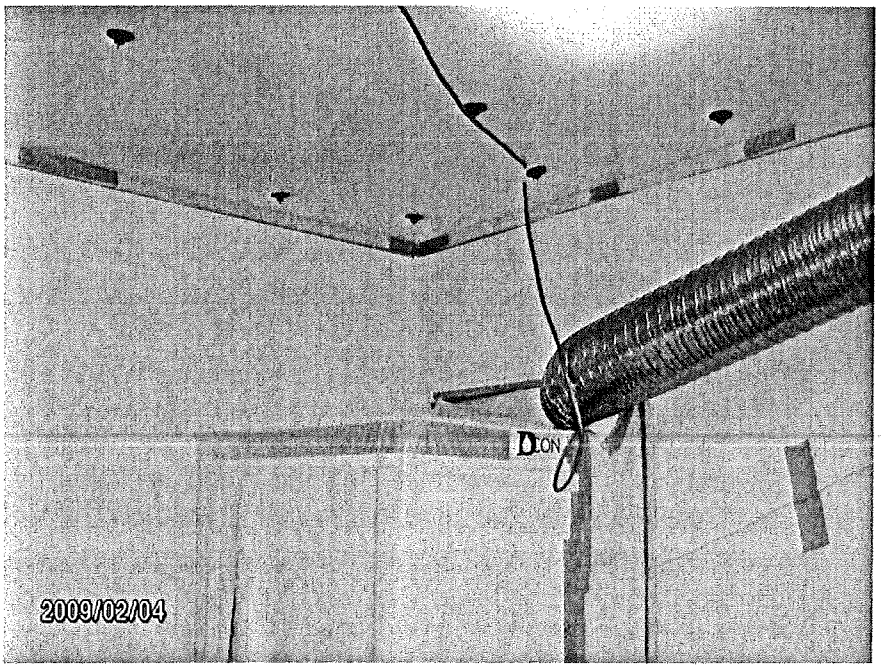
9) Image of air sampling equipment and exposed wall cavity as viewed from within Break Room 304 containment at time of assessment.
