Appendix B
Daily Logs

LaCroix Davis LLC
Building & Environmental Forensics

DAILY PROJECT LOG - DATE: 10/1/09

Client	**Department of General Services (DGS)**	Shift PM	
Project	**California State Board of Equalization**	Number of Workers	JLS 1
Building	**450 N Street, Sacramento CA**	Compound(s) of Concern	Mold
Location	**Floor:** 2 **Room:** All - VAV's	**Area:** above ceilings	
LCD Project #	**2372.02-572; SOW** _____		
Contractor	**JLS Environmental**

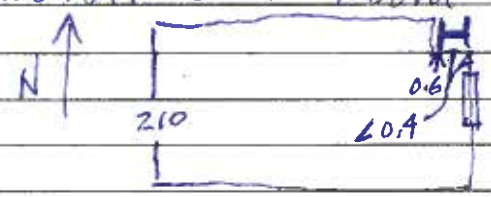
6:00 AM Floor 2 Room 210 - test column moisture content more drying of column edge is necessary.

6:00 PM set Fan in Room 210 at column edge (0.6)
schedule pick up at 6:00 AM

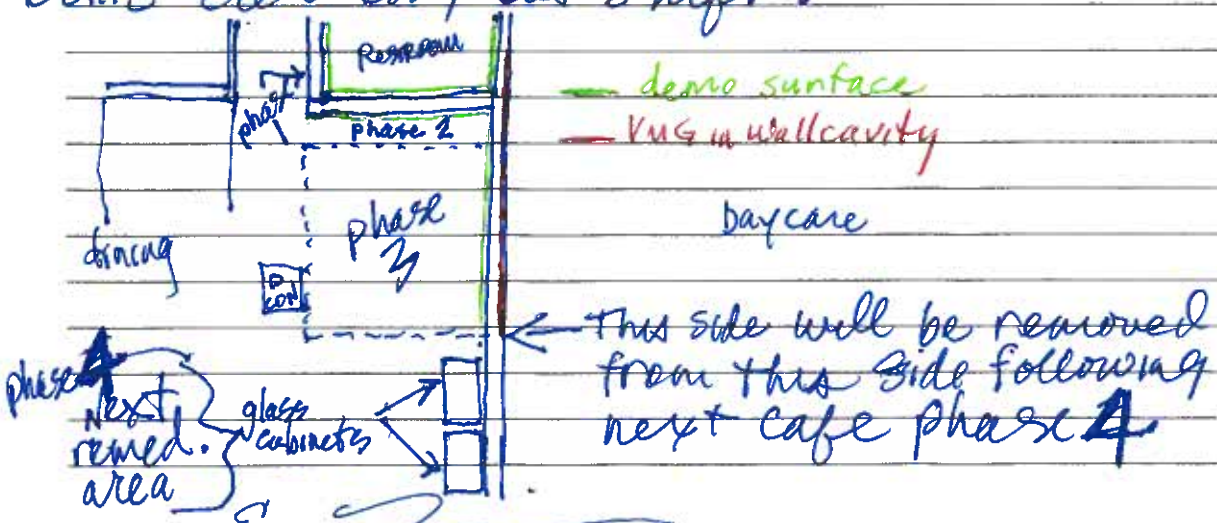
21:30 Lunch break
22:00 Final prep.
22:30 containment set and removal of cabinet base at west wall begins followed by gypboard removal 2' high behind cabinets (10 stud bays) VMG (same as observed previously) is present on daycare side of framing approx 2' ↑ entire opened wall & continues past containment. (containment set up as close to glass cabinets as feasible).

23:30 bagout completed detail cleaning underway (carpet beneath wall cabinets also removed & disposed, adhesive scraped).
00:00 cleaning continues
01:00 cleaning completed and prep for Encap.

01:30 encap followed by foam cracks
02:00 final cleanup and demob
02:15 Crew completes shift.
