Appendix B
Daily Logs

DAILY PROJECT LOG - DATE: 11-17-09

Client	**Department of General Services (DGS)**	Shift	DAY 8-5
Project	**California State Board of Equalization**	Number of Workers	(2) CC/TM1
Building	**450 N Street, Sacramento CA**	Compound(s) of Concern	Mold
Location	**Floor:** PH **Room:** entire	**Area:** Supp WDA	
LCD Project #	**2372.03-572; SOW** 4.0		
Contractor	**JLS Environmental**

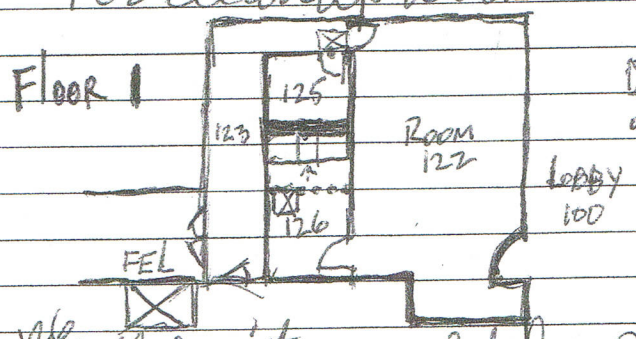
☒ decon unit
ooo containment barrier

21:00	126 Wall cavity completed - Begin Wiping + Vac cabinets and drawers. - OK to cncp following surface cleaning.
	125 surface cleaning - wet wipe HEPA Vac
21:30	PH cleaning horizontal surfaces continues W to E
22:00	Room 126 final HEPA Vac and clean decon - photo and seal
22:30	Room 125 final clean HEPA and caulk seals/cracks

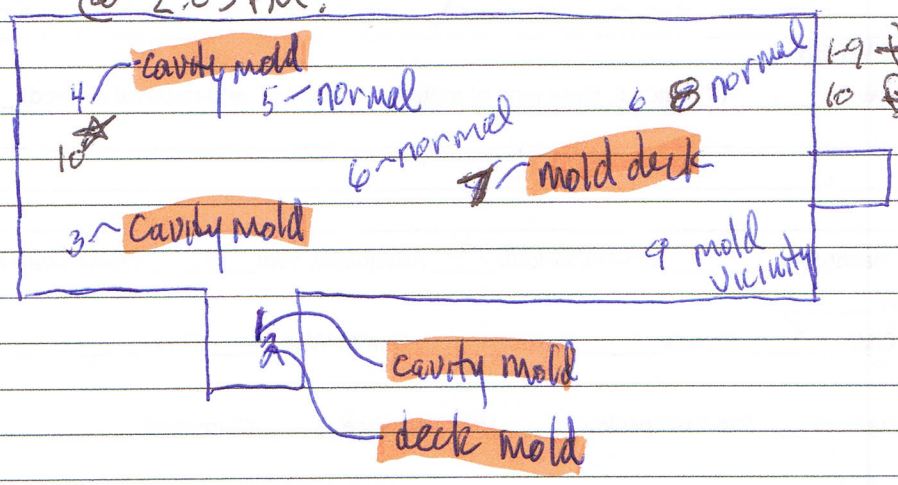
13:30 Enter containment, take tape sample of an unsampled (from yesterday) water stain, and leave for lab @ 2:05 PM.

19 ~~Blue~~ = 12/21
20 ~~Black~~ = 12/22

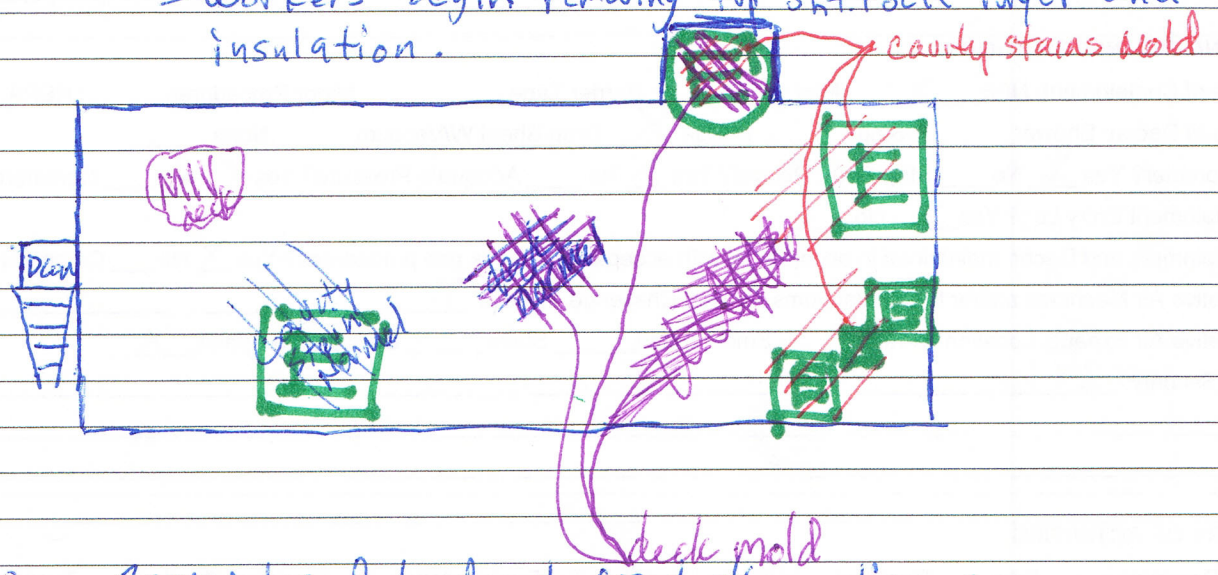
7:00 Work begins, meet w/ ~~JE from~~ JCS. E. Ramos
- Workers begin removing top sht.rock layer and insulation.

9:00 - Removal and load out GB deck continues
11-12 lunch
12:00 Cleaning resumes, demo of top layer sht.rock is complete.
1:00 - Inspect for water stains, take no samples, as no staining was found.
- Give JCS ok to encap areas with confirmed mold.
1:30 - See ~~attached~~ above map for areas of encapsulation.
- Active leaks are being fixed by BPM.
3:00 Final visual of encap and cleaning (detail)
3:30 shift completed

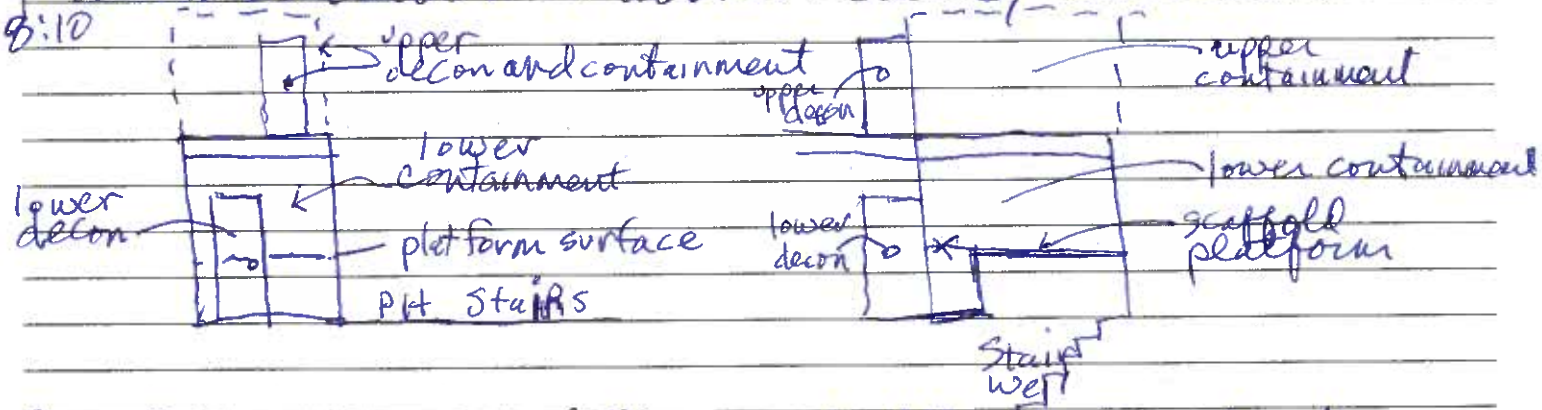
8:15 JLS begins removal of stairwell ceiling materials at water damaged/stained locations from upper containment
9:00 bagged materials are lowered to lower containment and then double bagged. All ceiling demo complete and
↓ load out underway - Prelim detail cleaning begins
11:00
11:30 following load out of all materials, cleaning reveals additional 1" board upper surface w/ VMG to be removed
12:30 Removal of all stained materials underway.
14:00 all removal & rough wipe down cleanup completed.
& sheetrock stair lid begins
