APPENDIX C – FIGURES

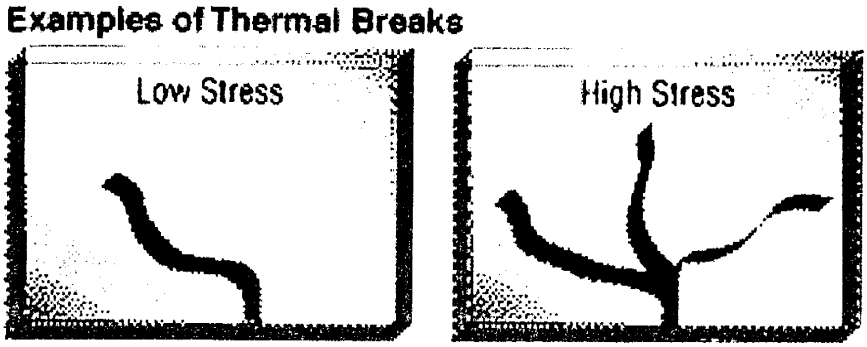
Figure 1: Typical Thermal Break Pattern in Glass
(Taken from www.glassresource.com)

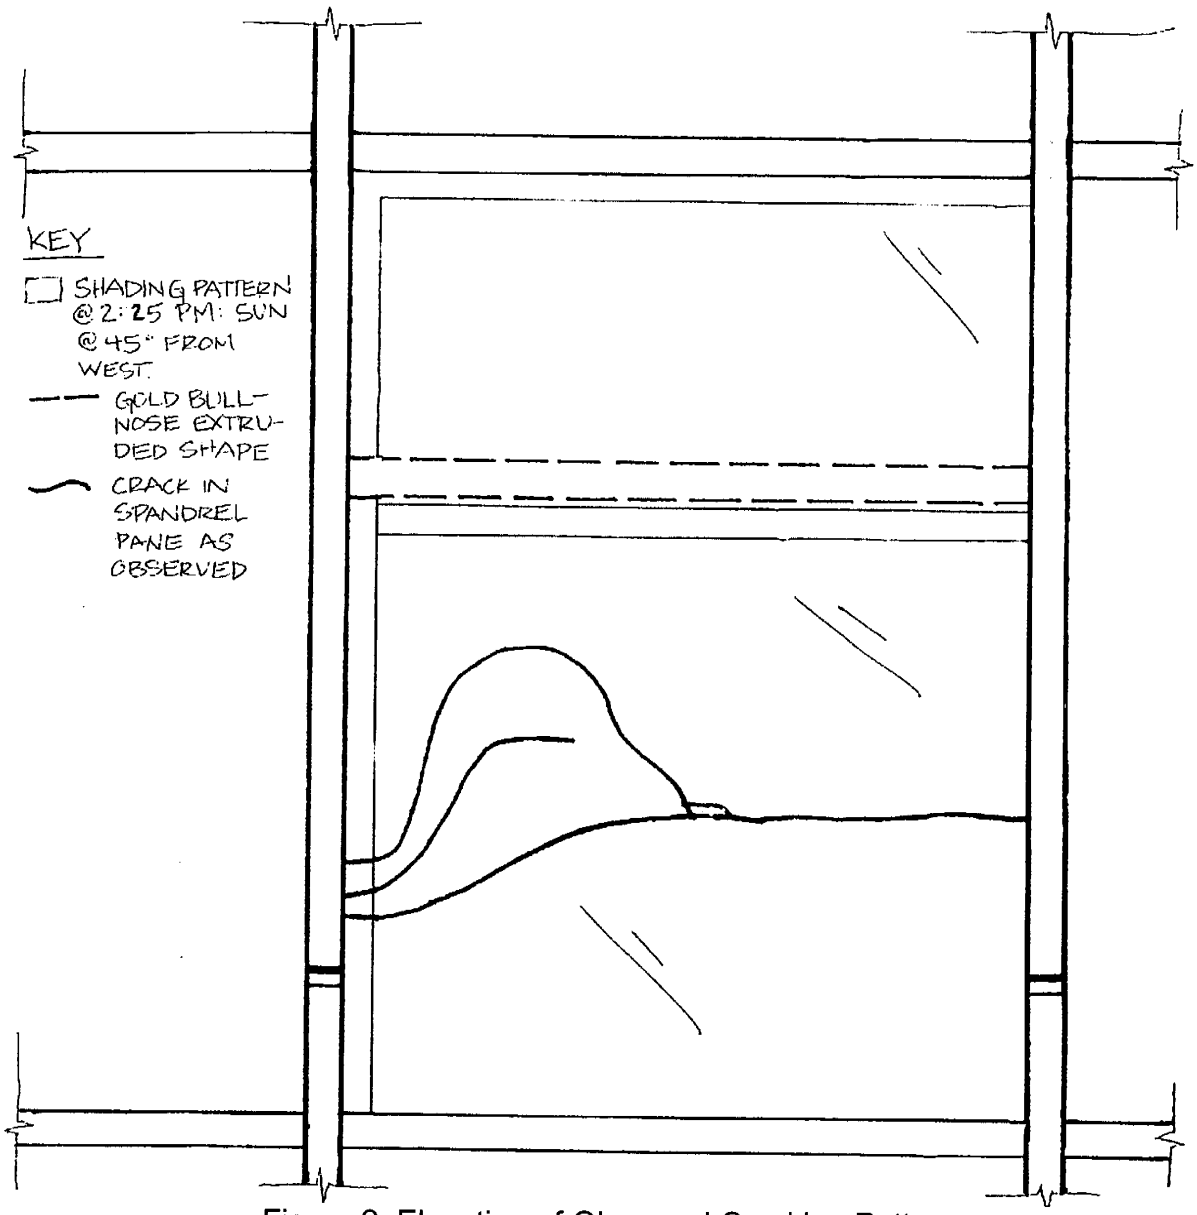
Figure 2: Elevation of Observed Cracking Pattern
