BioMax Environmental
Environmental Consulting and Industrial Hygiene Services

April 3rd, 2008

Post Mitigation Assessment
Department of General Services Board of Equalization Building
24th Floor Break Room Areas
450 N. Street
Sacramento, California

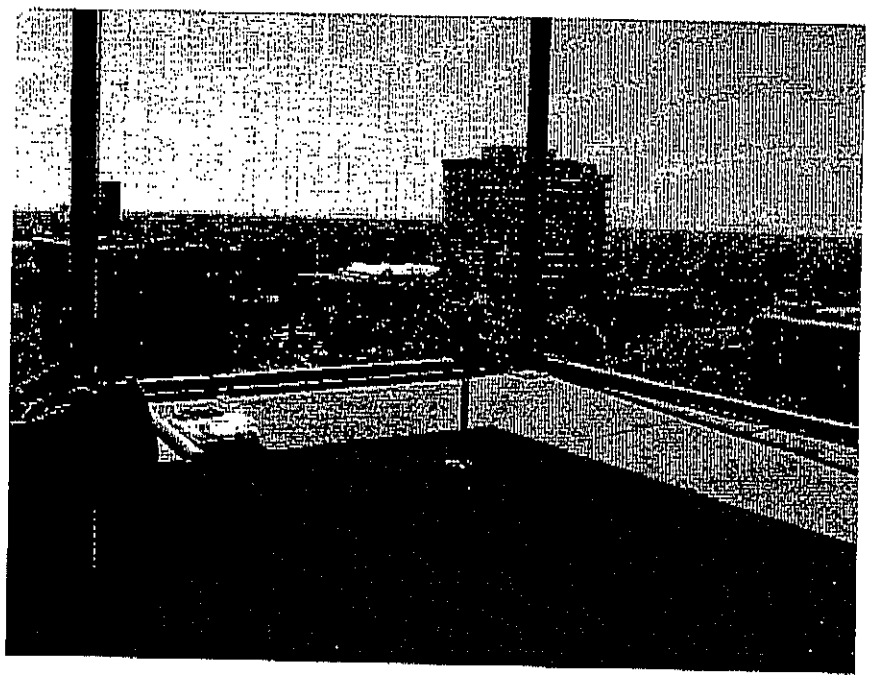
2) Image of ambient air sampling location on 12th Floor southeast deck area at time of assessment.

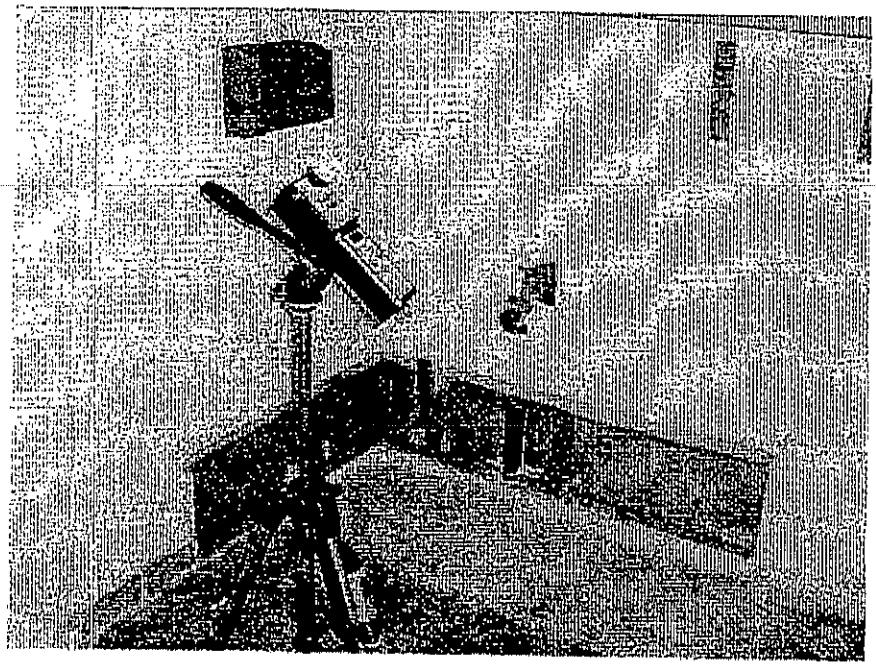
5) Image within 2424 containment indicating location of air sampling equipment and removal of cabinetry and wallboard materials.

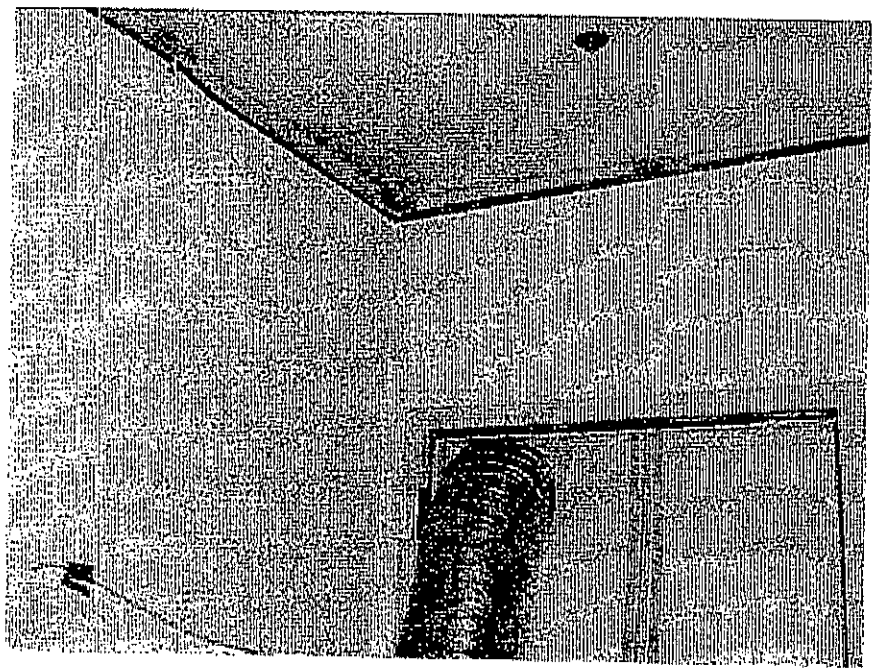
6) Image within 2424 containment viewing ceiling containment and exhaust ventilation at entry/exit chamber doorway.

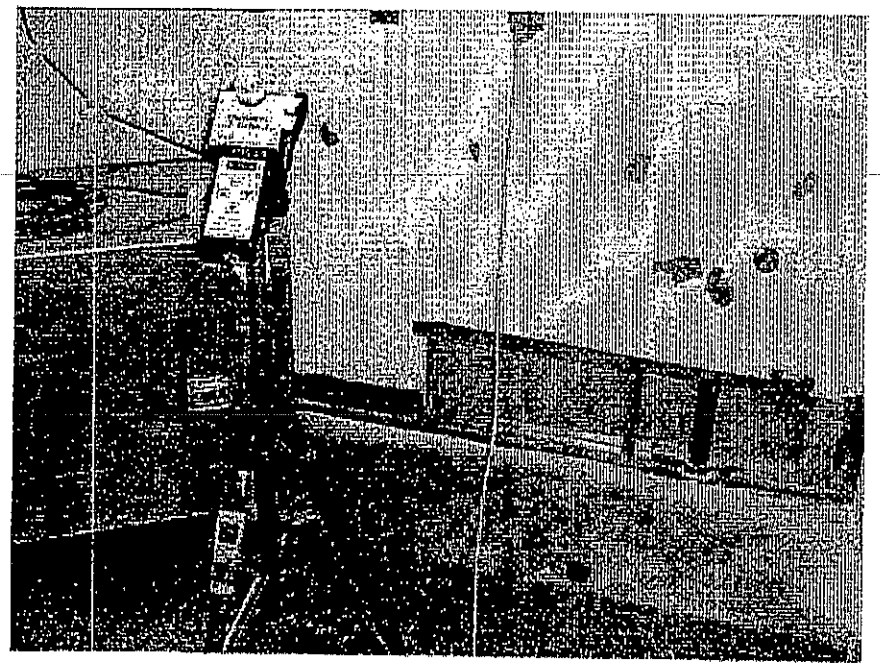
7) Image within 2402 Break Room containment indicating location of air sampling equipment and physical cabinet and wallboard removal at time of clearance assessment.
