California State Board of Equalization
450 N Street, Sacramento, California

Mold Remediation – 11th Floor
Closure Report Addendum

Project No. 2372.02-572

Addendum Date: October 31, 2012

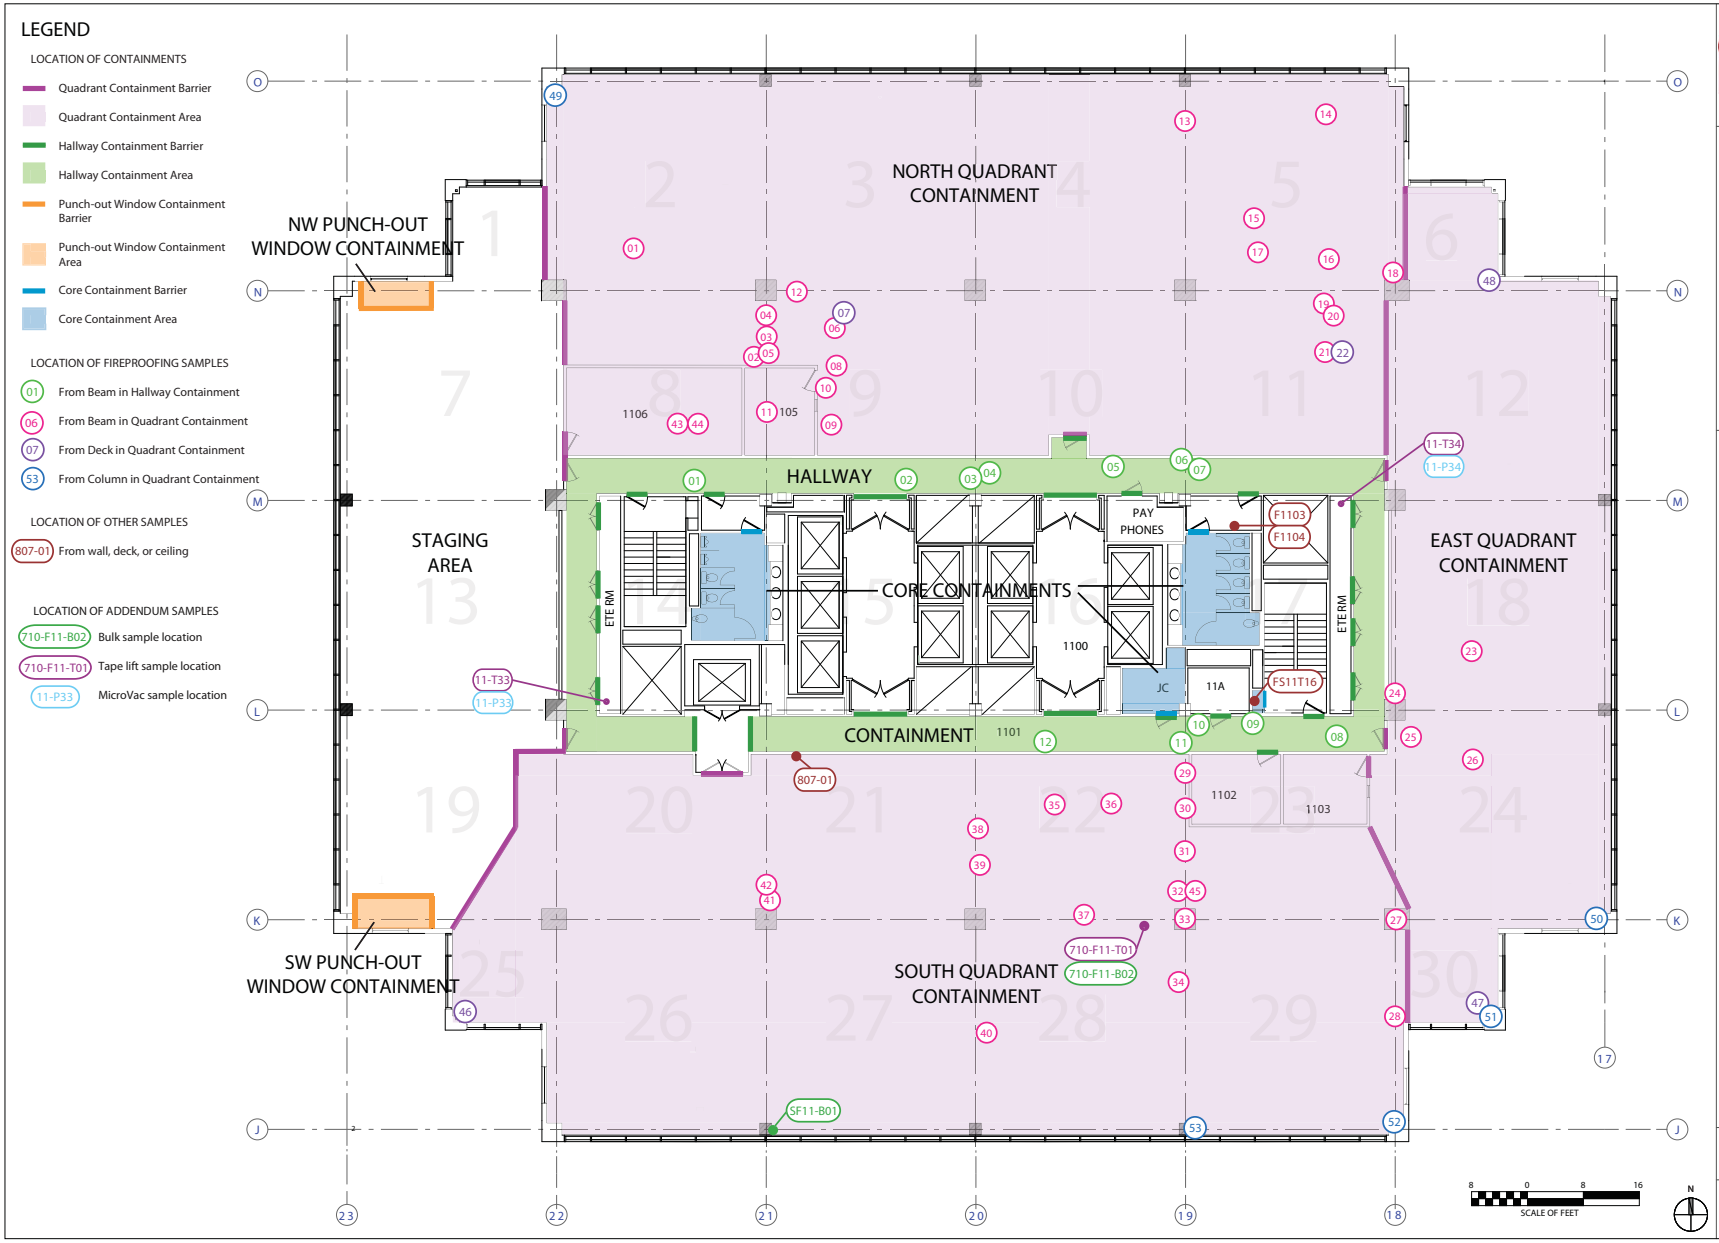
Subsequent to the completion of the closure report, a need for additional investigation and/or remediation activities was identified. Identified areas were subjected to sampling. Using a combination of surface tape lift and/or bulk samples, LCD tested stains on walls and other building materials to determine if the stains were indicative of mold growth. The sample locations are depicted in a revised Figure 2 attached to this addendum.

Containment and Sample Locations (Oct 2012)
