California State Board of Equalization
450 N Street, Sacramento, California

Mold Remediation – 16th Floor
Closure Report Addendum

Project No. 2372.02-572

Addendum Date: October 31, 2012

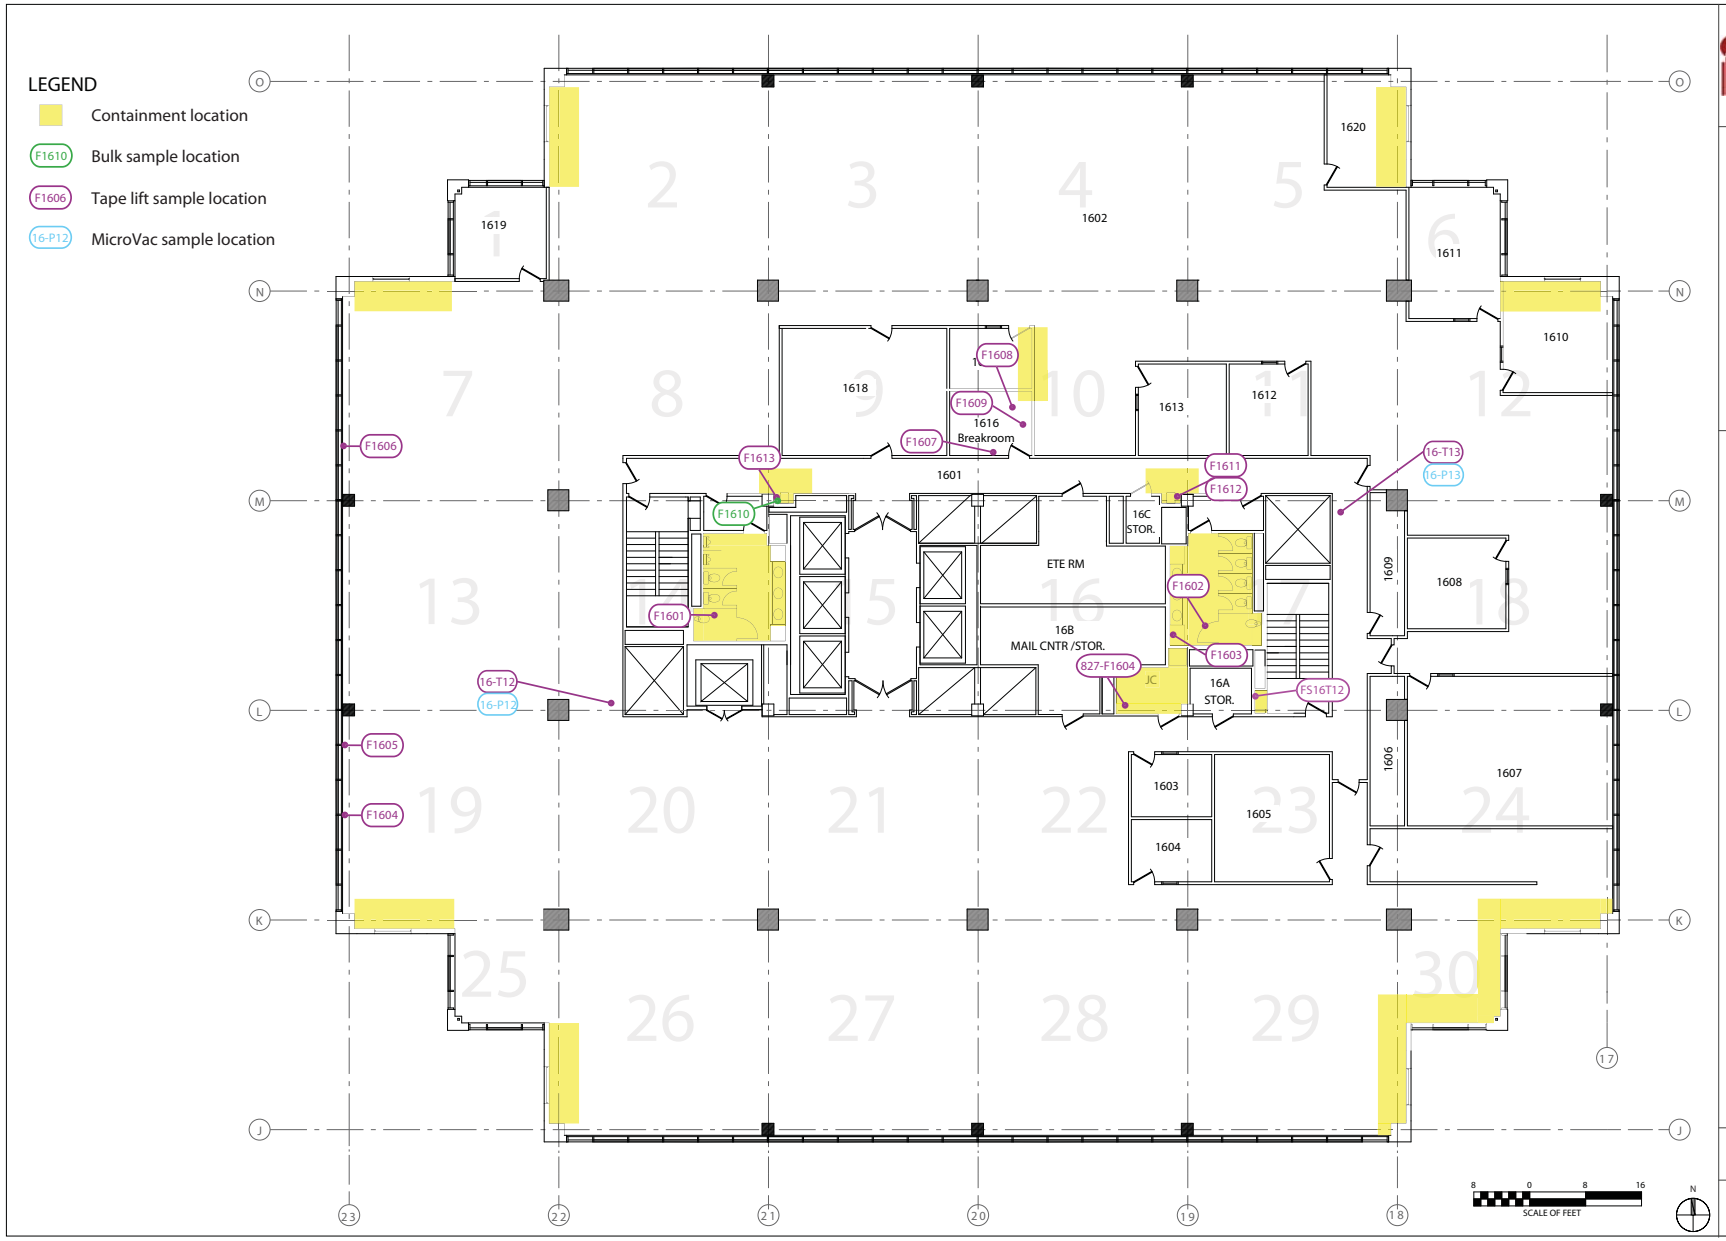
Subsequent to the completion of the closure report, a need for additional investigation and/or remediation activities was identified. Identified areas were subjected to sampling. Using a combination of surface tape lift and/or bulk samples, LCD tested stains on walls and other building materials to determine if the stains were indicative of mold growth. The sample locations are depicted in a revised Figure 2 attached to this addendum.

Containment and Sample Locations (Oct 2012)

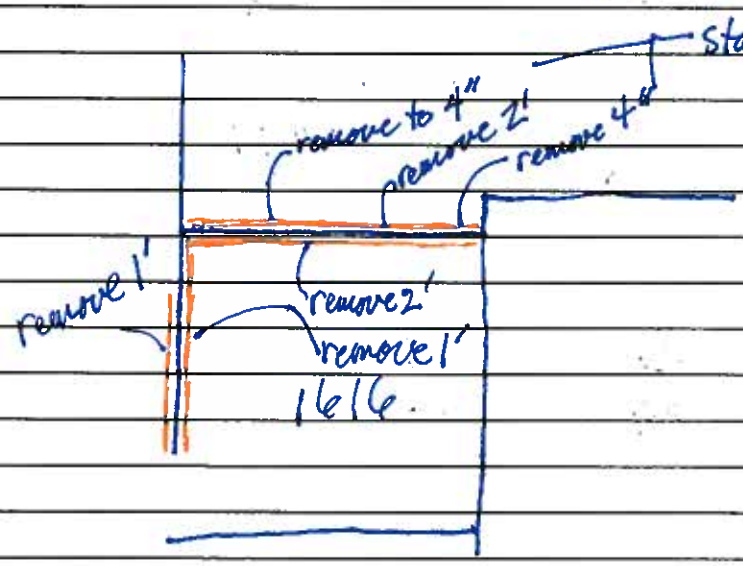
1800 - prep begins Floor 16 - room 1616
complete containment and begin removal of wall/cabinet
expand containment to address staining in conference room 1618 and hallway at 1616. (2 popup/tents)
