California State Board of Equalization
450 N Street, Sacramento, California

Mold Remediation – First Floor
Closure Report Addendum

Project No. 2372.02-572

Addendum Date: October 31, 2012

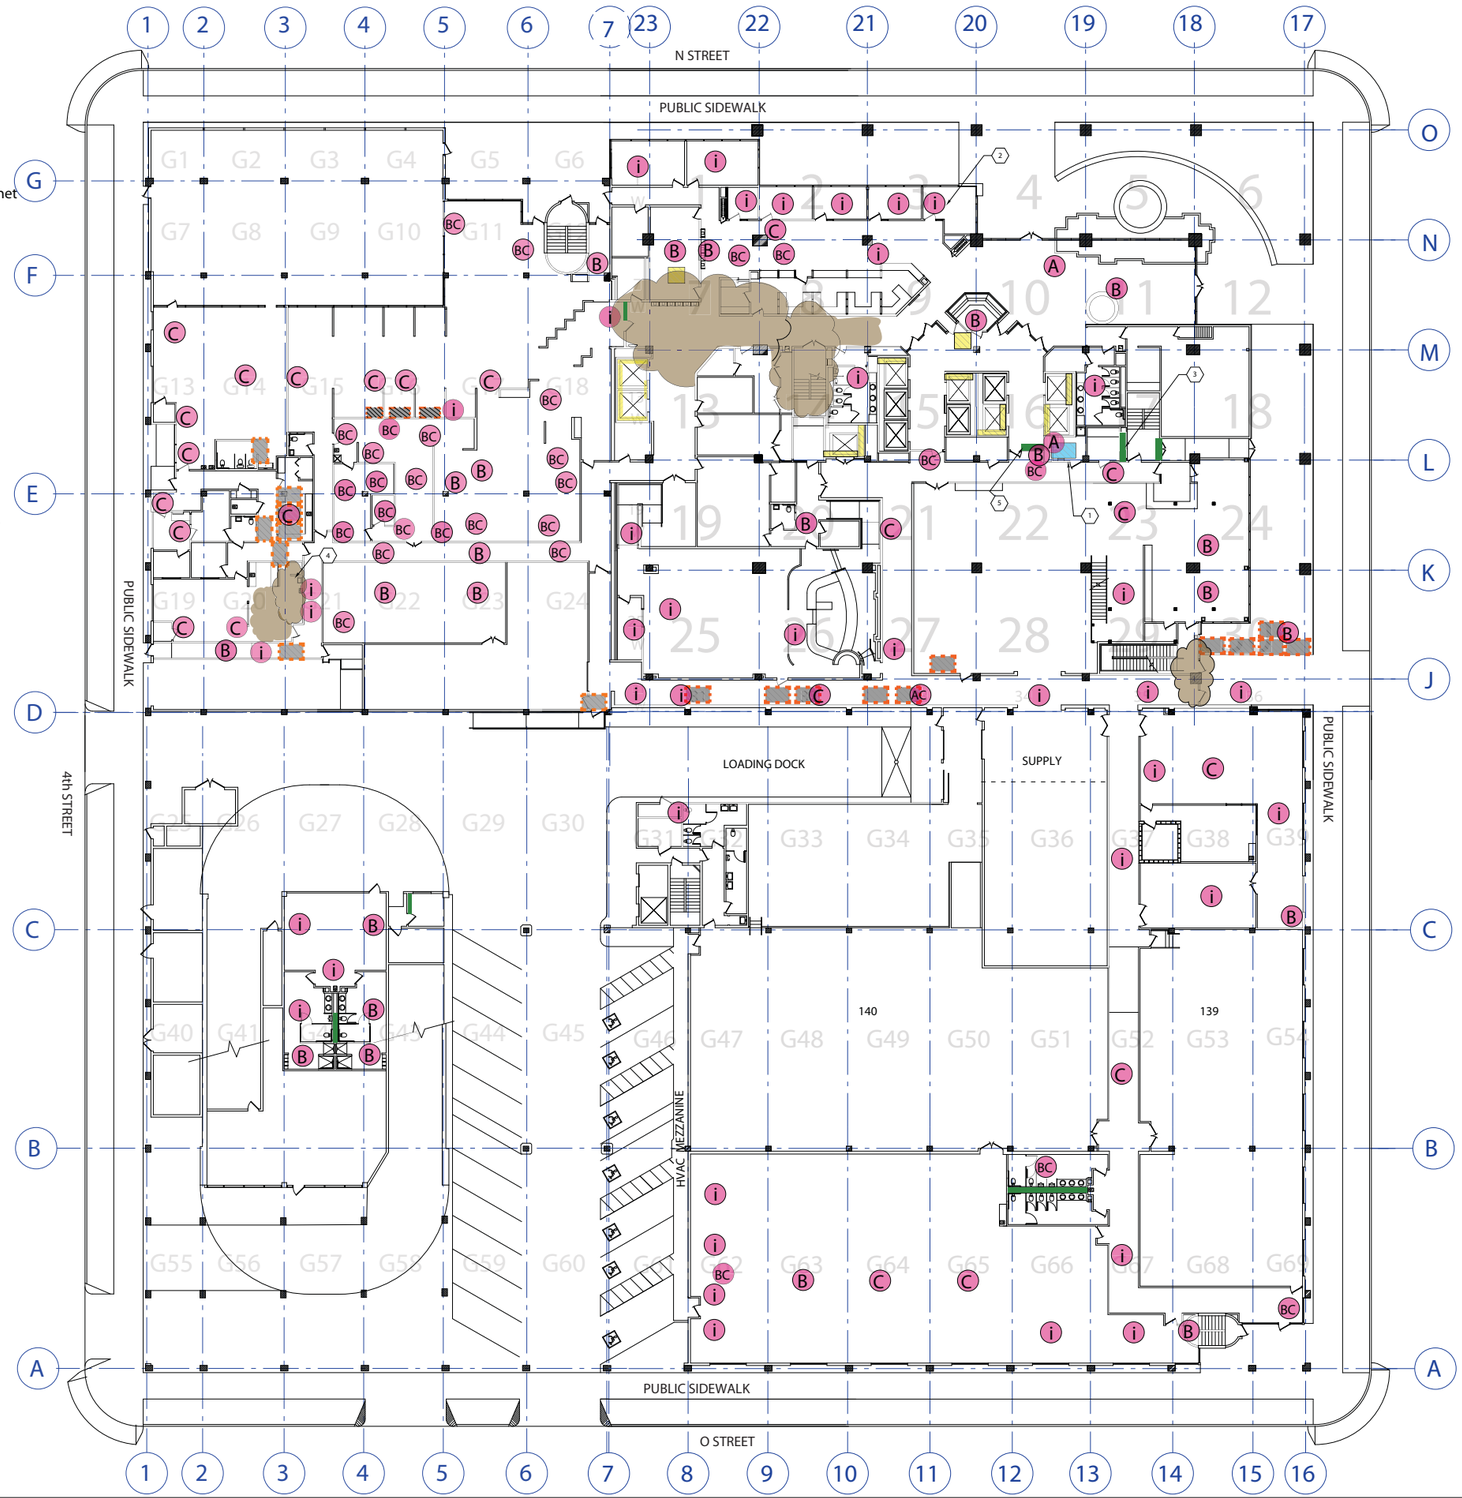
Figure 1

1. Weeping pipes with water stains on walls and ceilings
2. City storm drain cause of historic water damage
3. Visible mold growth on walls in fire sprinkler riser cabinet
4. Floor drain cause of historic water damage
5. Visible mold growth above ceiling in hallway

Water Damage Assessment - Revised (Jan 2013)

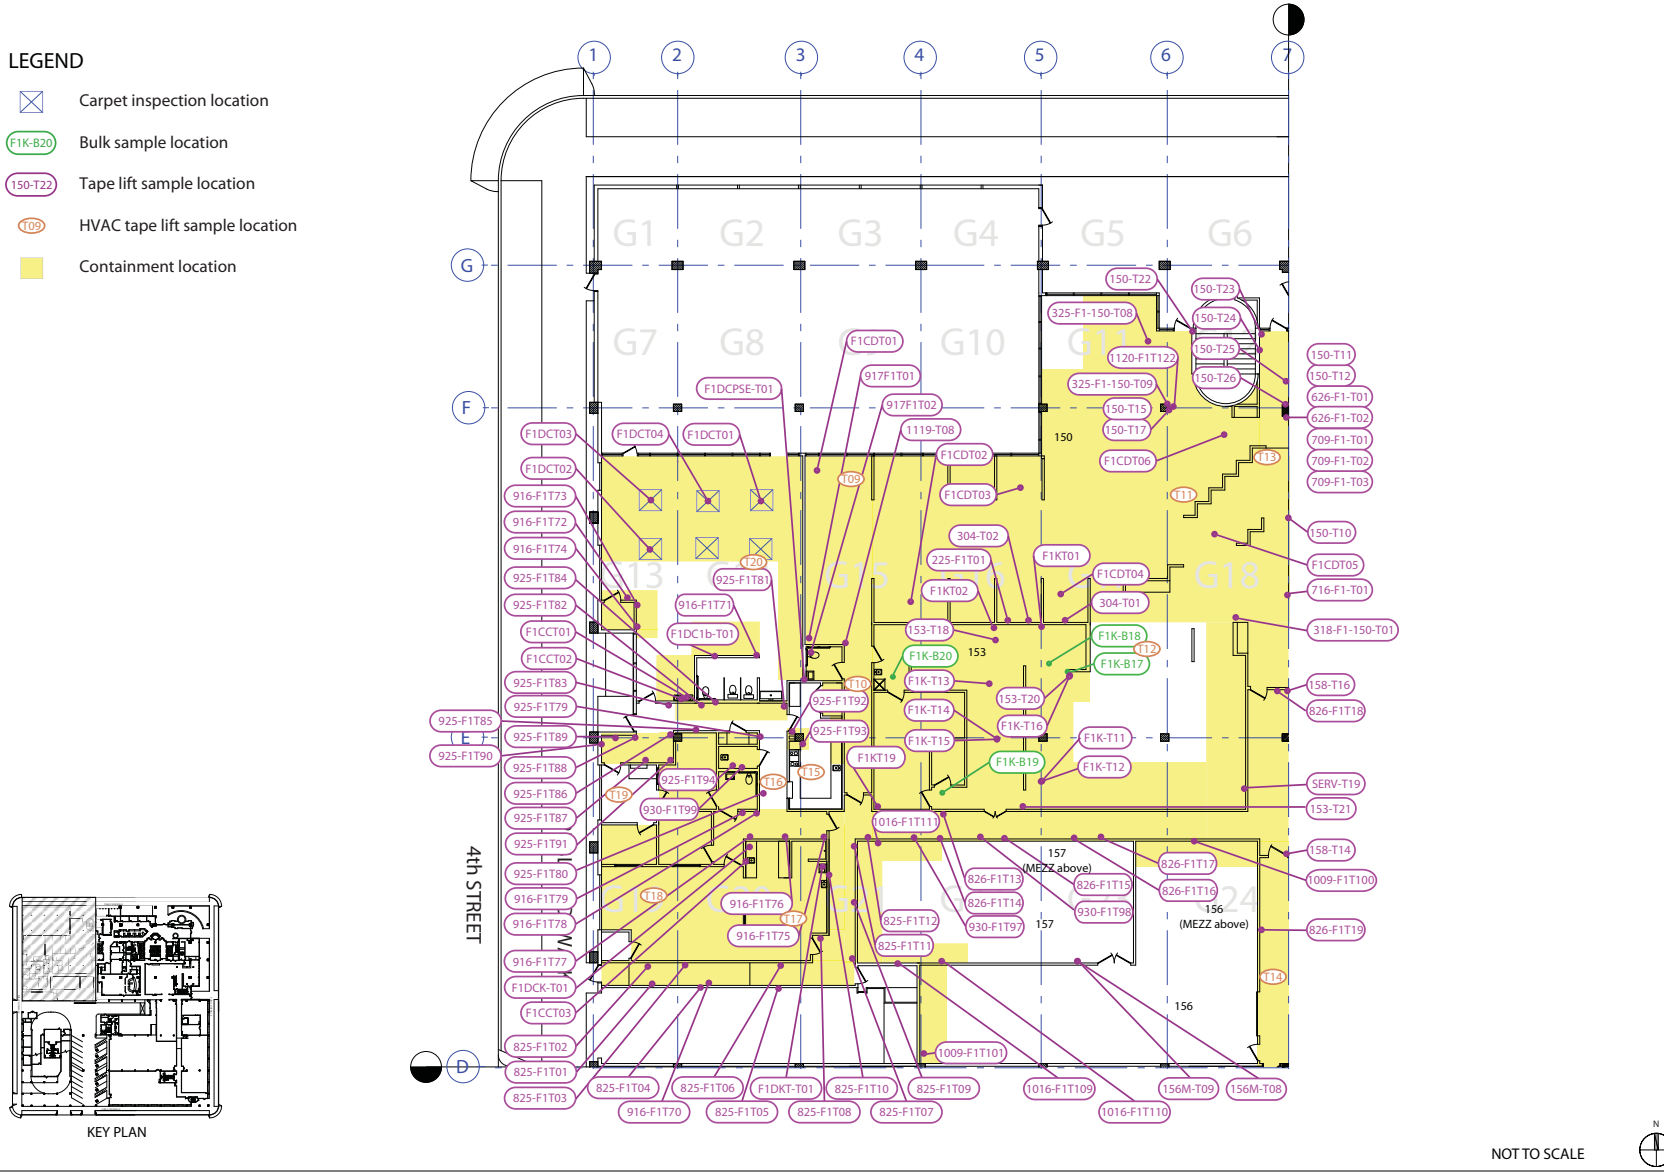
Figure 2a

Containment and Sample Locations (Oct 2012)

1st Floor
NW Quadrant

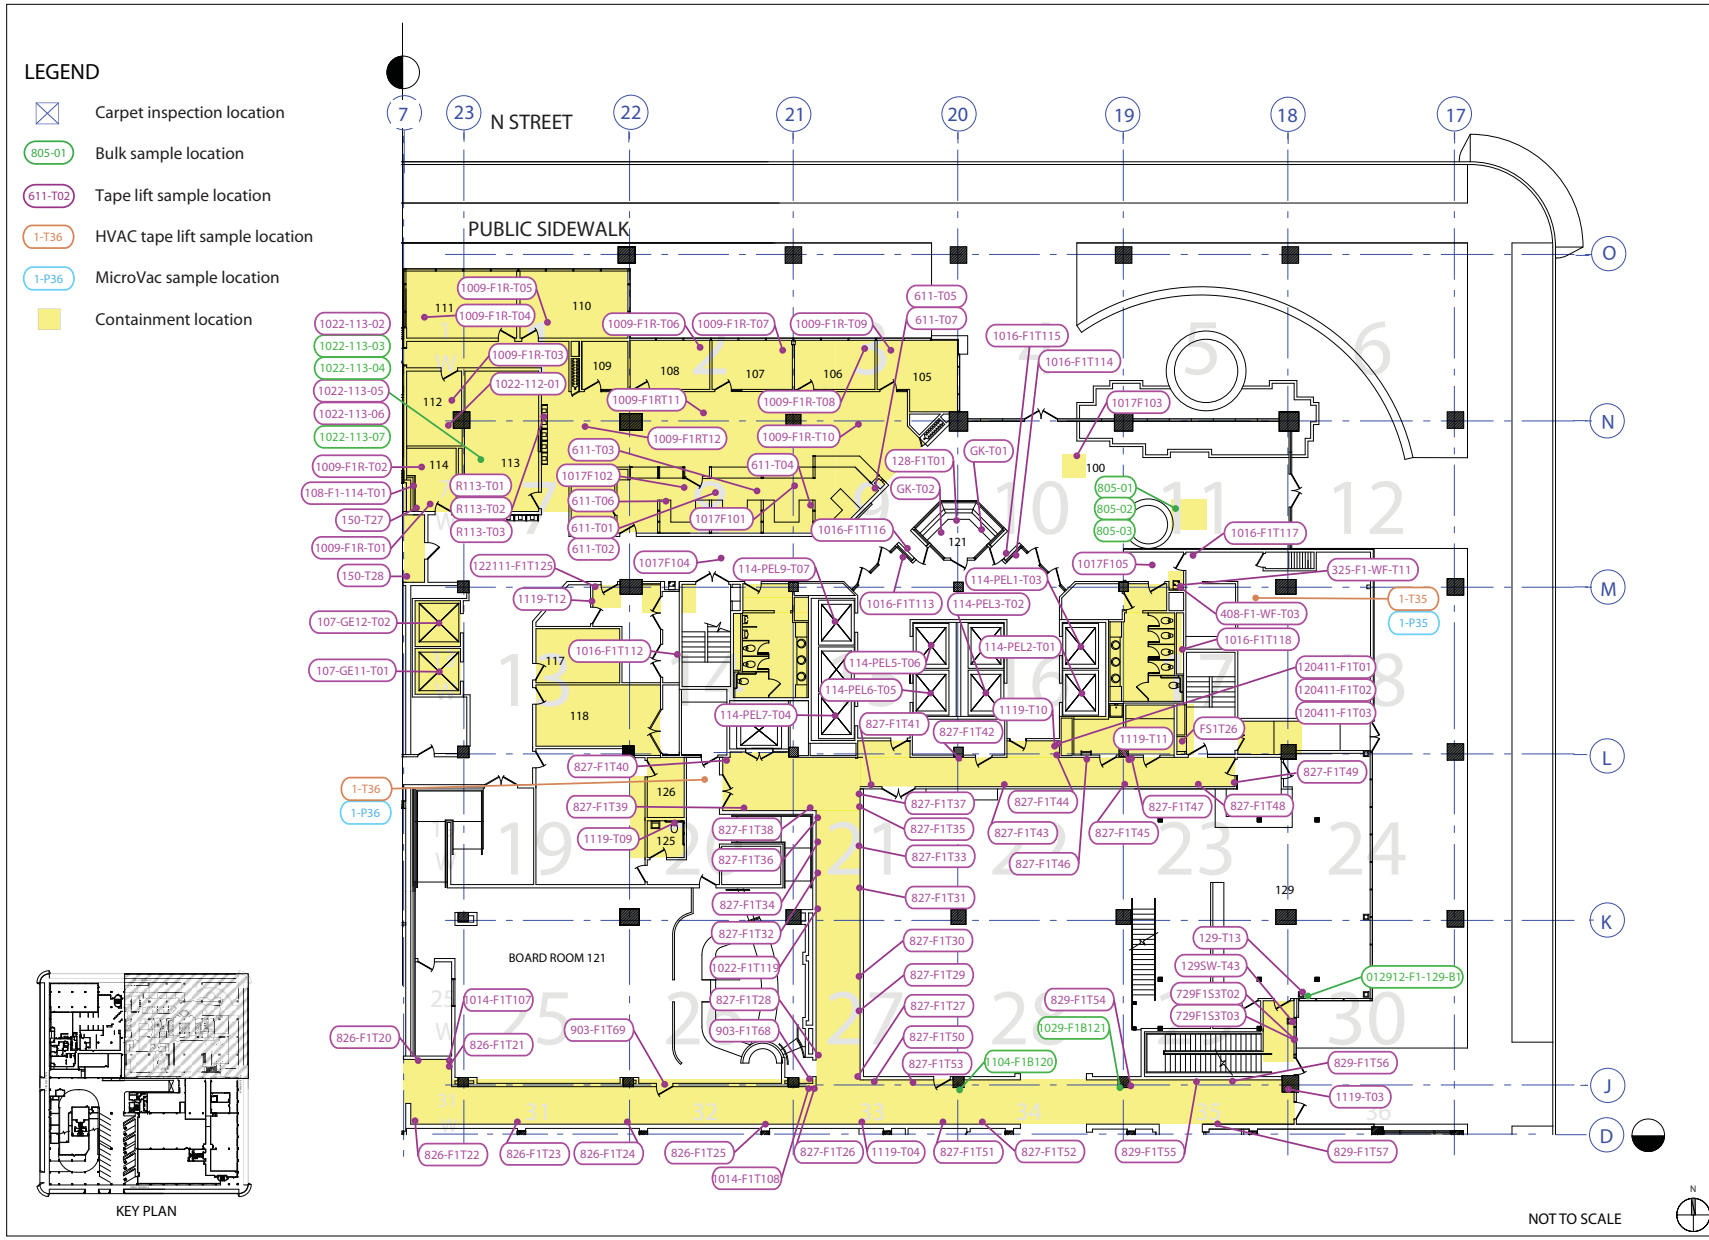
Figure 2b

Containment and Sample Locations (Oct 2012)

1st Floor
NE Quadrant

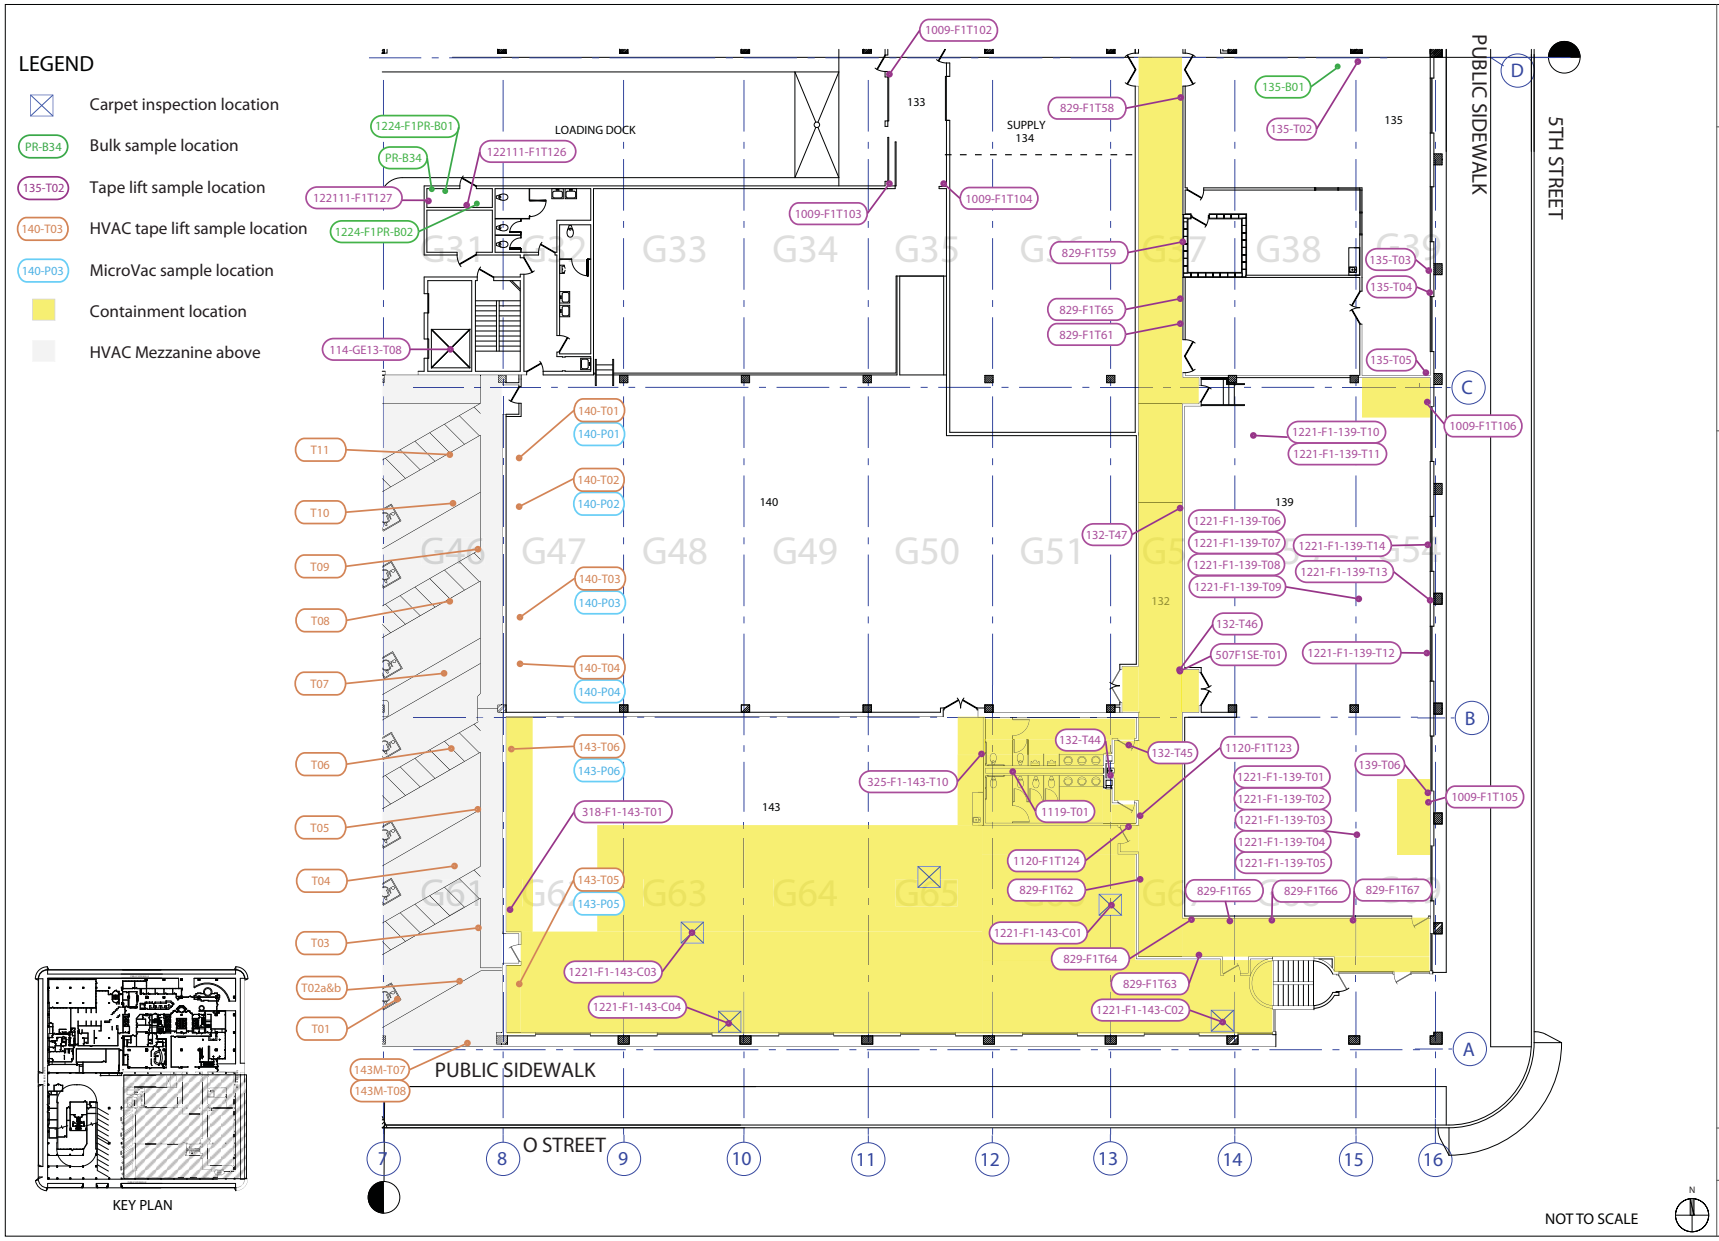
Figure 2c

Containment and Sample Locations (Oct 2012)

1st Floor
SE Quadrant

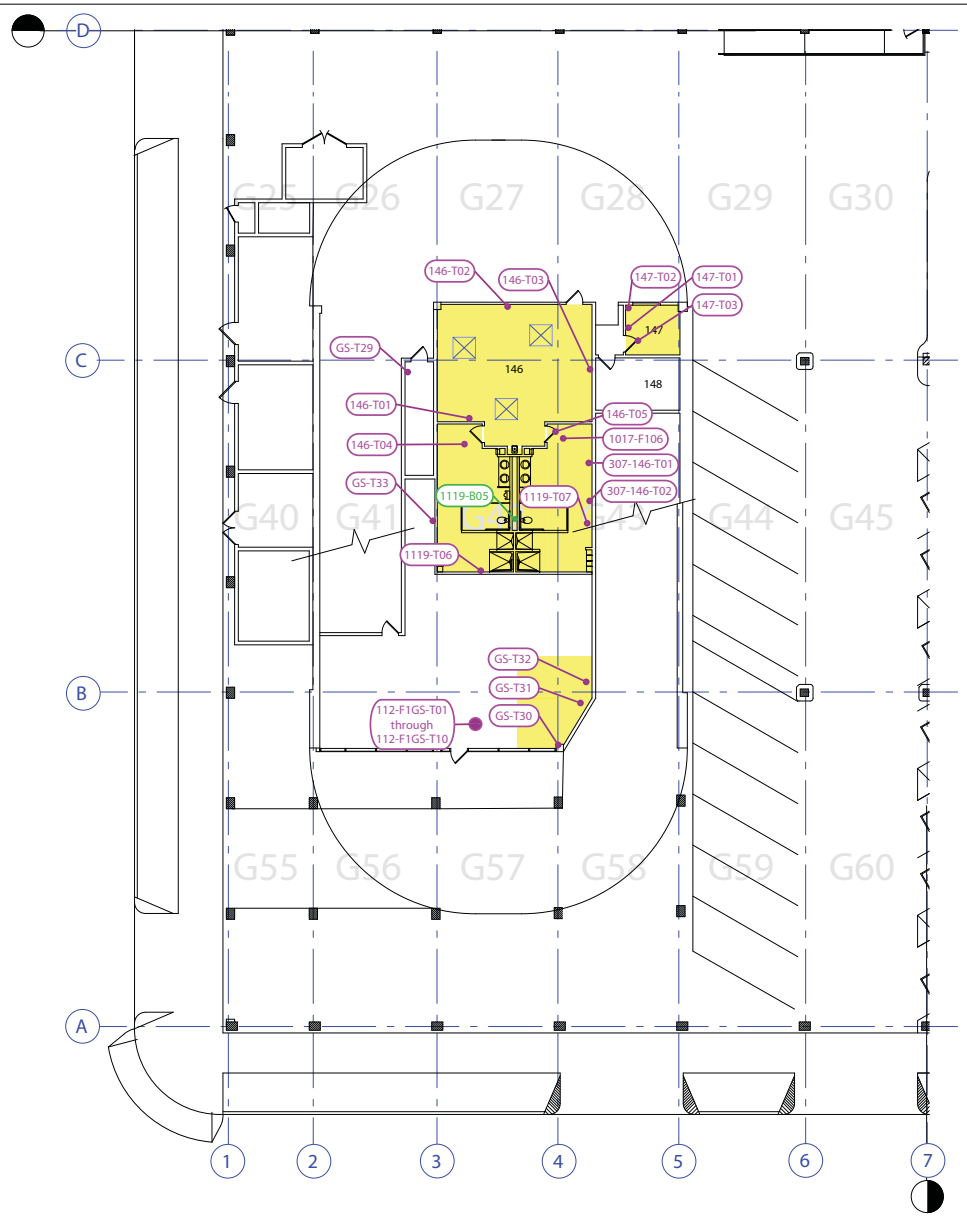
Figure 2d

Containment and Sample Locations

1st Floor
SW Quadrant

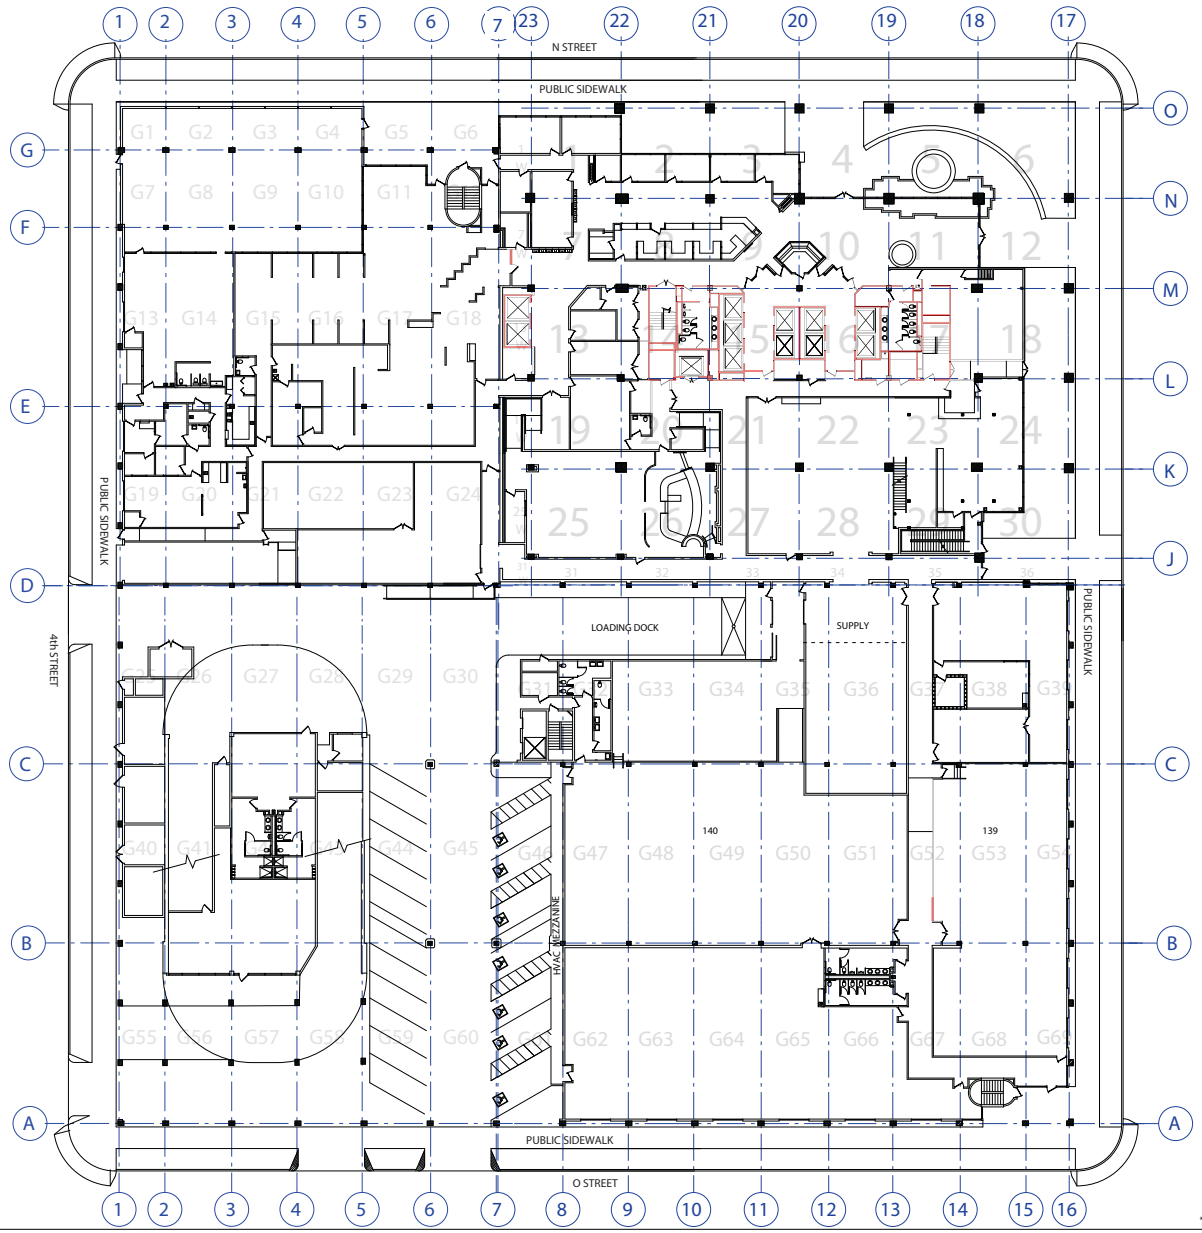
Figure 3

Suspect Mold - February 2012 (Oct 2012)

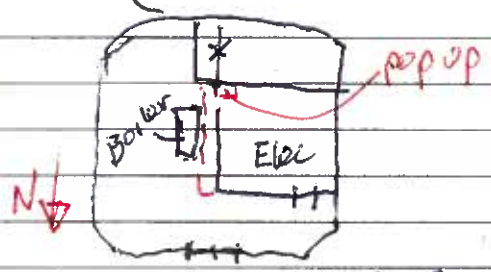
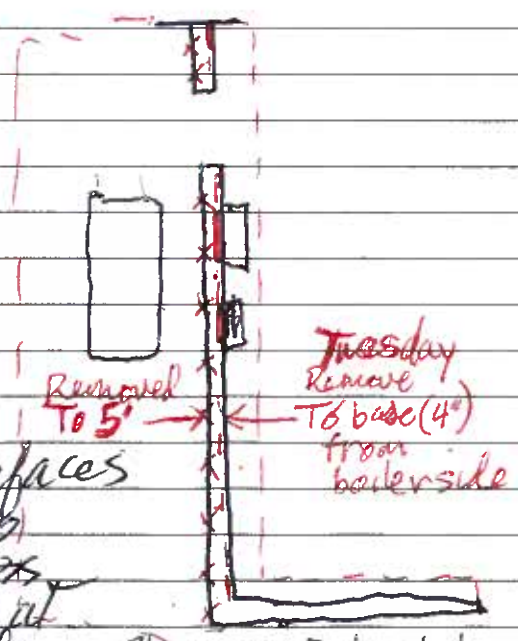
7 JLS begins Mob to Garage ramp Level 3 mechanical Rms.
8 prep of Boiler West wall (partition).
9 prep continues - ~~Pop-up~~ to be located in electrical at South door to Boiler Room containment to remove electrical south (section next to door) East wall at South end.

10:15 prep Completed
11:00 Lunch Break
11:30 removal of wall and insulation
12:45 load out bags
13:30 begin cleaning surfaces
meet w JLS - GS + ER to discuss how to address elec Rm partition wall at base and behind panels. - Plan create tent to allow removal of base + fl
14:00 detail cleaning (rough clean) continues Boiler side
15:15 crew wraps up effort for day - everything ship shape.
15:30 shift complete to Tuesday 07:00

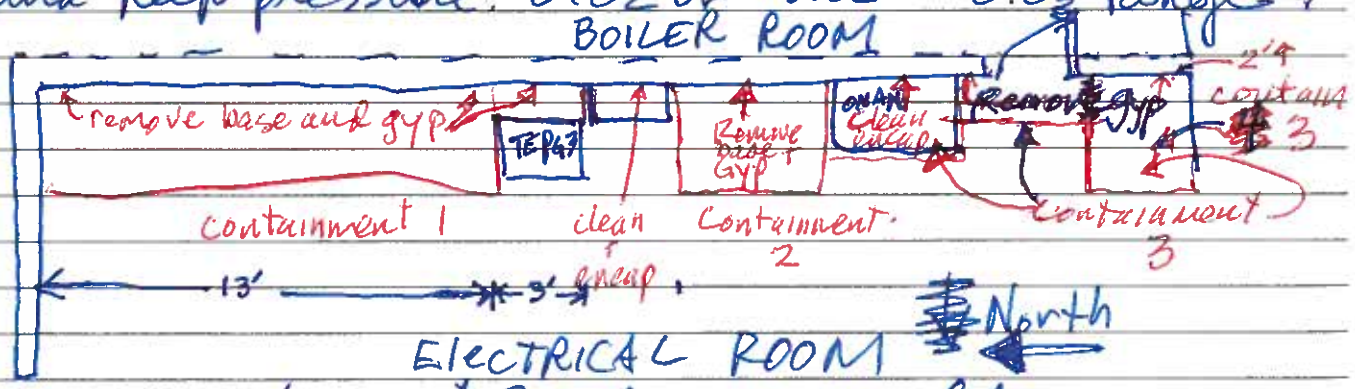
7 JLS begins prep electrical room
8 prep continues
9 prep continues. discuss how to address surfaces beneath wall mounted panels that cannot be removed w/ E Remos = clean and encap.
10:00 prep completed and ready to remove lower base + gypboard walls in electric room 3 mini containments
10:30 adjust flow on Hepa air machine to increase flow and keep pressure ≥0.02 or -0.02 to -0.03 range.

10:45 visual containment 2 - clean and complete. approx 1 sq. ft of gypboard removed. scattered VMG <1sf.
11:30 work in containments 1 and 3 continues
12:30 removal and cleaning in containments 1 and 3 cont'
13:30 cleaning completed containment 1 OK dismantle OK dismantle containment 2
cleaning continues containment 3 and 4 and replacement of dry wall in 3 and 4 in progress
14:40 dry wall complete. containments clean and ready for dismantling

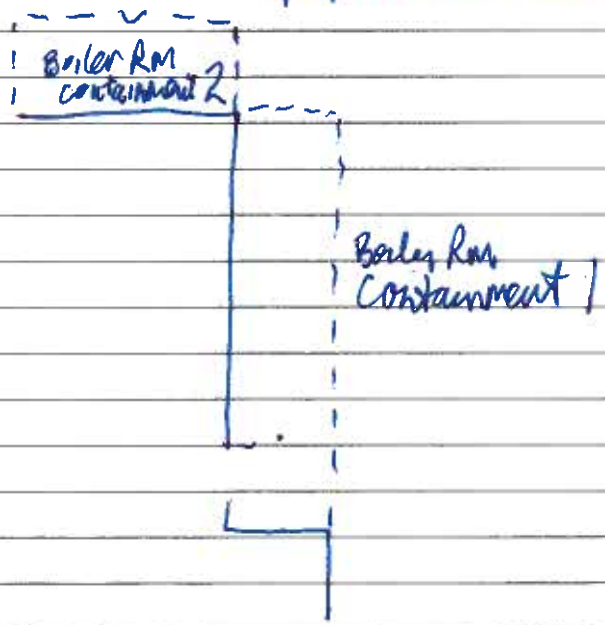
VLS performs detail cleaning of Boiler Room Containment. all removal and rough cleaning completed.
preclearance inspection scheduled for 17:00-18:00 w/ JLS E. Ramos.
LCD onsite - inspection postponed to 8/12

8/12/10 testing Boiler Room connections to Electrical popouts. Electrical popouts visual.

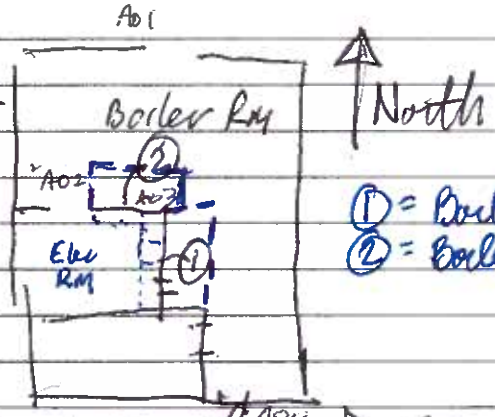
① = Boiler Room #1 Containment
② = Boiler Room #2 Containment
