California State Board of Equalization
450 N Street, Sacramento, California

Mold Remediation – 21st Floor
Closure Report Addendum

Project No. 2372.02-572

Addendum Date: October 31, 2012

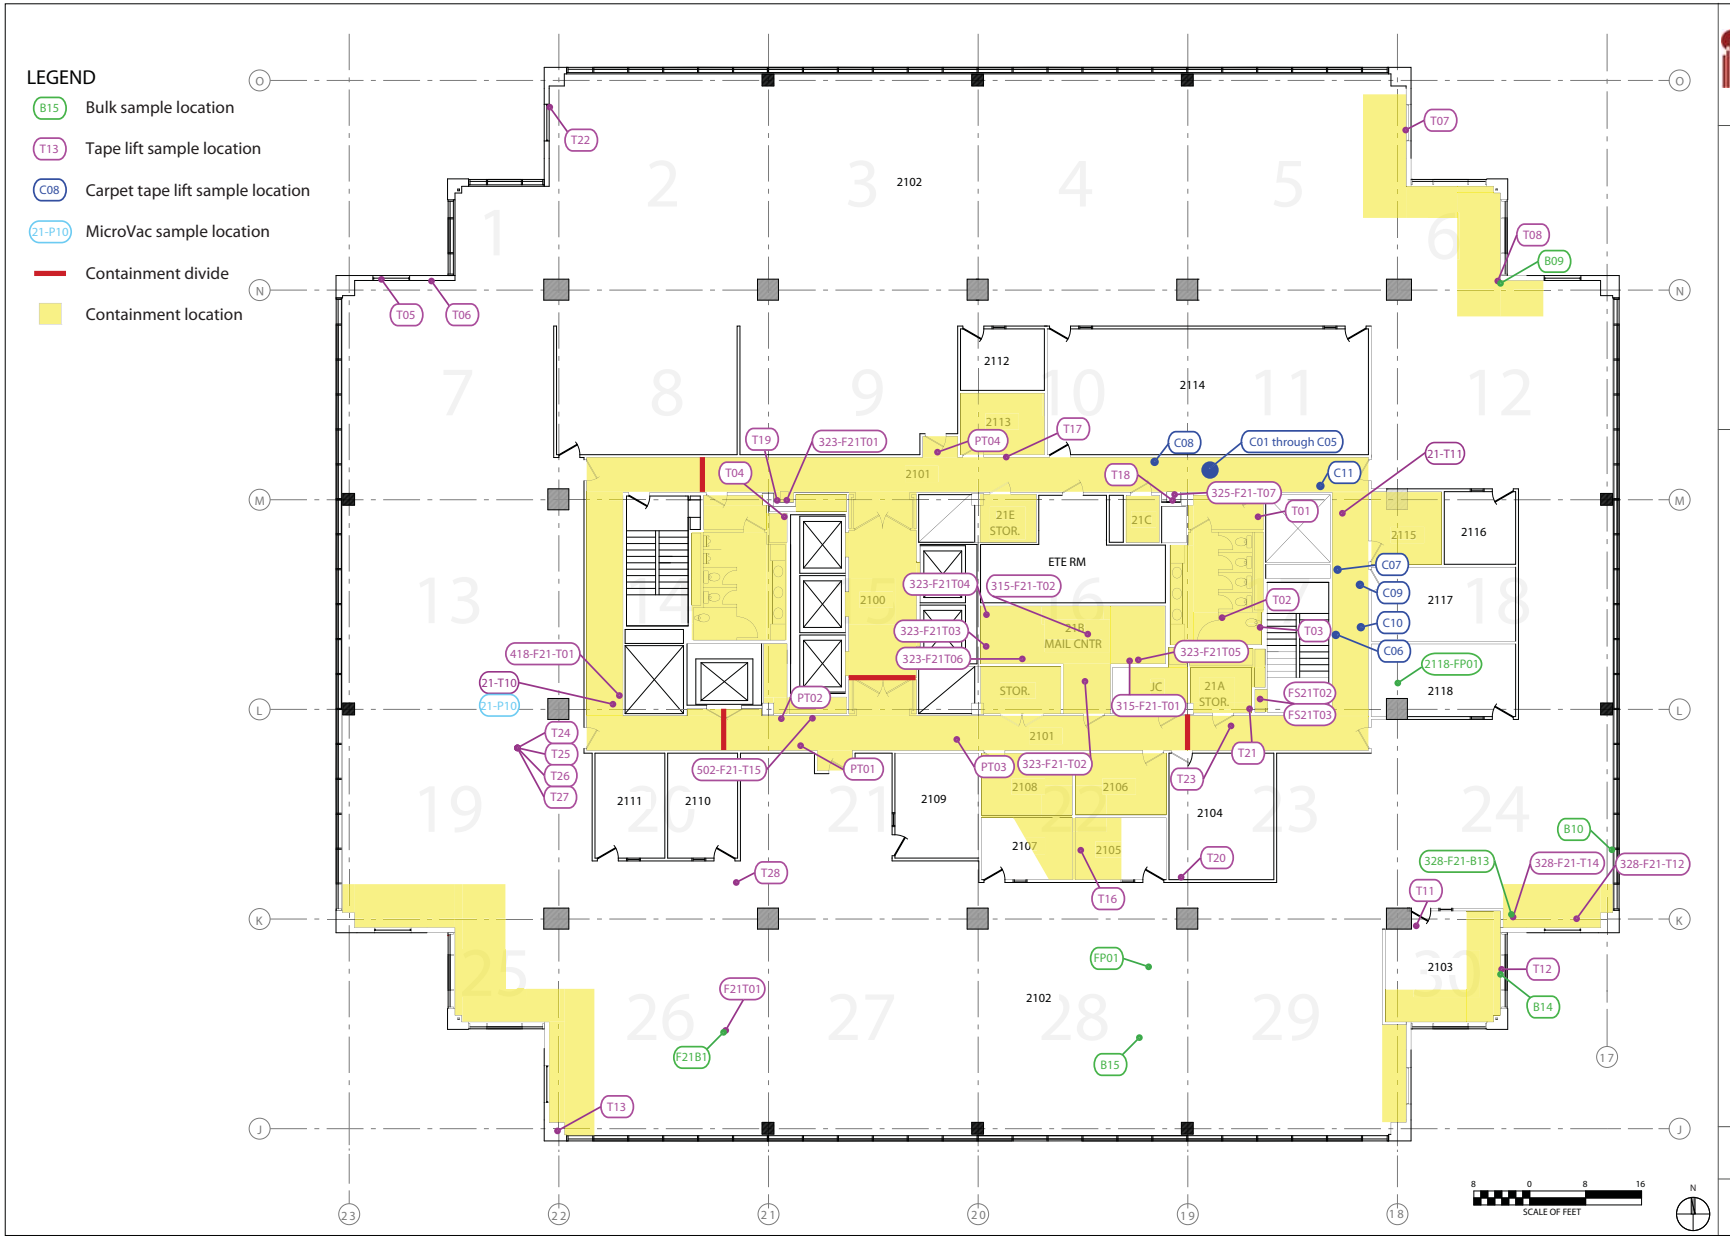
Subsequent to the completion of the closure report, a need for additional investigation and/or remediation activities was identified. Identified areas were subjected to sampling. Using a combination of surface tape lift and/or bulk samples, LCD tested stains on walls and other building materials to determine if the stains were indicative of mold growth. The sample locations are depicted in a revised Figure 2 attached to this addendum.

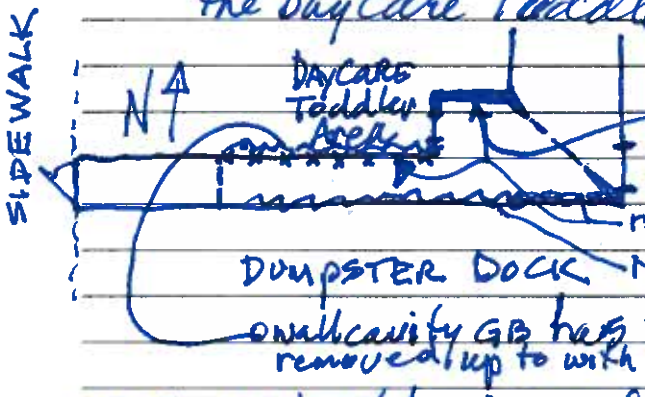
18:00 mob & prep underway - HLS crew
inspect Floor 21 w/ HTI - pickup RH sensors w/ fyle CO2 + HTI. LS shows areas of concern some streaks on vertical blends appear as if water vapor trails other smudges seem oily.
20:00 observe removal of FRP and Sheetrock in containment. VMG in wall cavity on North side of E-W Hallway (in the DayCare Toddler dining area.

22:45 - Load out begins and cleanup/detail cleaning
23:30 - Load out completed detail cleaning continues
01:00 - Final wipe down underway prior to encap
02:00 - perform ENCAP

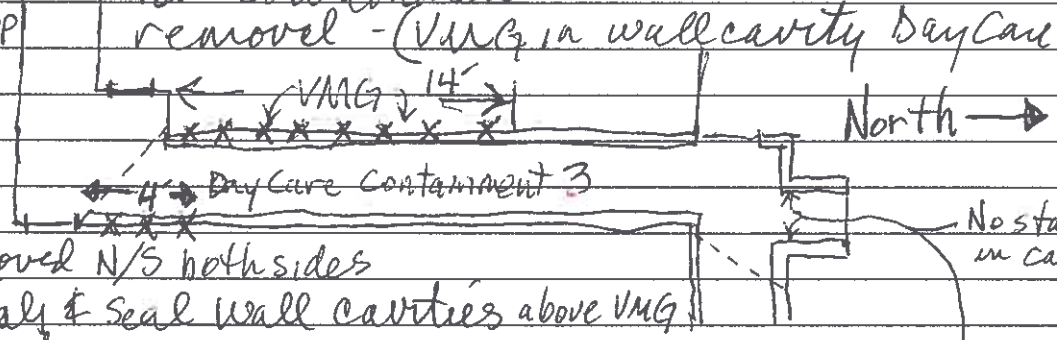
1800 meet w/ Lyle to collect moisture data loggers
meet w/ M Hoy & L Coe to discuss & read data
JCS prep continues Day Care N-S Hall
JCS preps for sampling wall E-W Hall above ceiling - sample w/ HTI-K
20:45 OK prep for containment -
21:00 inspect (FRP and GB) removal - (VMG in wall cavity Day Care & Stora

to 2' of GB removed N/S both sides
bag material & seal wall cavities above VMG
22:00 lunch break
22:45 begin bag out and continue removal at North doors
23:00 detail cleaning begins (removing VMG in wall cavities HTI · LS insi
00:30 detail cleaning continues - prep for encap
(evidence of past f(ood) holes in Day Care wall above wall base pla
indicate reponse to water intrusion in Toddler dining area
01:20 Encap begins -
seal holes and cracks w/ foam
02:00 final wipe and cleanup
install scrubber
load out tools/rags
clean exterior staging area
02:30 complete - testing scheduled 12:00 AM w/ JCS + HTI
12:00 meet HTI and perform testing to 12:55 COC and
deliver to San Bruno EML P&K - Amin
