Appendix B
Daily Logs

LaCroix Davis LLC
Building & Environmental Forensics

DAILY PROJECT LOG - DATE: 8/18

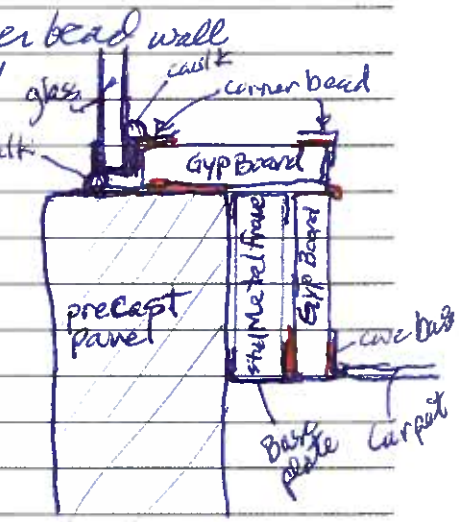
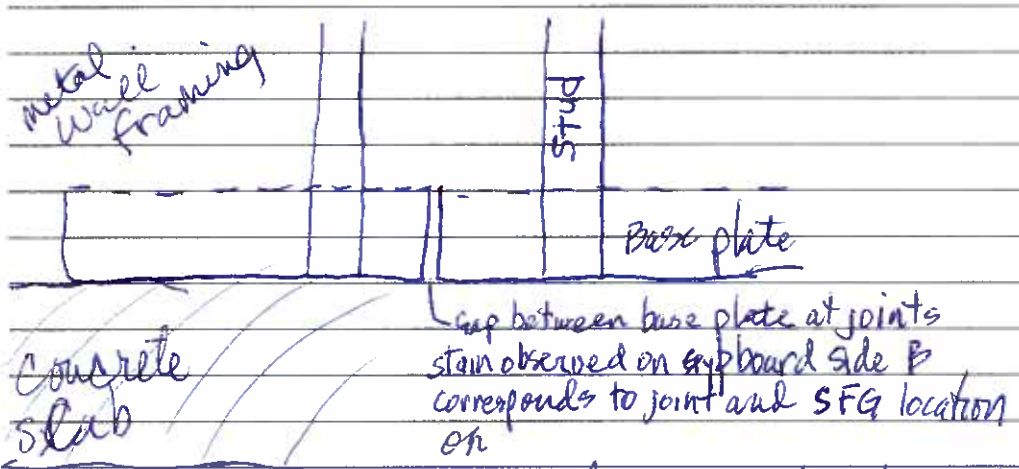
gap between base plate at joints
stain observed on gypboard side B
corresponds to joint and SFG location
on

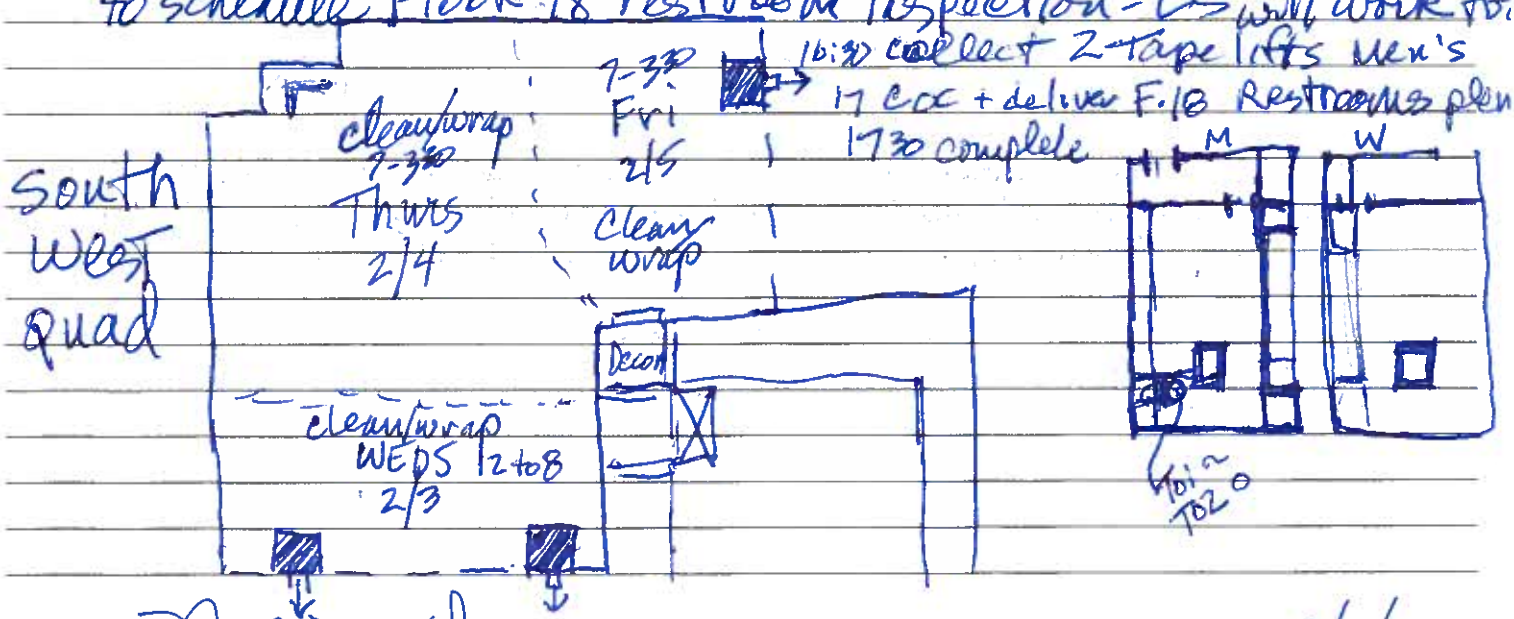
Effort continues PM project discussion re: removal sequence - JLS recommends removing ceiling tiles first - contact HTI and discuss - carpet will be removed 1st followed by rough cleaning bare concrete prior to removing ceiling tiles. Detail cleaning will follow from top down.

- Floor 18 will be turned over to JLS today at 3:30 - above ceiling inspection will be performed - contact HTI to schedule Floor 18 restroom inspection - LS will work to

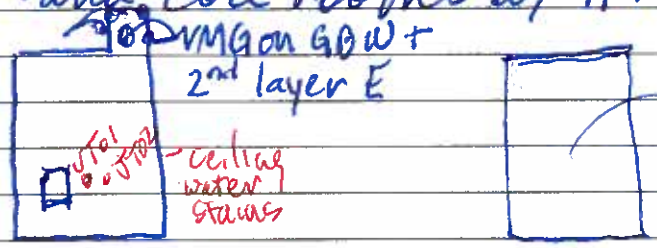
women's - HTI collect 2 samples of stained wall (plumbing wall) - JCs will encap all stained (cleaned) locations. (typical response action)
men's collect tape lift backside of water fountain

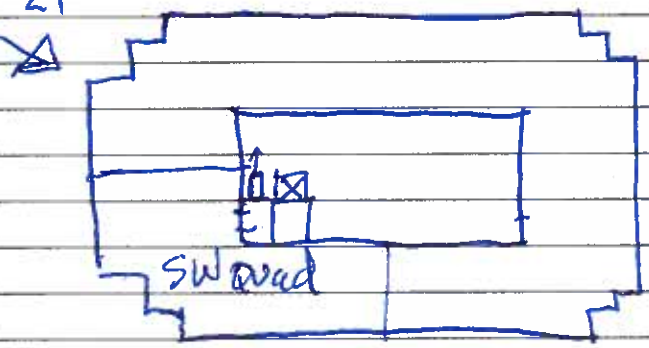
Removal and bagging carpet begins ≈ 9:00 AM after remaining cubicles is cleaned and bagged monday - Quality will lift and Block so carpet under pads can be removed and concrete can be cleaned.

PM Perform above ceiling inspection at perimeter wall w/ HTI
NW - NE SE, ~~SW~~ ~~SW~~ collect samples at water stained locations. (open all SW to SE access)
inspect Janitor Room above ceiling + collect samples of water stains
PM: Photo doc Floor 21 efforts - and observe HTI collect air samples at elevator lobby.

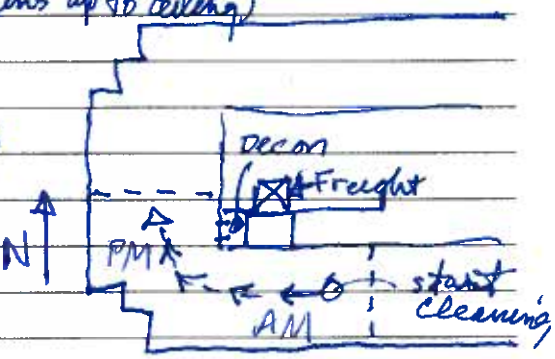
F18 containment @ Column J21

containment prep ok (11 - removal to 12:30
(VMG on sill at each end). detail to 3:30
VMG on GB Wall (water stains up to ceiling)

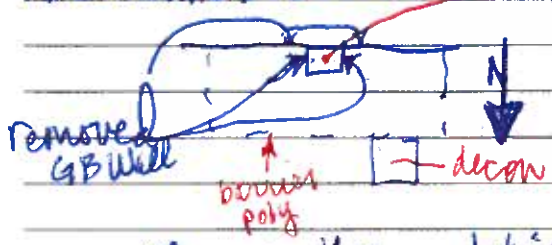
No VMG
HTI collects 2 tapes
Bulk Insulation } Normal Trapping
cleap Water Stains
remove, dispose, detail clean
SE P02 - more detail cleaning will occur Friday AM

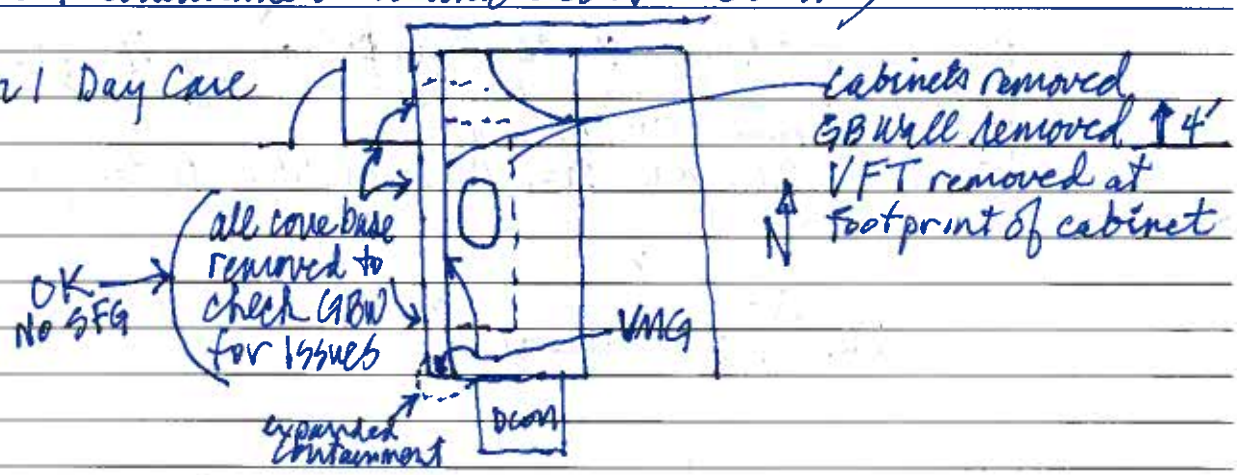
Floor 1 Day Care

(1) DayCare Kitchenette containment is constructed and complete at 7:30 PM
cabinetry and wall materials are removed to 10:30 PM
detail cleaning underway and completed at
preclearance inspection is passed
testing will occur at 12:00 Noon Saturday.
VMG was identified behind sink cabinet on GB wall + SE end
(18) SE PO 1 Containment is under construction
