California State Board of Equalization
450 N Street, Sacramento, California

Mold Remediation – 14th Floor
Closure Report Addendum

Project No. 2372.02-572

Addendum Date: October 31, 2012

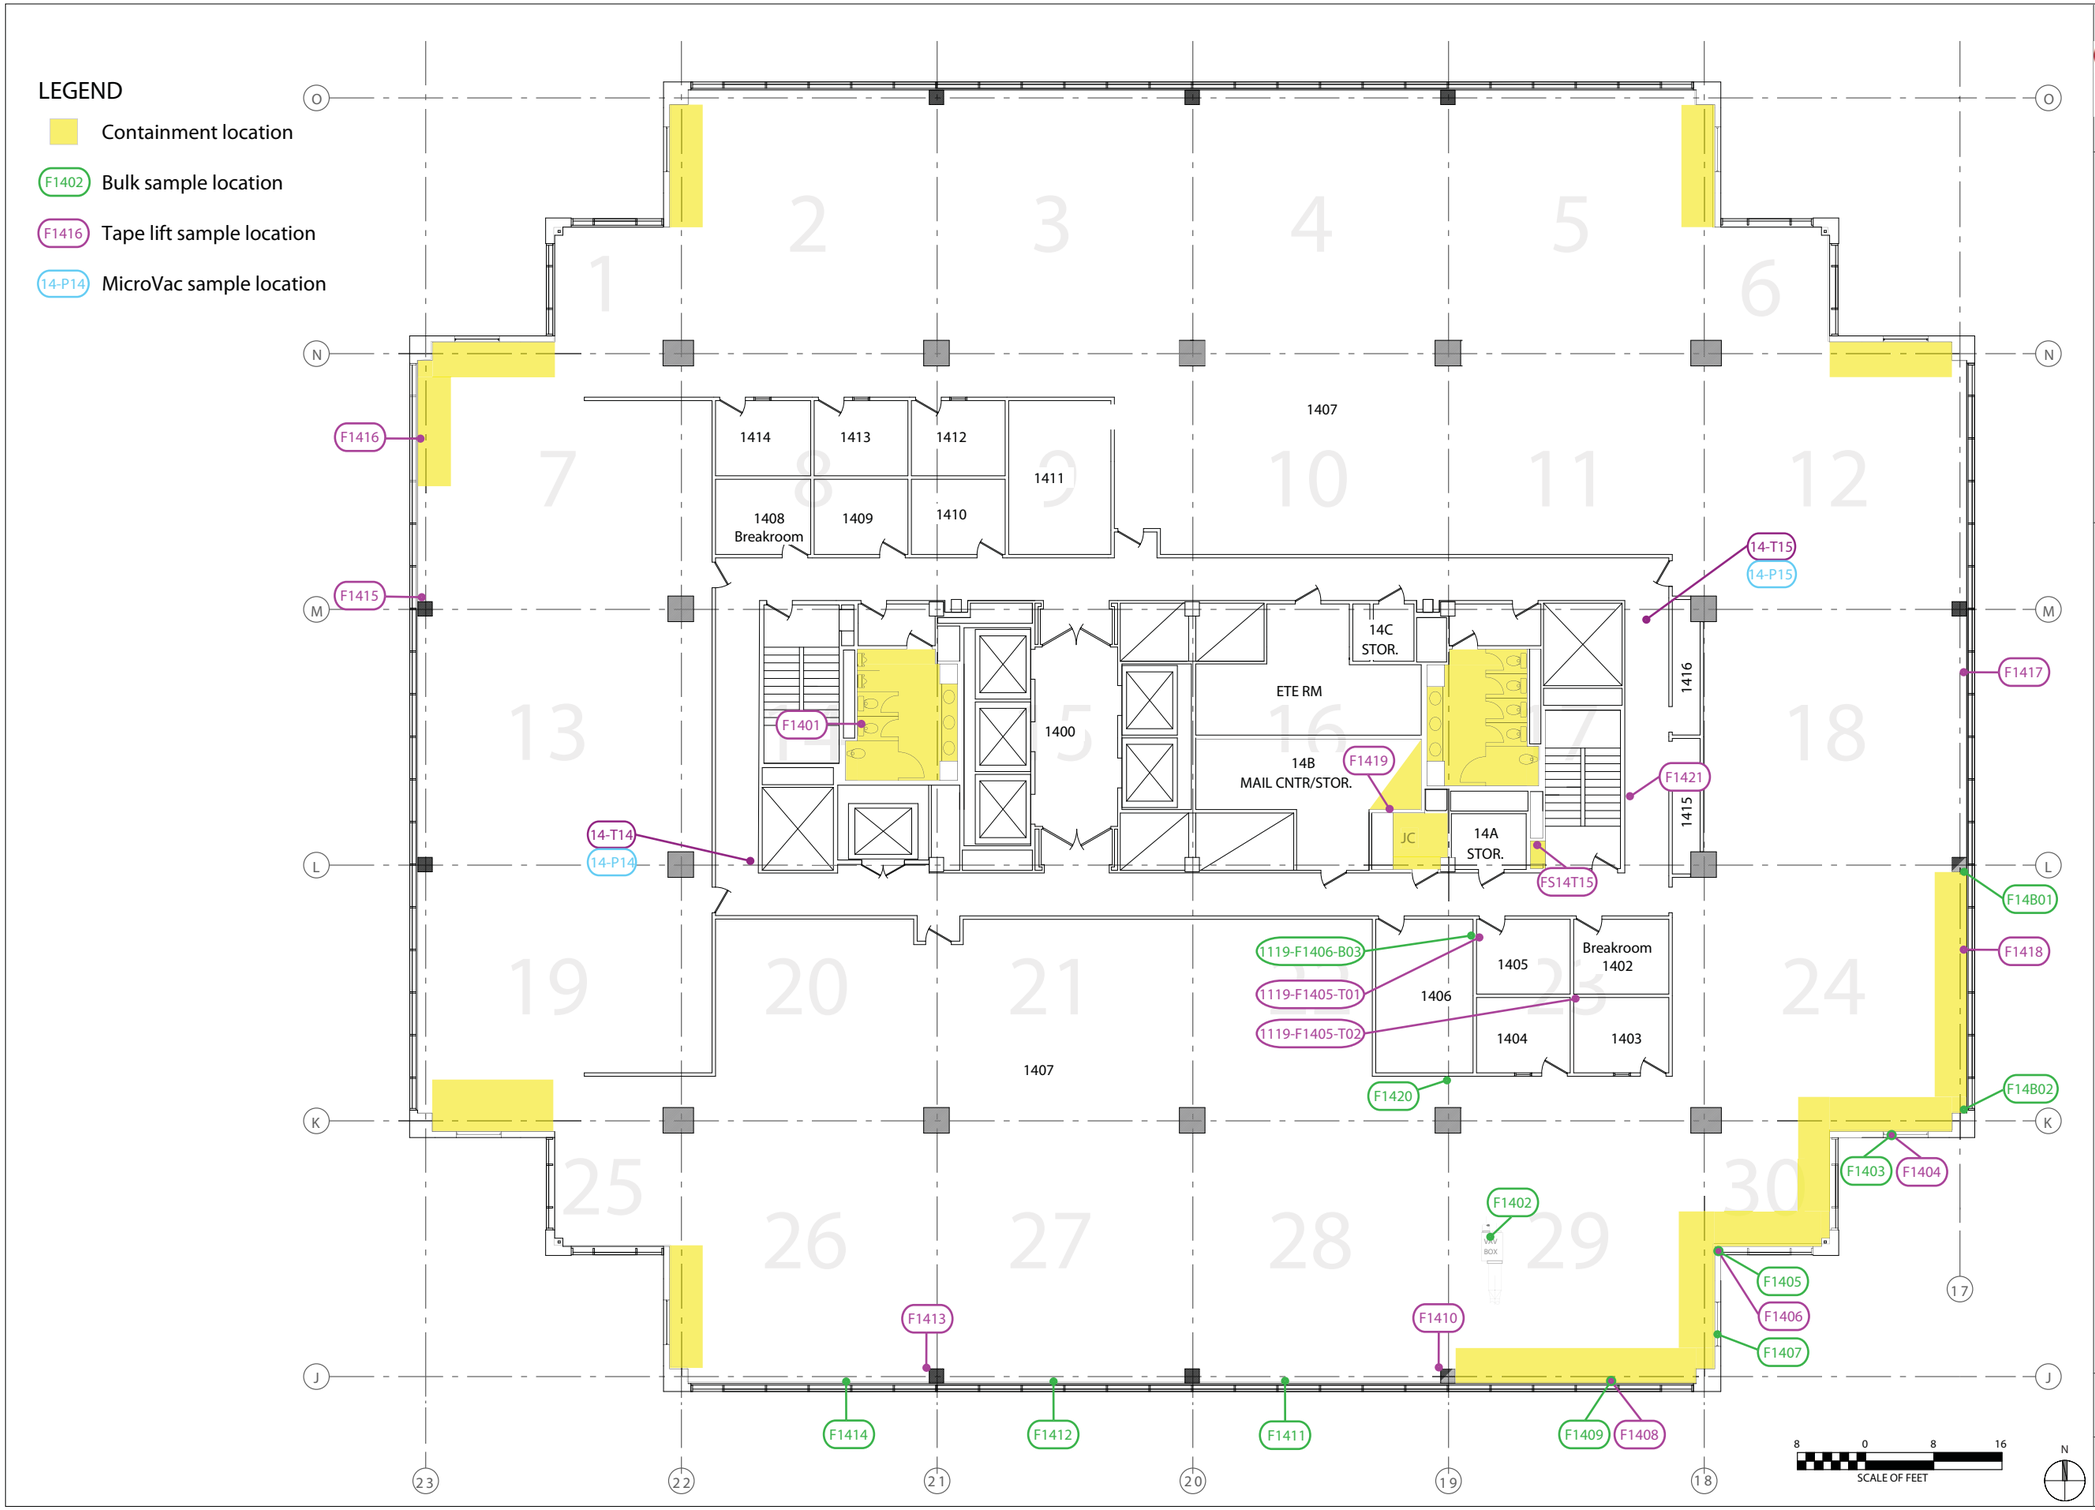
Subsequent to the completion of the closure report, a need for additional investigation and/or remediation activities was identified. Identified areas were subjected to sampling. Using a combination of surface tape lift and/or bulk samples, LCD tested stains on walls and other building materials to determine if the stains were indicative of mold growth. The sample locations are depicted in a revised Figure 2 attached to this addendum.

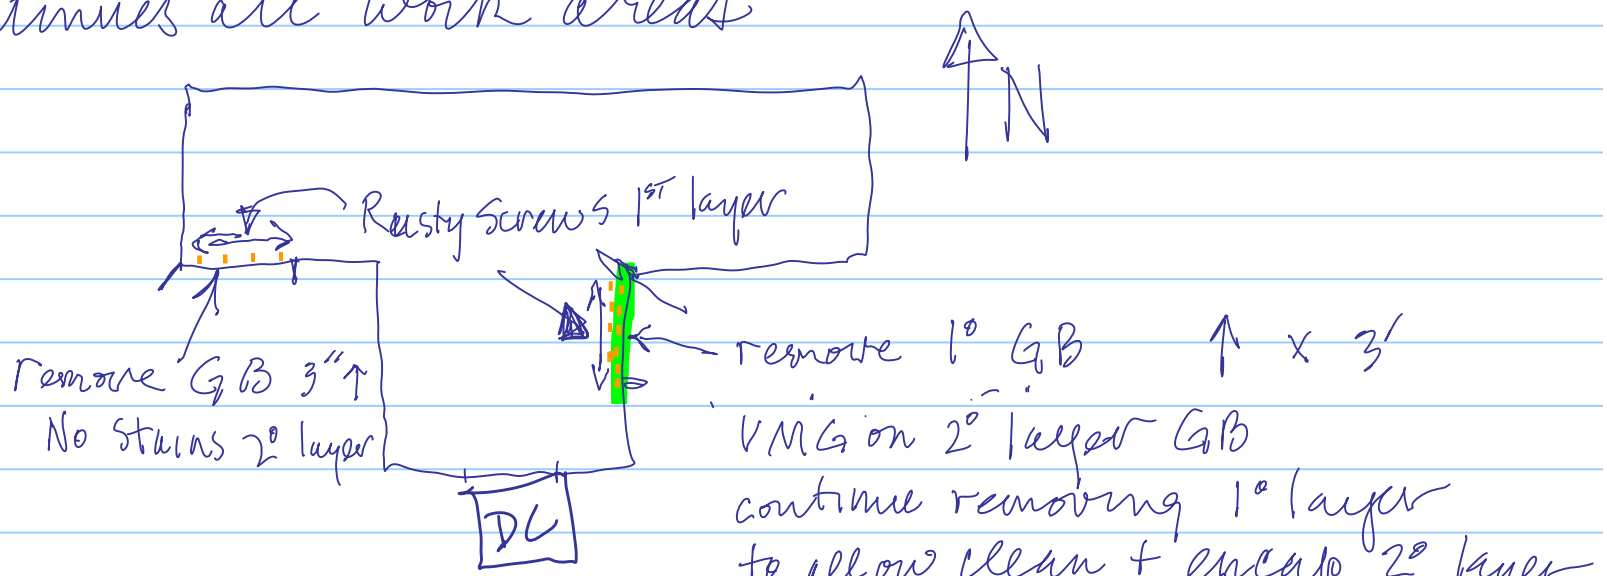
14 B

01:00 1405 VCT removal underway - completed 2:00
14B remove 1° layer GB at Entry E Wall to 4'
where VMG is visible on 2° layer GB at 2'

1405 waiting for GB removal (Sawzall)
in 14B - Next shift.
14B GB trim completed

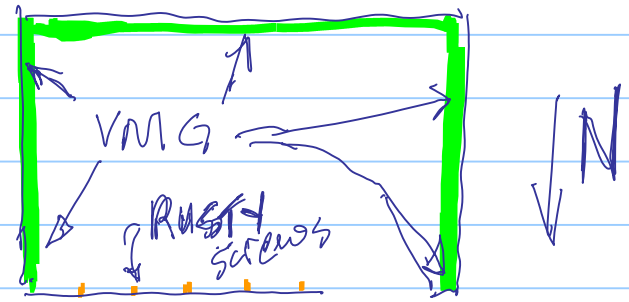
1405

VMG all lower walls
Remove 1' ↑ entire

remove

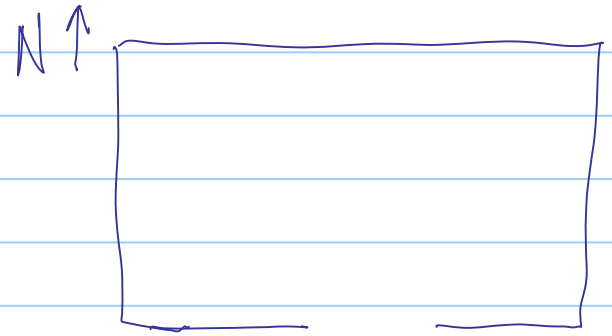
8A

No VMG at CB
22:50 removal VCT
trim base of GB ½"

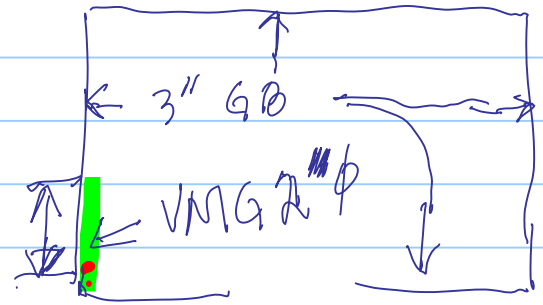
N↑
B04

VMG w wall at S CB
rust screws other walls
remove 3" entire = No VMG

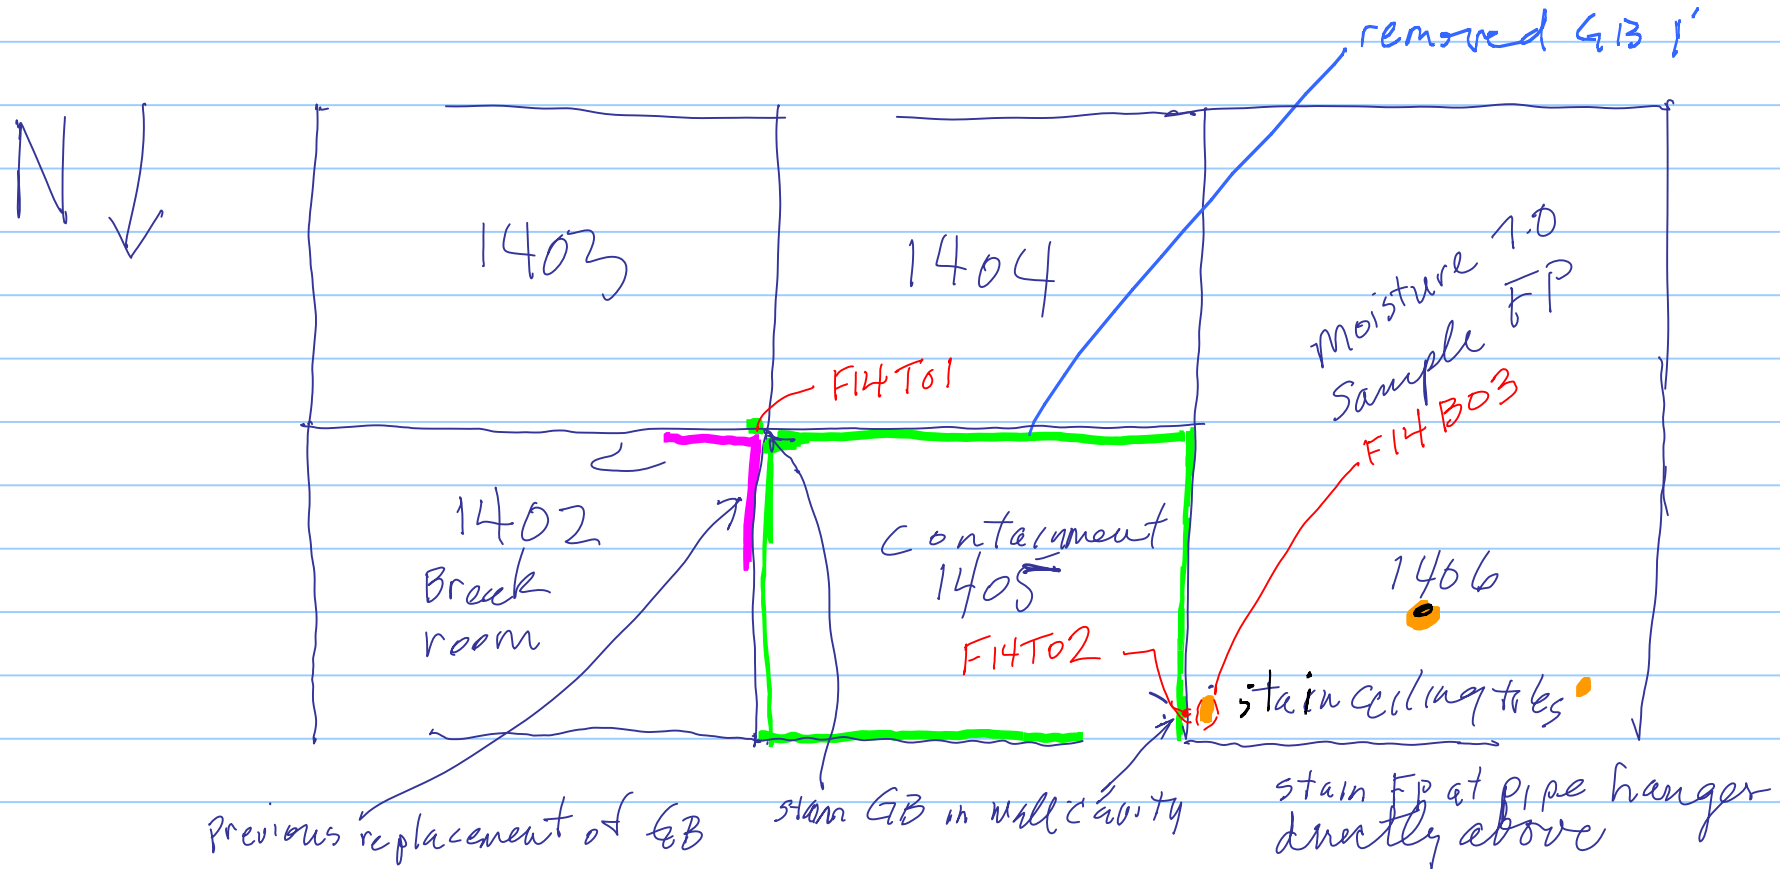
1405 inspect wall removal 1405
ID 2 small stains in wall cavity - collect 2 samples one in NW area common w/ 1404 and one in SE area common w/ 1403 - test FP moisture content

N
1403
1404
1402
Break room
Containment
1405
1406
removed GB 1'
F14T01
F14T02
F14B03
moisture 1.0
Sample FP
stain ceiling tiles
previous replacement of GB
stain GB in wall cavity
stain FP at pipe hanger directly above

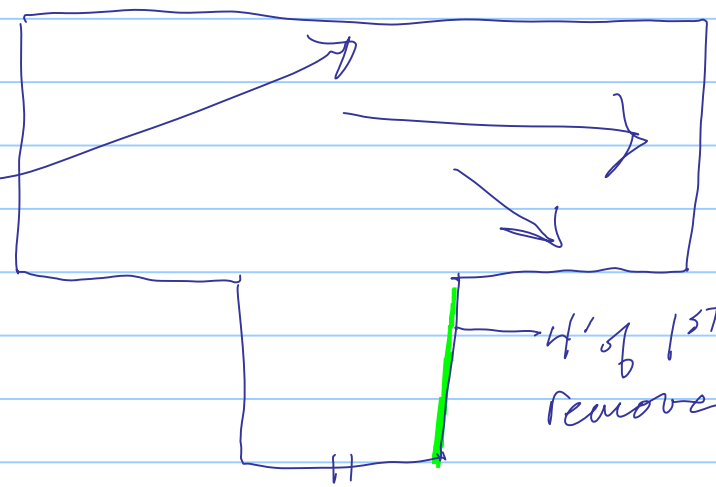
14B

trimming base of GB continues

4' of 1ST layer GB removed, 2nd layer cleaned
