RE: California State Board of Equalization
Closure Report Addenda

California State Board of Equalization
450 N Street, Sacramento, California

Activities on Floors 22 through 24
Report

Project No. 2372.02-572

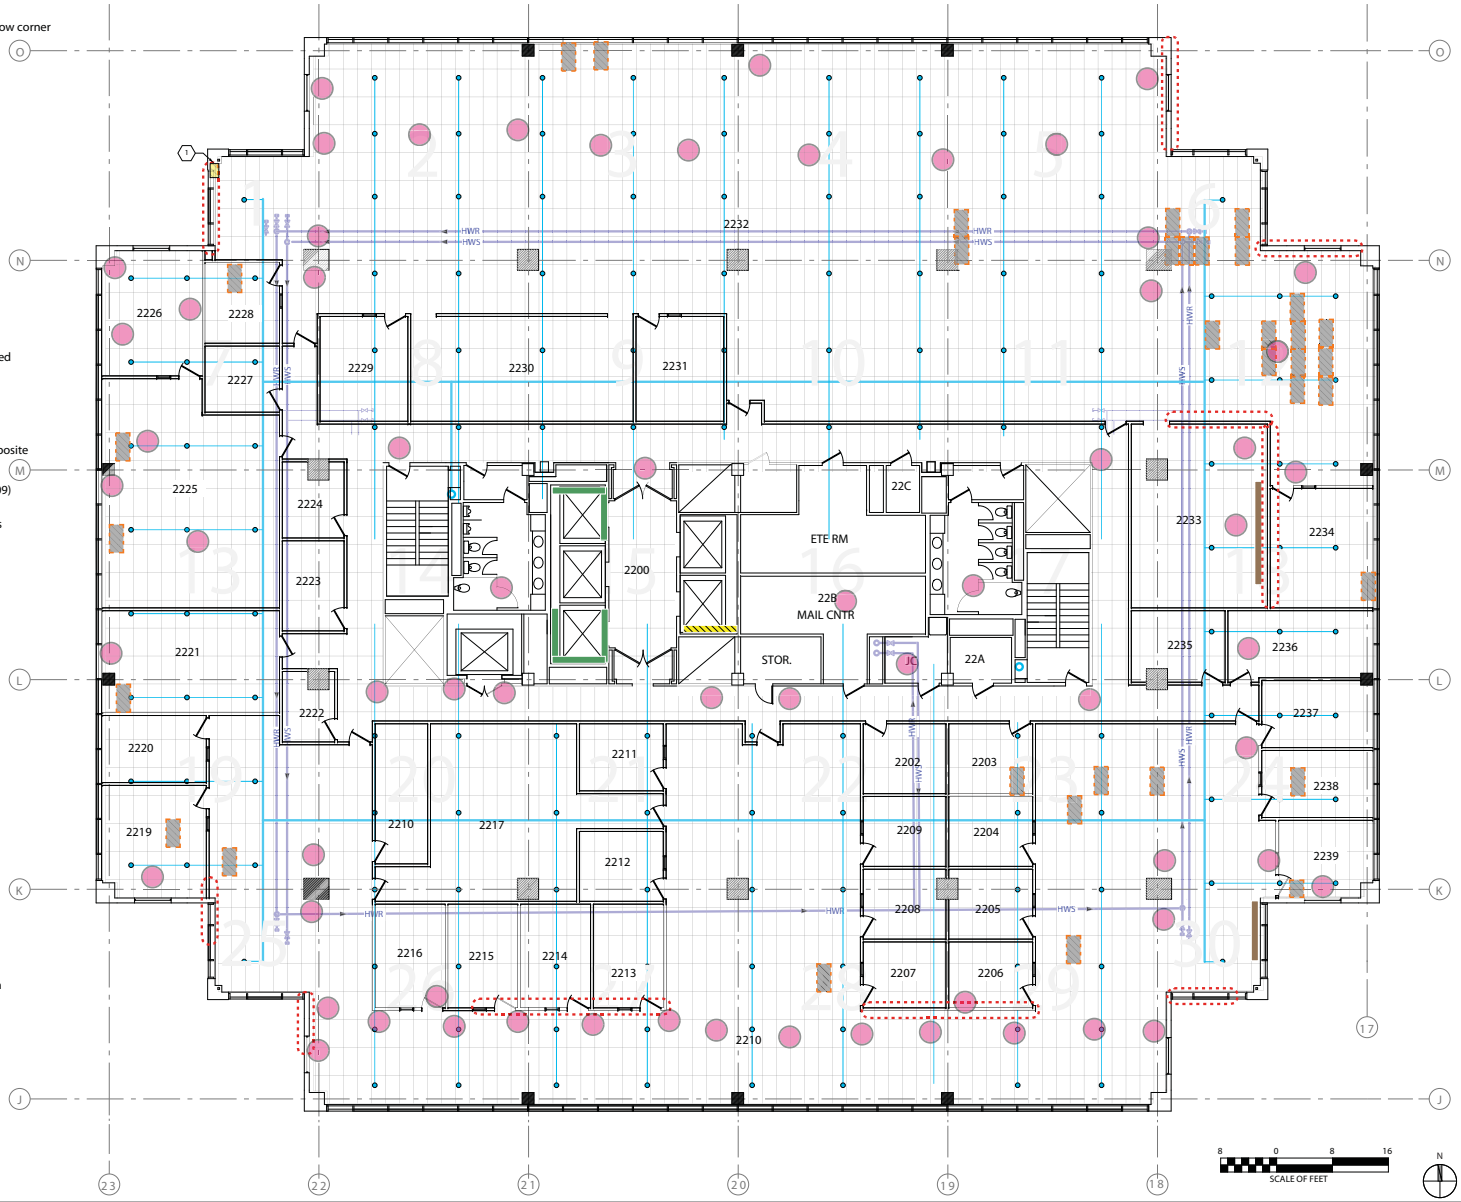
1. Water stain on gypsum board in window corner

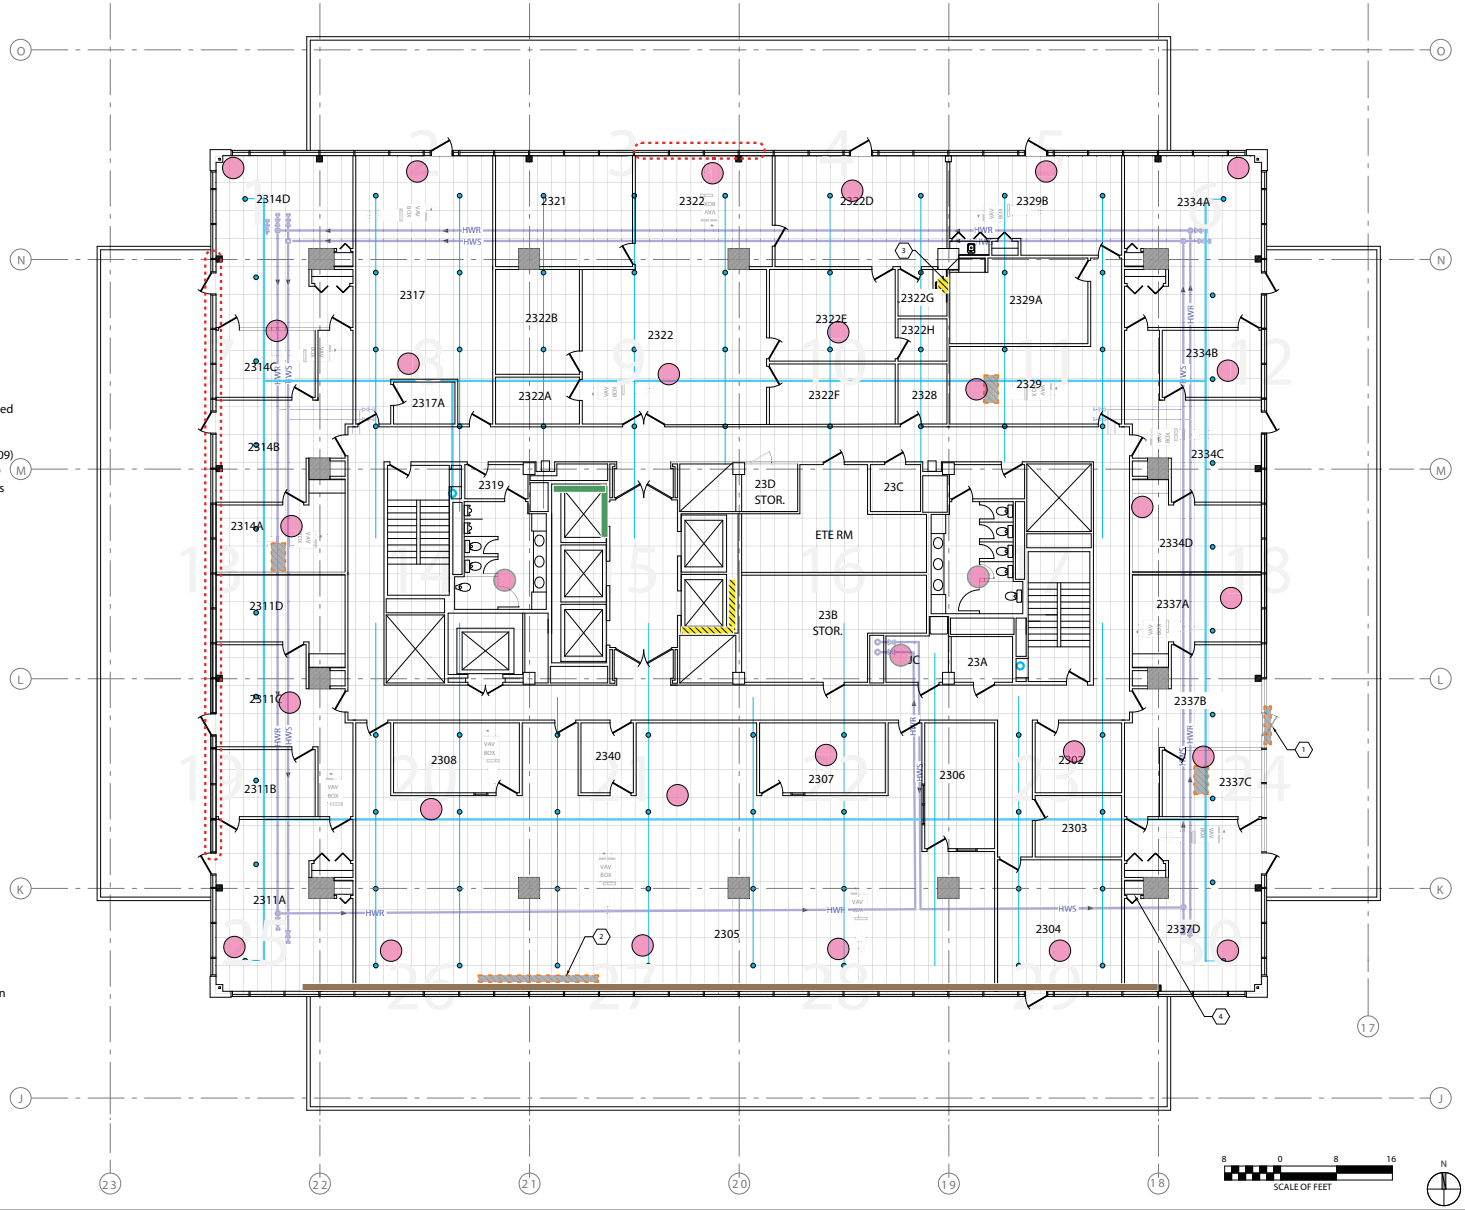
1. Balcony door leak
2. Window seal leak
3. Water stained tile at sprinkler head
4. Damaged paint from sink (Current)

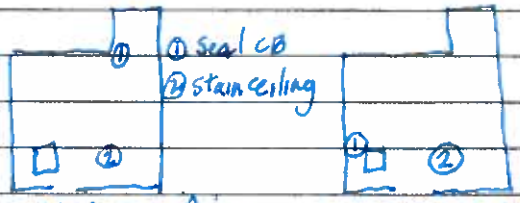
Floor 23

① stains on FP and GB wall B01, T01
② stains on FP and GB wall T02
③ Stain on GB ceiling T03

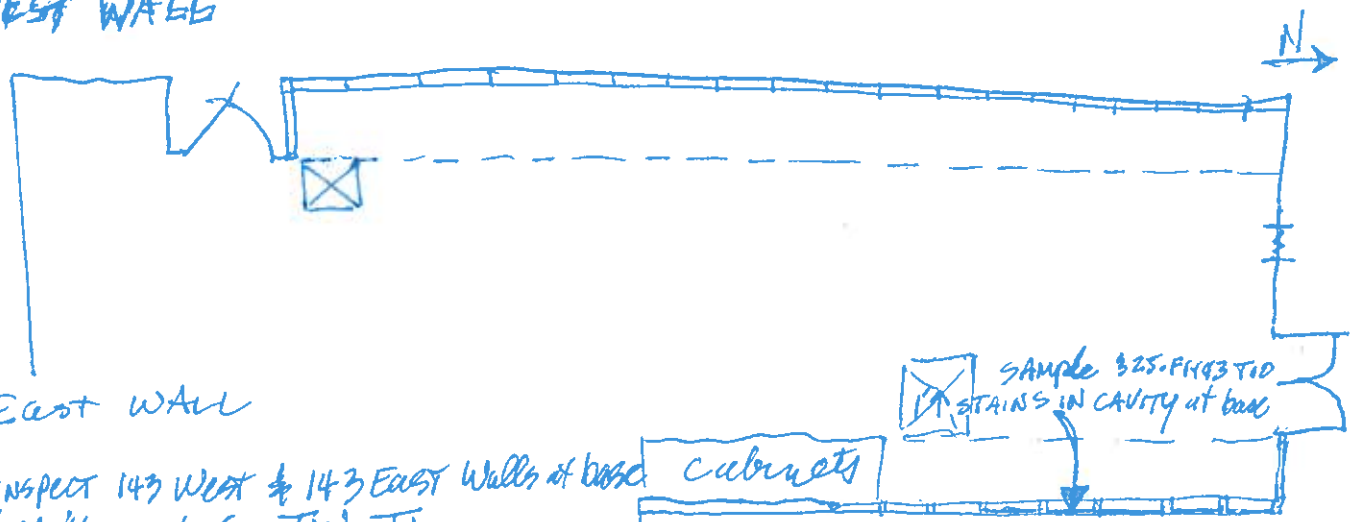
WEST WALL

1'↑ entire wall west containment and east containment.
