California State Board of Equalization
450 N Street, Sacramento, California

Mold Remediation – Fourth Floor Closure Report Addendum

Project No. 2372.02-572

Addendum Date: October 31, 2012

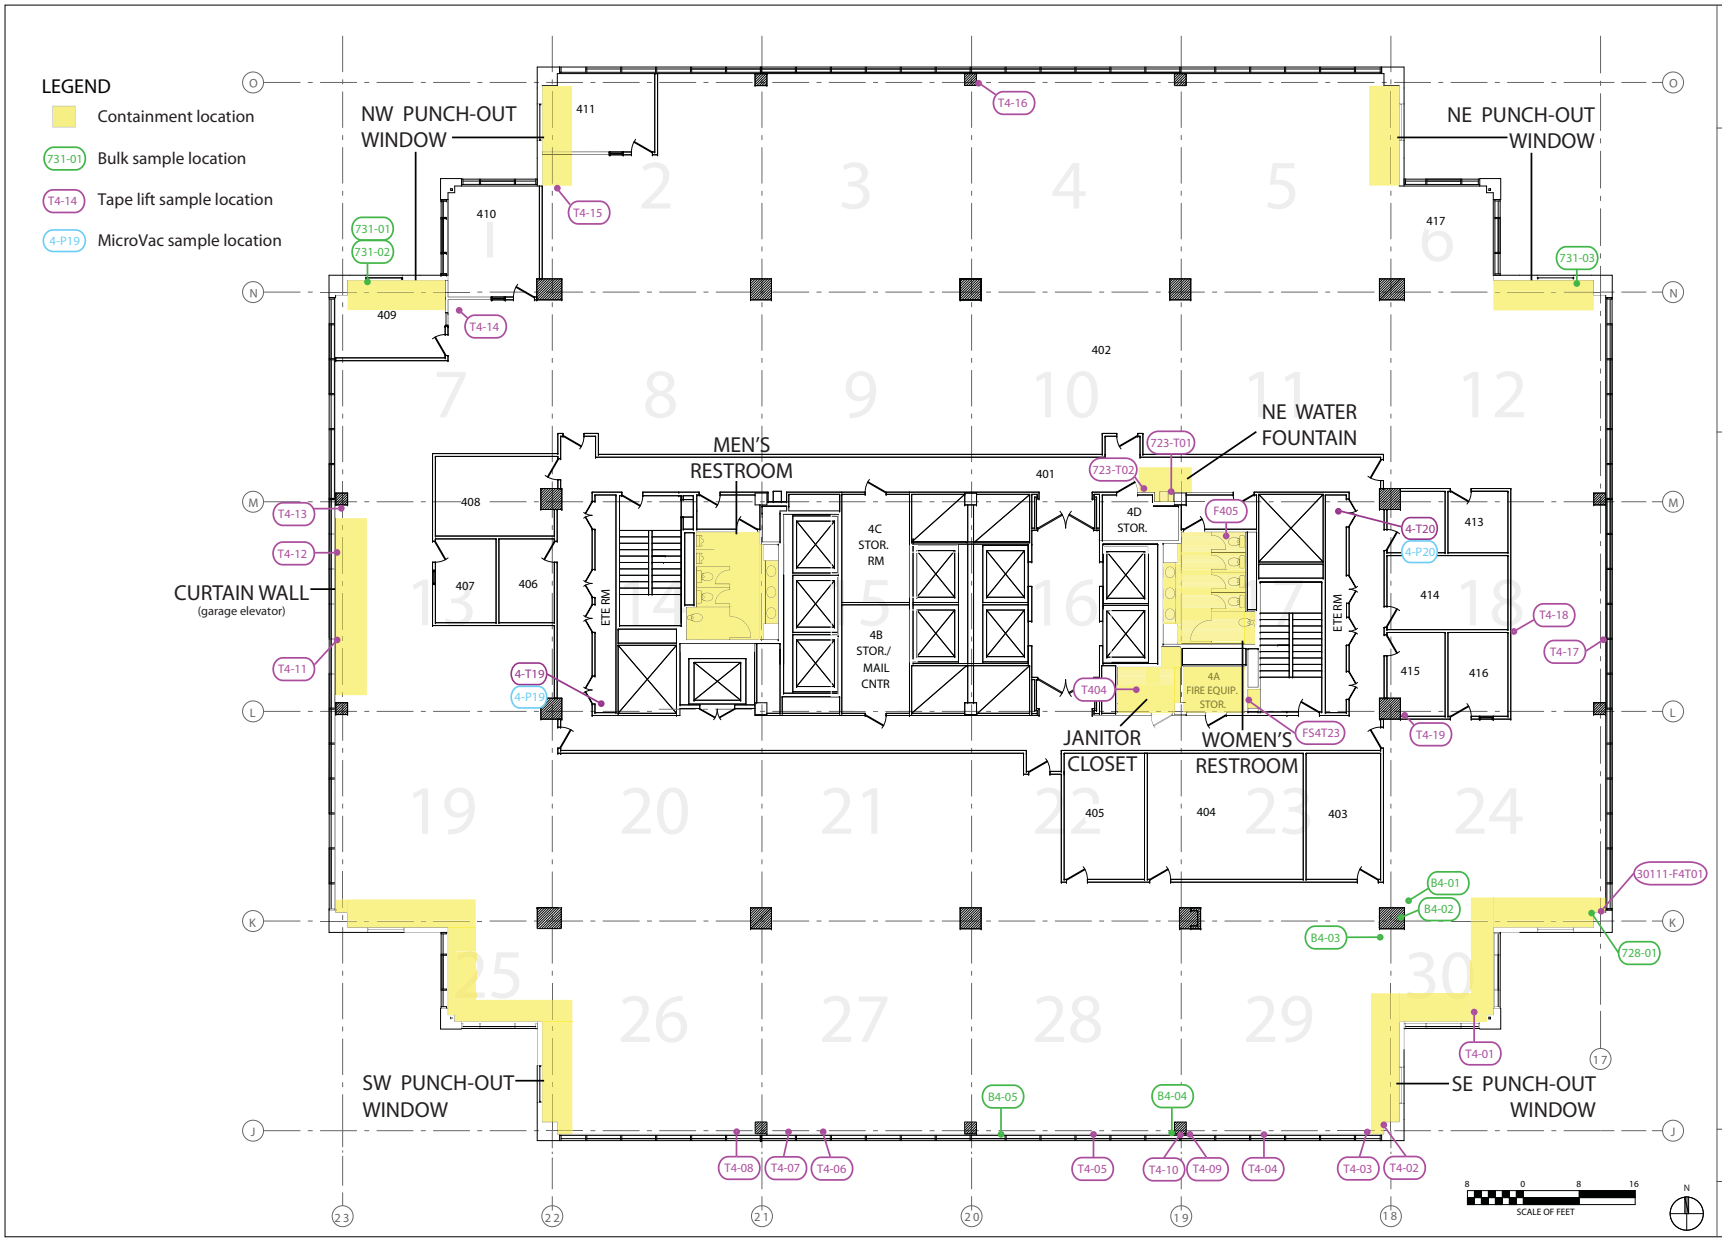
Subsequent to the completion of the closure report, a need for additional investigation and/or remediation activities was identified. Identified areas were subjected to sampling. Using a combination of surface tape lift and/or bulk samples, LCD tested stains on walls and other building materials to determine if the stains were indicative of mold growth. The sample locations are depicted in a revised Figure 2 attached to this addendum.

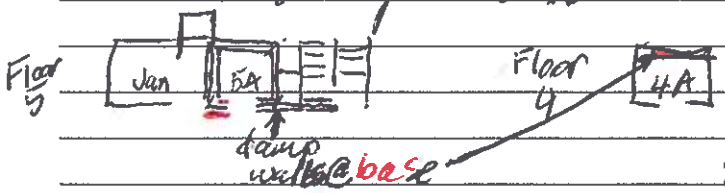
9:20 Floor 5 - Room 5A and Janitor Room install air movers to dry damp wall materials at cove base - check CB in PM
Floor 4 Room 4A install air movers to dry damp wall (North) Check CB in PM.

4A North wall
5A all walls
5 Janitor East wall
} monitor daily for changes

Floor 4 and 5 check wall moisture content, seal the cove base w/tape where it is not perfectly attached, cracked or slightly pulled away.
