BioMax Environmental

June 26th, 2008

**Microbial Assessment and
Mitigation Procedures for 19th Floor Men's Restroom
Department of General Services Board of Equalization Building
450 N. Street
Sacramento, California**

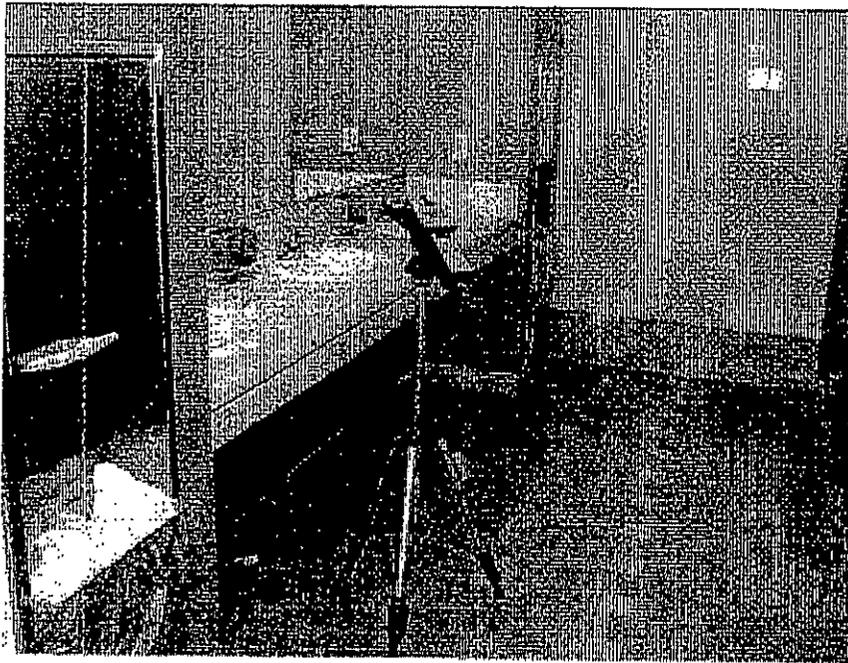
9) Image of air sampling equipment utilized within men's rest room on May 5th, 2008 to assess potential exposures during normal occupied times.

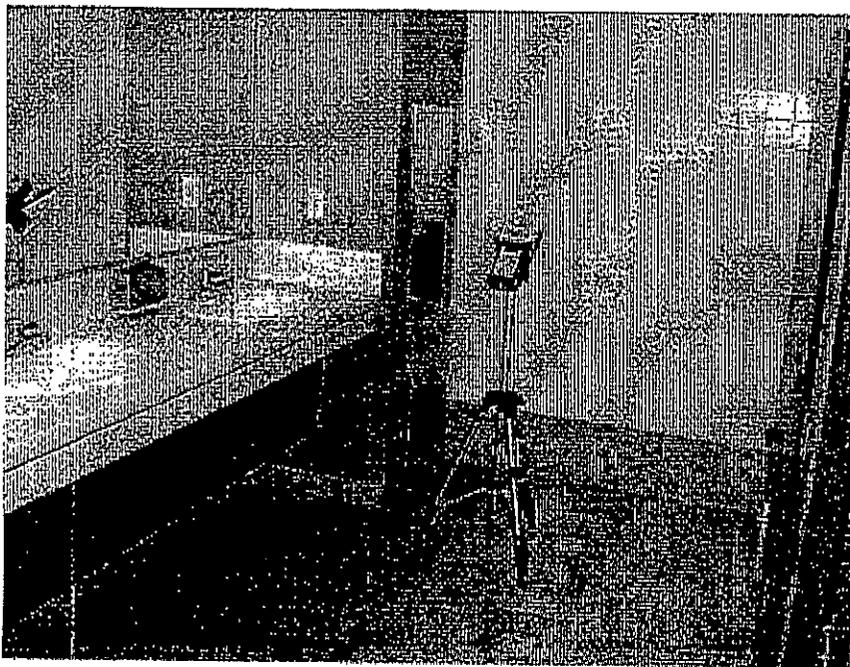
10) Image of second interior airborne sample collected within men's rest room area at time of supplemental assessment performed on May 5th, 2008.
