BioMax Environmental

January 15th, 2010

Post Mitigation Assessment Report
Department of General Services
Break Rooms 1814, 203 and Adjacent Conference Room 204
Board of Equalization Building, 450 N. Street
Sacramento, California

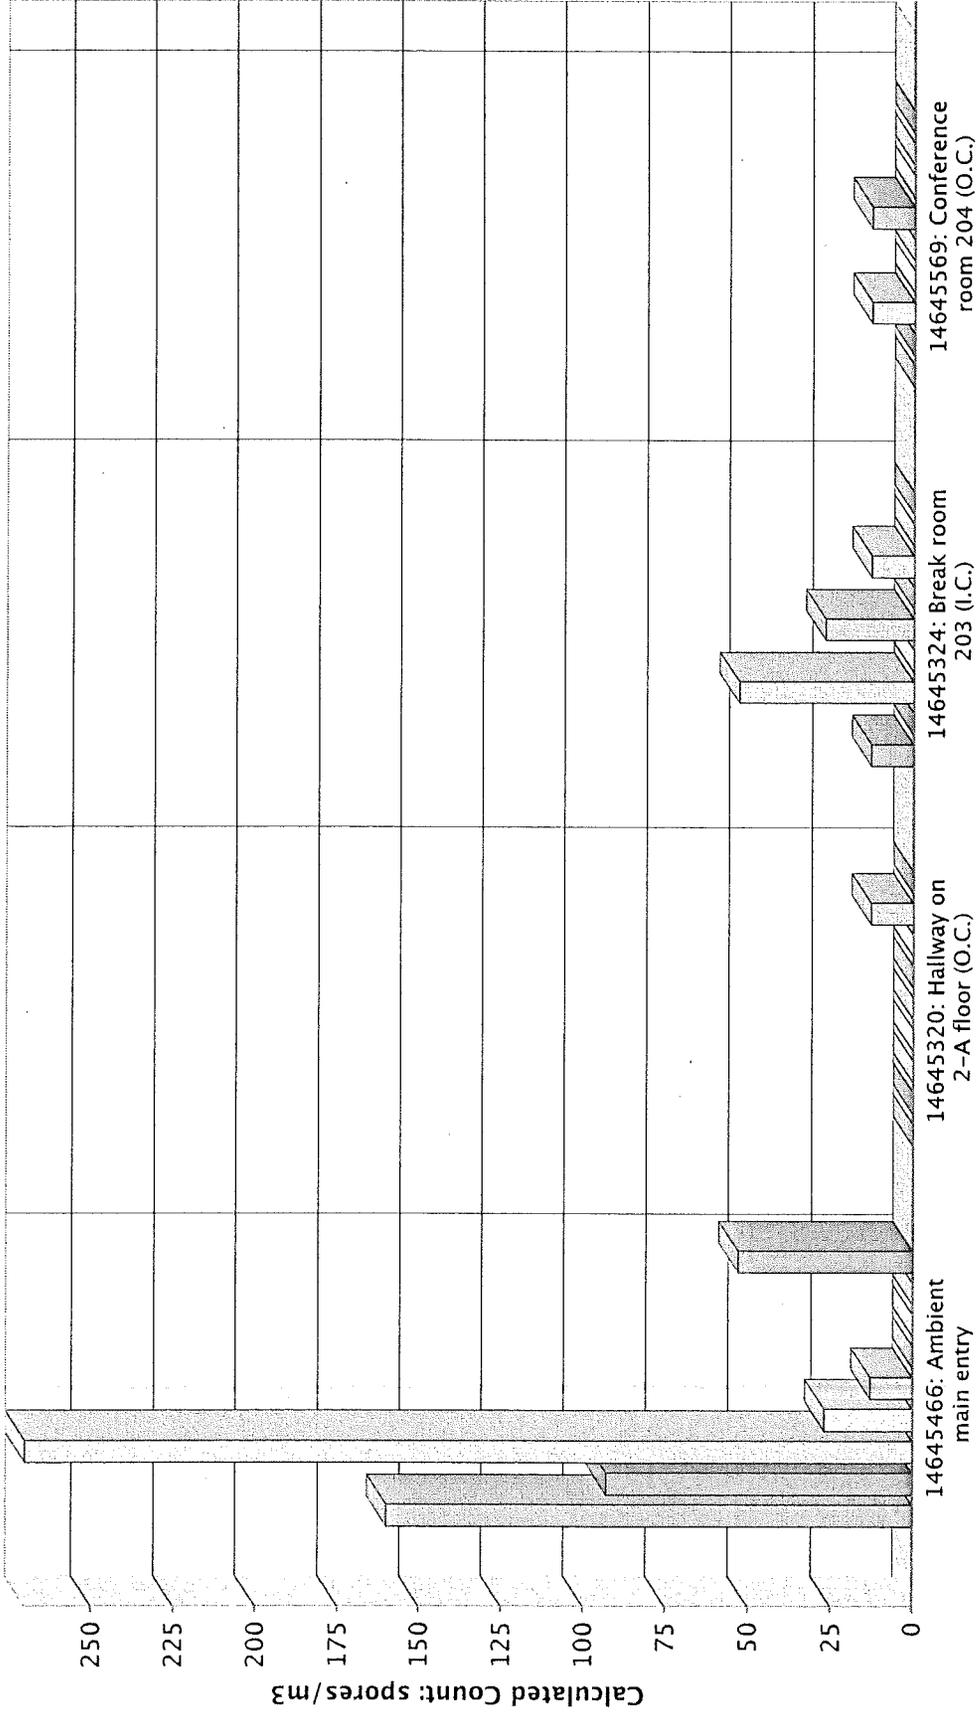
Comments:

Note: Graphical output may understate the importance of certain "marker" genera. TestAmerica Environmental Microbiology Laboratory, Inc.
