**California State Board of Equalization**  
450 N Street, Sacramento, California

**Mold Remediation – 17<sup>th</sup> Floor  
Closure Report Addendum**

*Project No. 2372.02-572*

**Addendum Date:** October 31, 2012

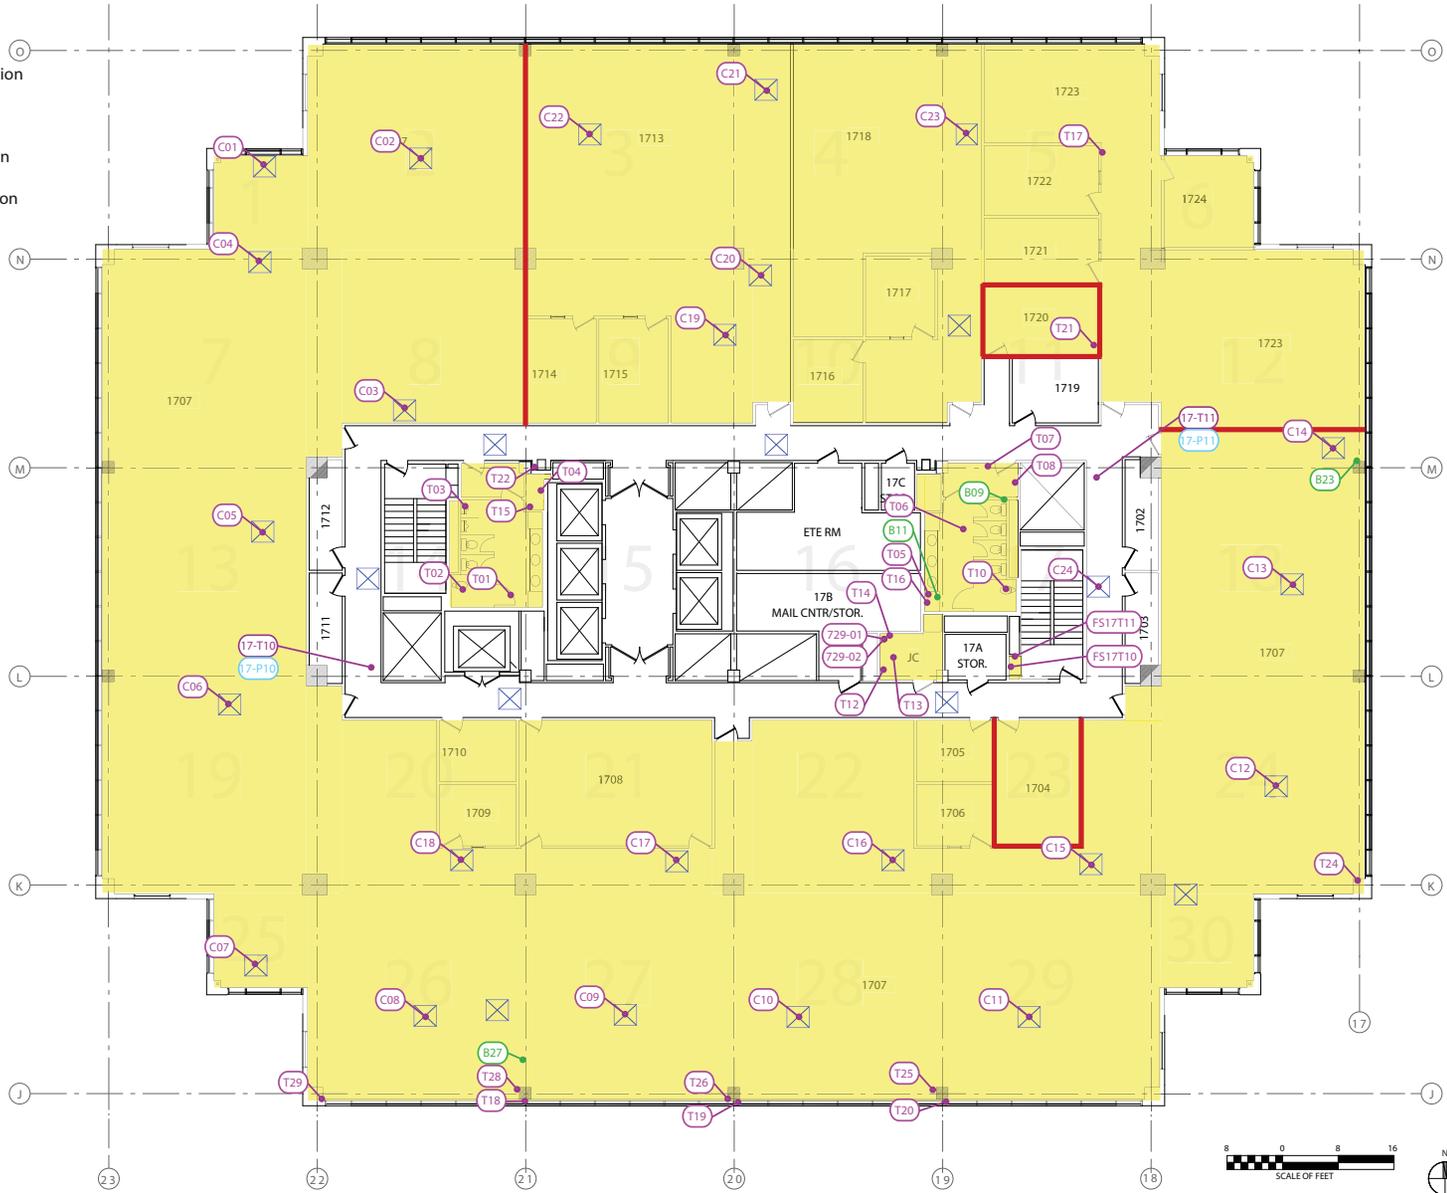
**Containment and Sample Locations (Oct 2012)**  
 Board of Equalization Building, Mold Remediation  
 450 N Street, Sacramento, California

- ① Water stain on North and West walls
- ② Water stain on wall and floor
- ③ Water stain on wall and floor
- ④ Stained ceiling
