1. Civil

B. ADA Accessibility

Civil site visits took place February 9th & 10th, 2009, to observe site characteristics that pertain to Americans with Disabilities Act (ADA) accessibility compliance for the 450 N Street building from the public sidewalk to the building entrances.

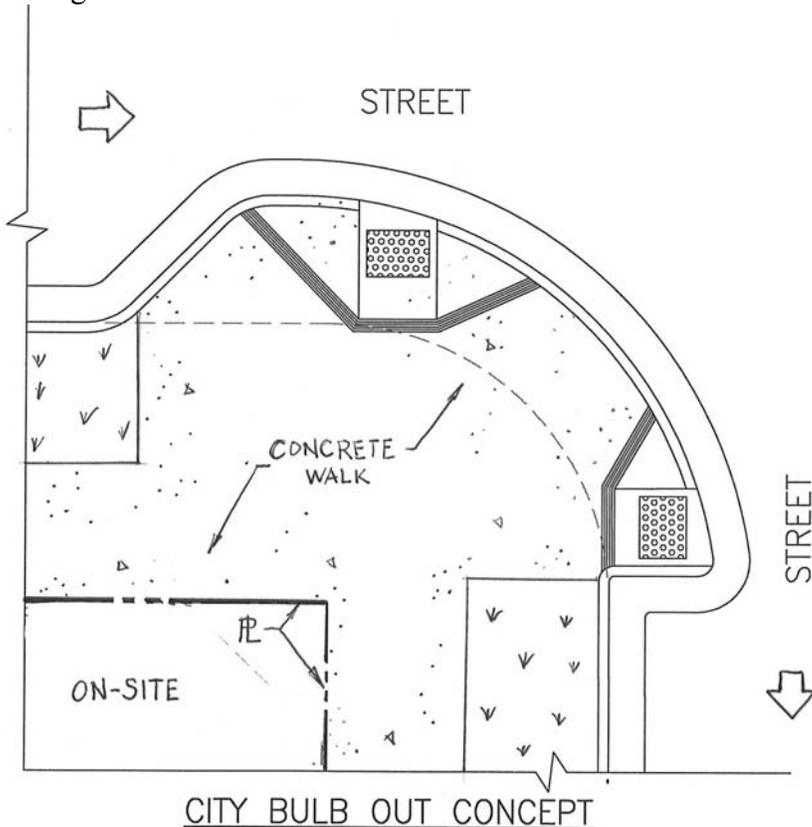
This is a conceptual detail of a standard "Bulb Out" Detail. This is the City's design concept to address the high pedestrian traffic flows at the signalized pedestrian cross walks. Most likely this will be required in two locations north "N" Street intersection and south "N" street intersection.
