**State Board of Equalization  
Generic Floor Remediation Protocol, Rev 1  
450 N Street  
Sacramento, California 95814**

*Project No. 2372.02-572 SOW 1.0*

# State Board of Equalization Generic Floor Remediation Protocol

## 450 N Street, Sacramento, California

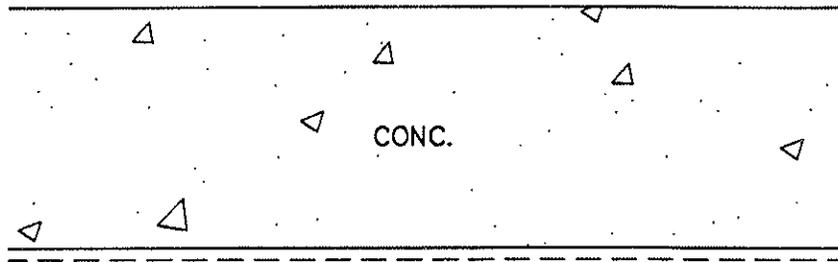
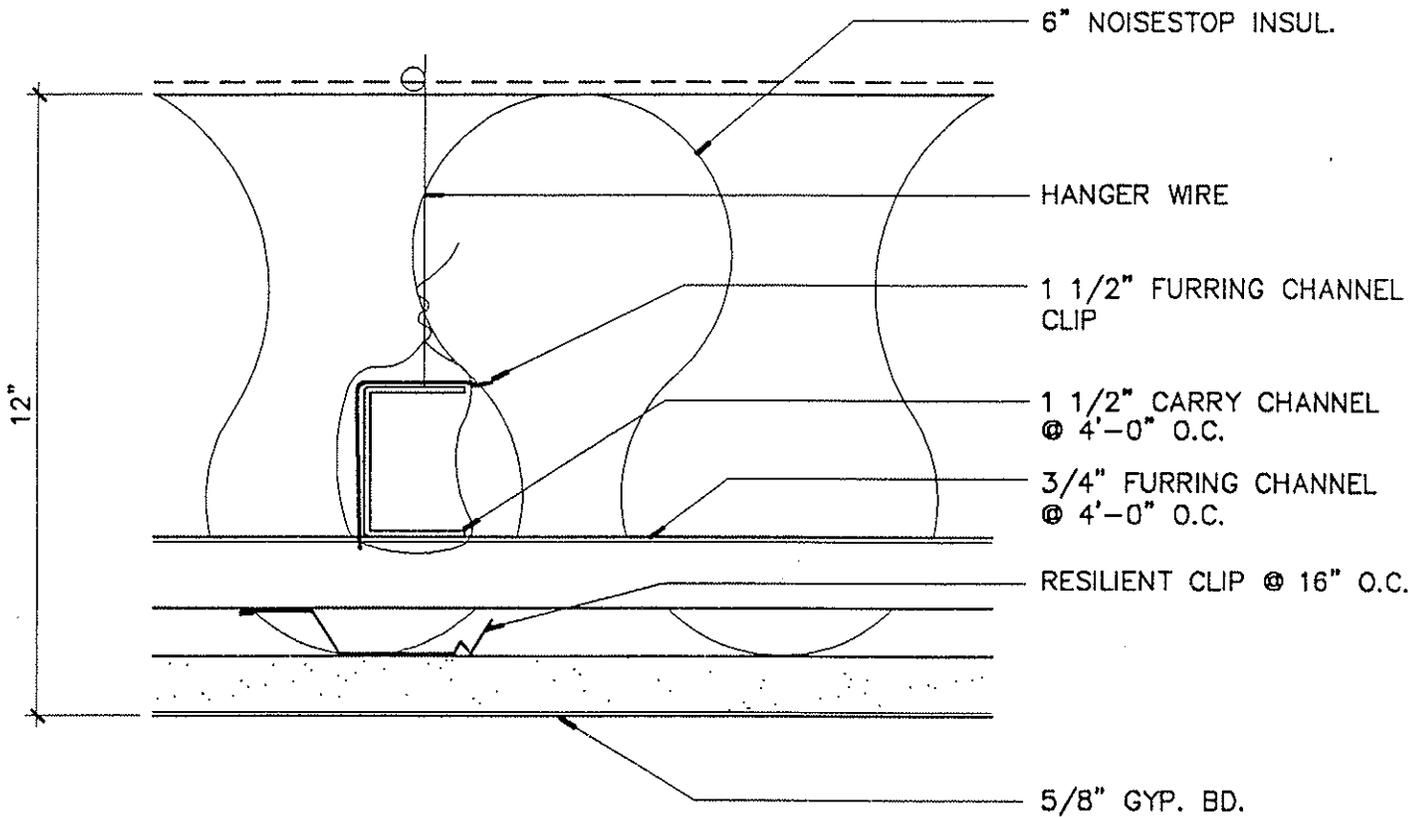
<p><b>Dreyfuss &amp; Blackford Architects</b> 3540 Folsom Boulevard Sacramento, California 95818 (916) 453-1234</p>		PROJECT: <b>CAPITOL SQUARE</b>	JOB NUMBER: 87178.07
		TITLE: GYP. BD. CLG @ 11TH & 24TH FLR.	DATE: 11/5/90
		SCALE: 1/2 SIZE

METAL DECKING

THIS CEILING IS ABOVE THE ACOUSTICAL BOARD CEILING. GYP. BD. INTERSECTION AT PERIMETER MUST BE TIGHT—ALL VOIDS TO BE FILLED WITH ACOUSTICAL SEALANT.

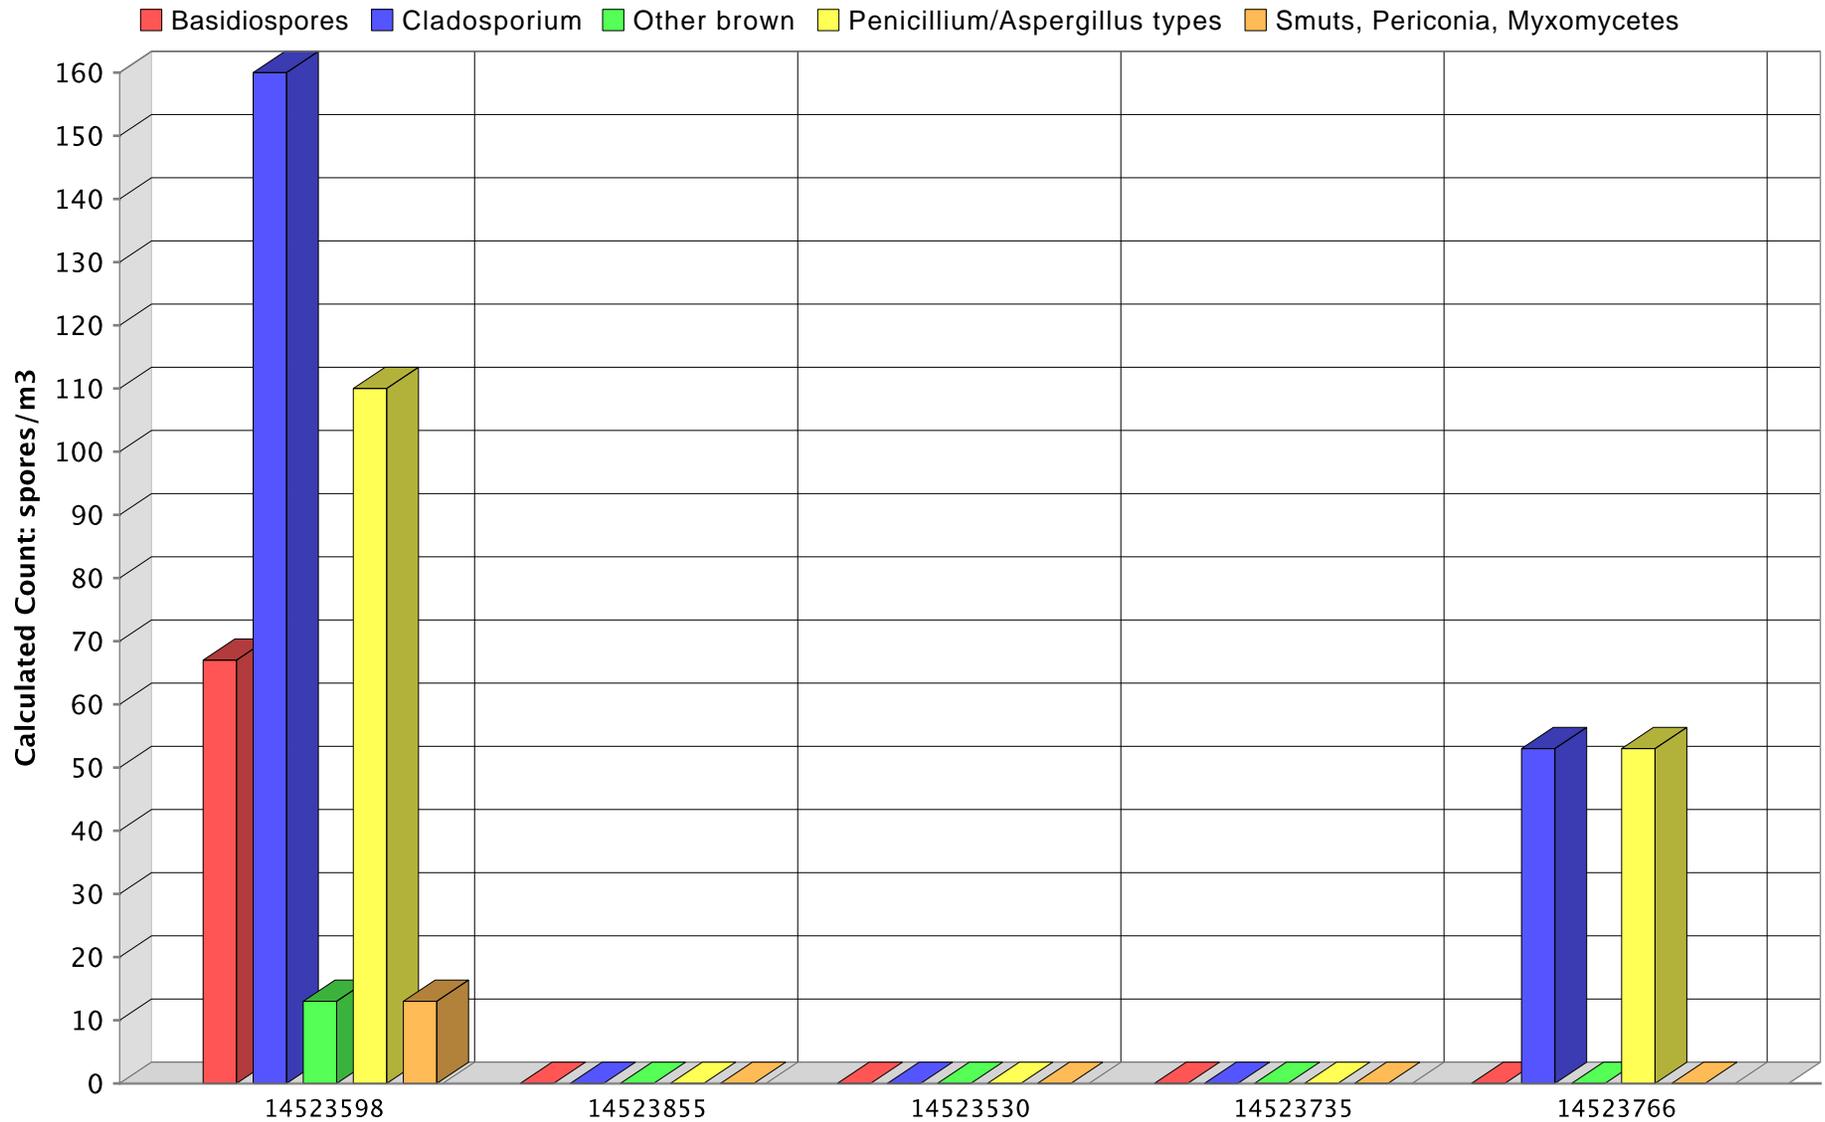
### SPORE TRAP REPORT: NON-VIABLE METHODOLOGY

Note: Graphical output may understate the importance of certain "marker" genera.  
TestAmerica Environmental Microbiology Laboratory, Inc.

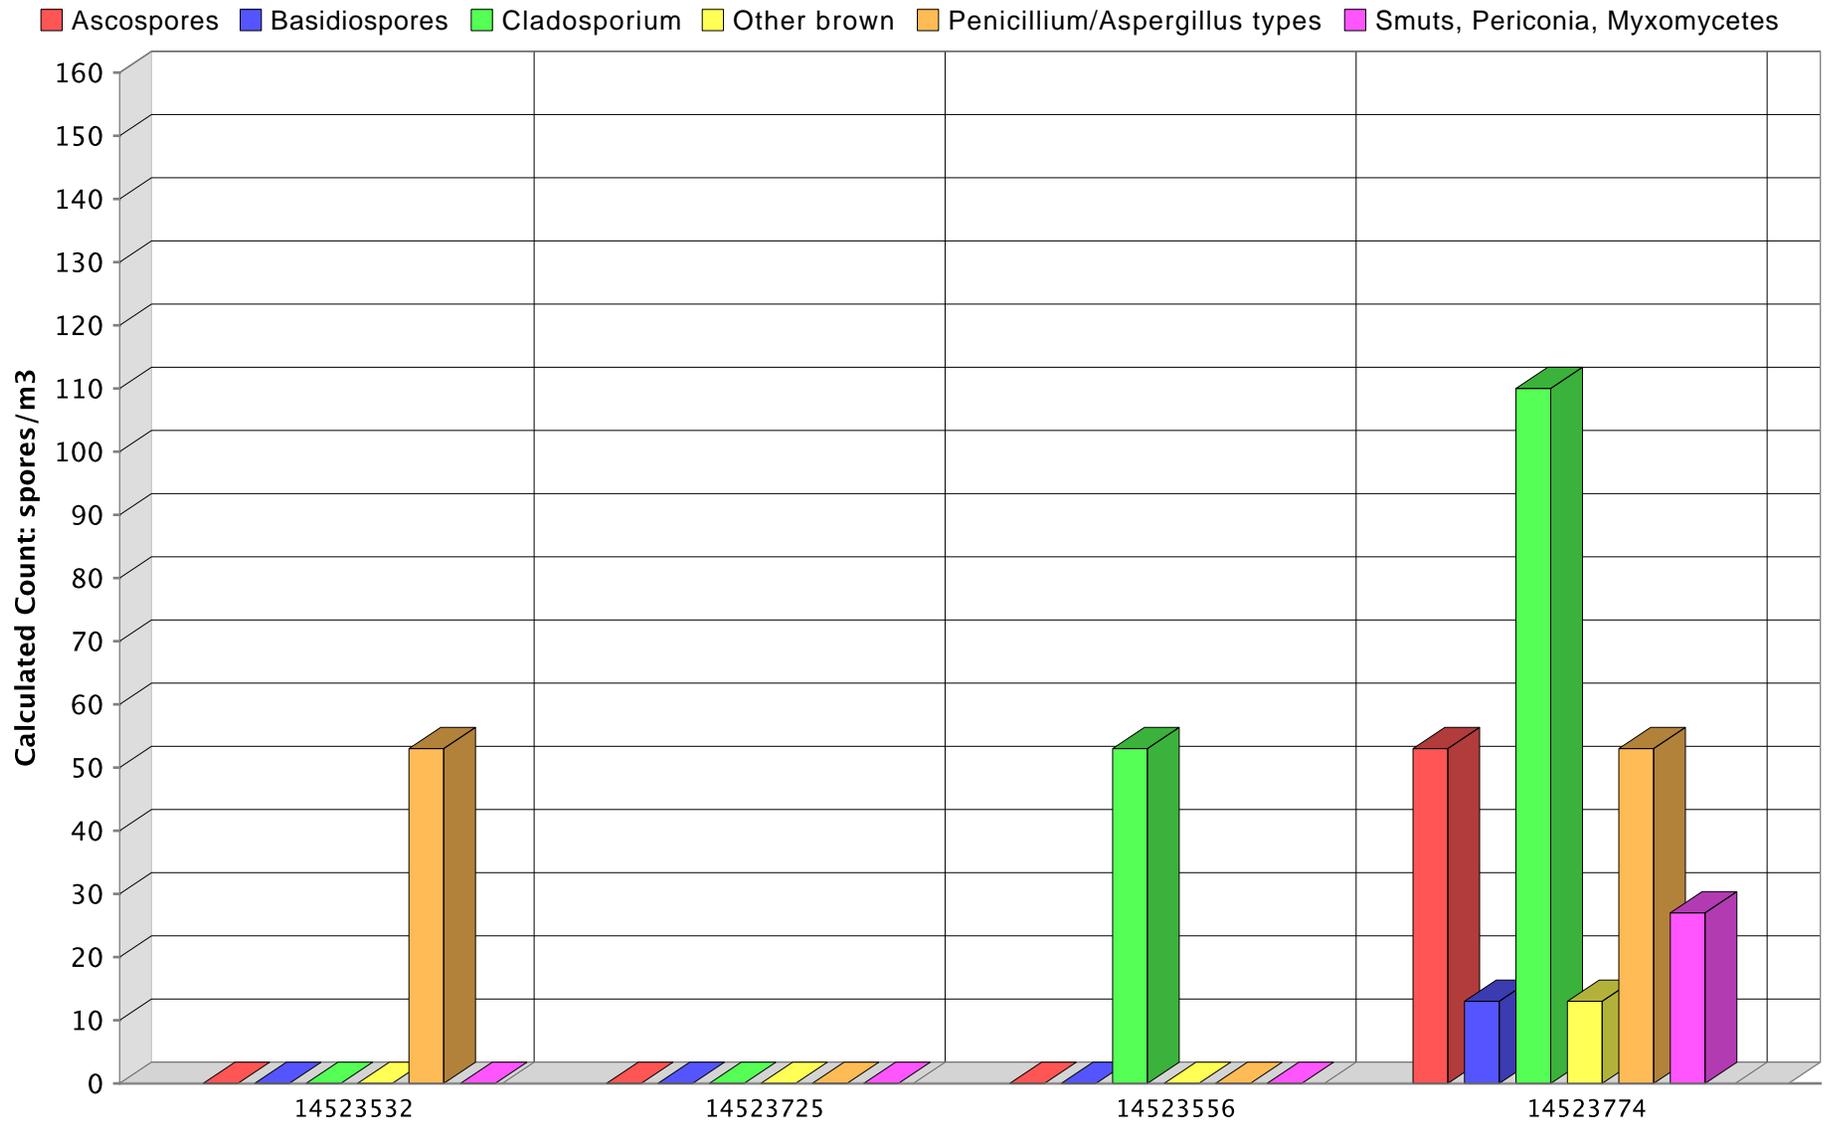
### SPORE TRAP REPORT: NON-VIABLE METHODOLOGY

Note: Graphical output may understate the importance of certain "marker" genera.  
TestAmerica Environmental Microbiology Laboratory, Inc.
