Board of Equalization Building
450 N Street, Sacramento, CA 95814
Forensic Analysis – Glass Breakage
Prepared for DGS

Interactive Resources Project No. 2011-099-01
IDGS Contract No. 3158936 (BPM #028)

June 25, 2012

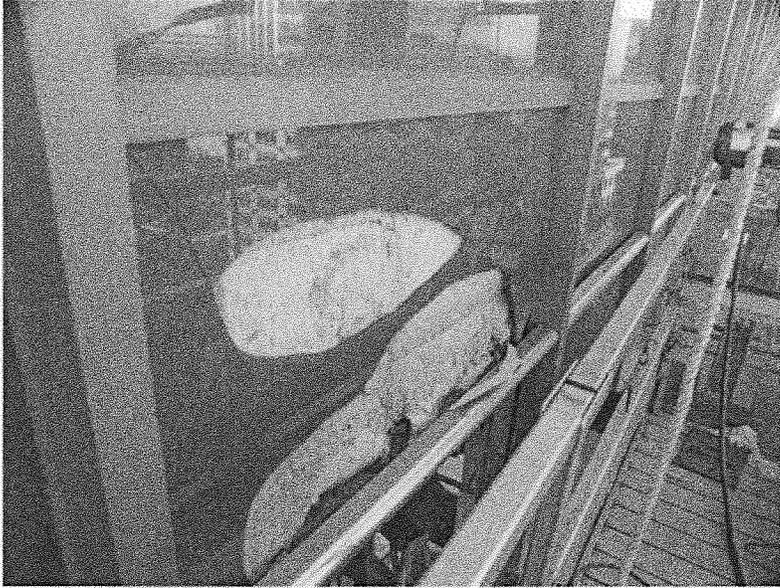
Martin Photo 016

- A horizontal bar that is attached to the vertical members of the curtain wall framing and sits slightly outboard of the outside surface of the glass, casts shade onto the glass (Martin Photo 016).
- A closely spaced series of fracture lines emanate from a point in the vicinity of the horizontal bar (Martin Photo 022).
- Another confluence of fracture lines is shown in Martin Photo 005 emanating from what appears to be the sill glazing pocket.

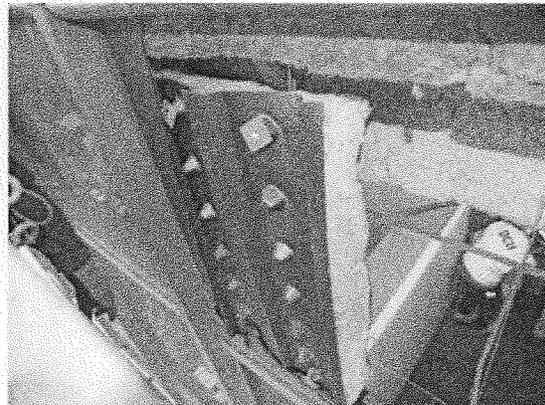
Upon MCA's arrival more glass below the floor line had fallen (Photos 2 and 3) and portions above the floor line had also fallen (Photos 4 and 5).

Photo 3 – View from exterior of additional glass that had fallen below the floor level.

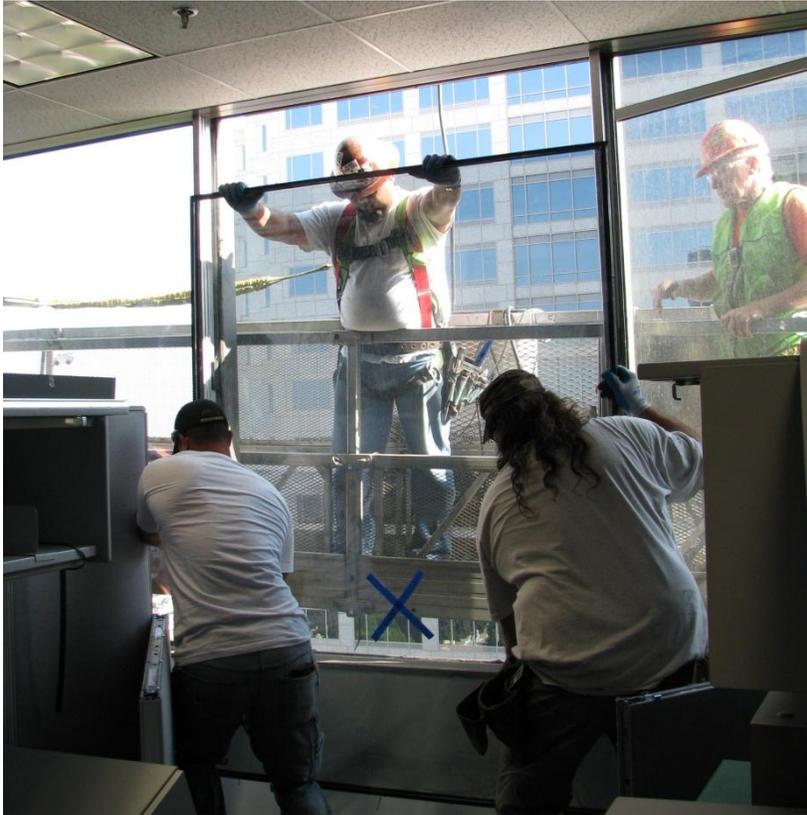
Figure 7. Removal of Lite #2.

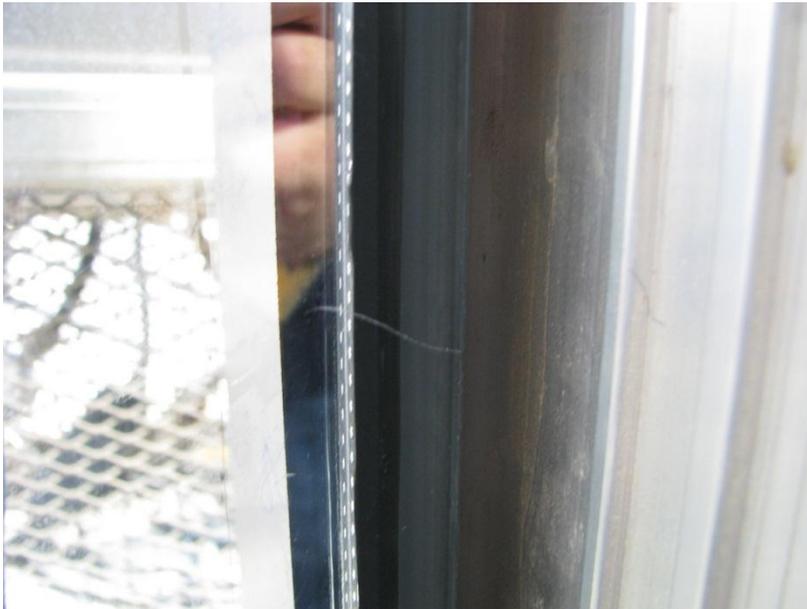
Figure 8. Scratch on Lite #2.

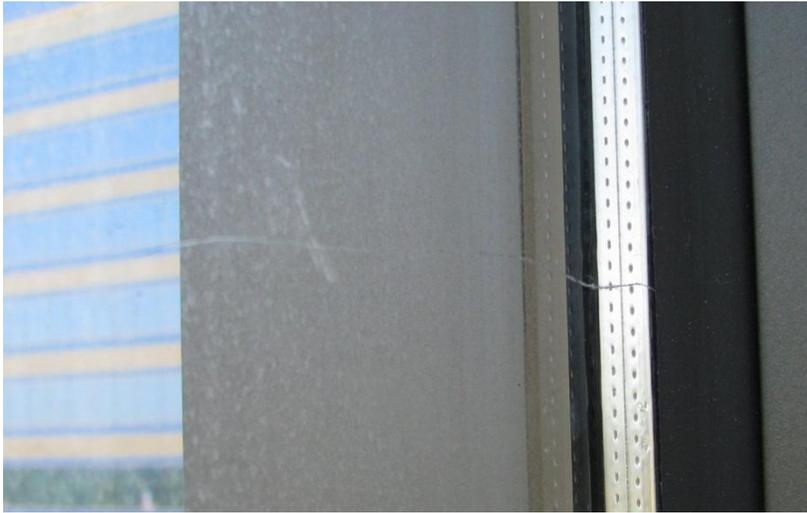
Figure 11. Scratch on Lite #3. Same location as Figure 10.

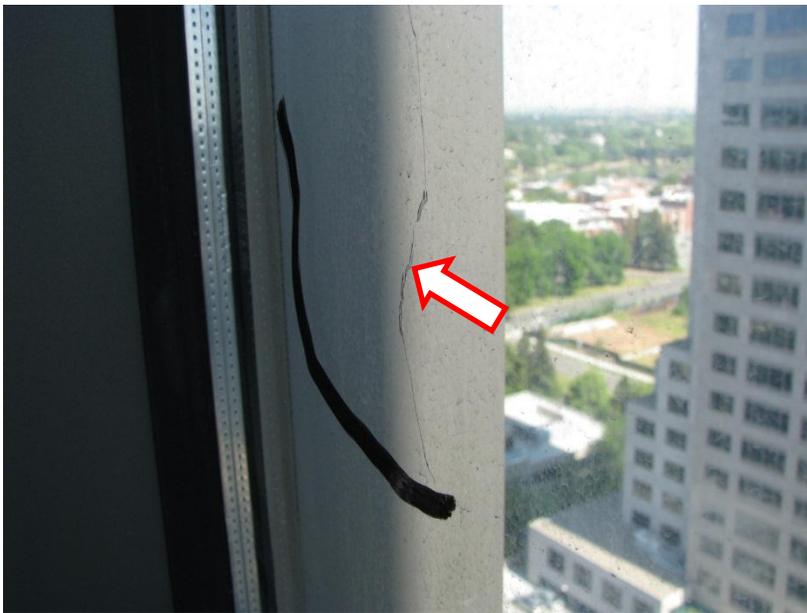
Figure 12. Scratch on Lite #4.

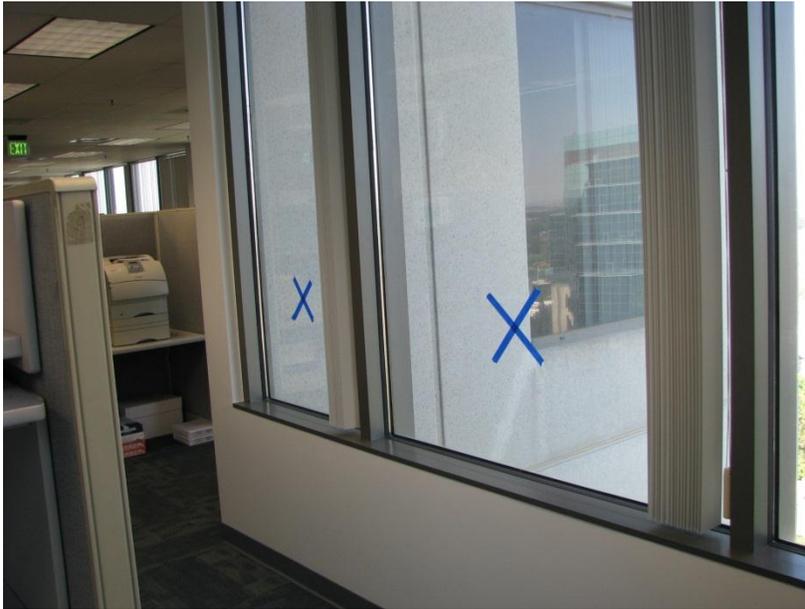
Figure 13. Lites #5 and #6 marked for removal.

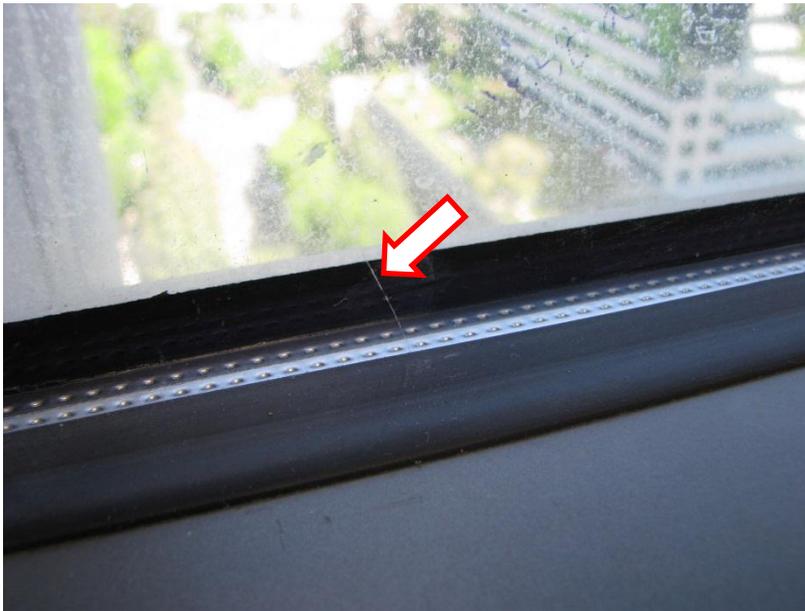
Figure 14. Scratch on Lite #5.

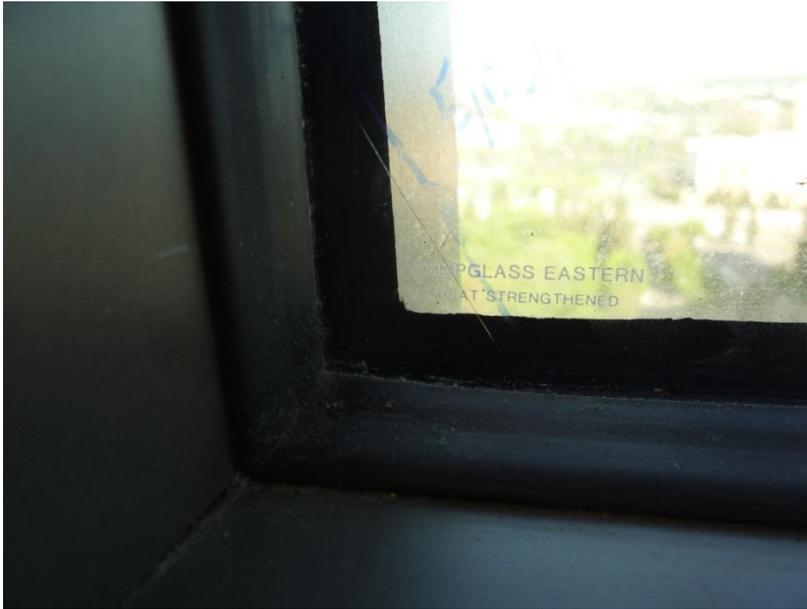
*Figure 15. Scratch on Lite #6, occurring on inner lite, surface no. 3.
"Tempglass Eastern" stamp is on outer lite.*

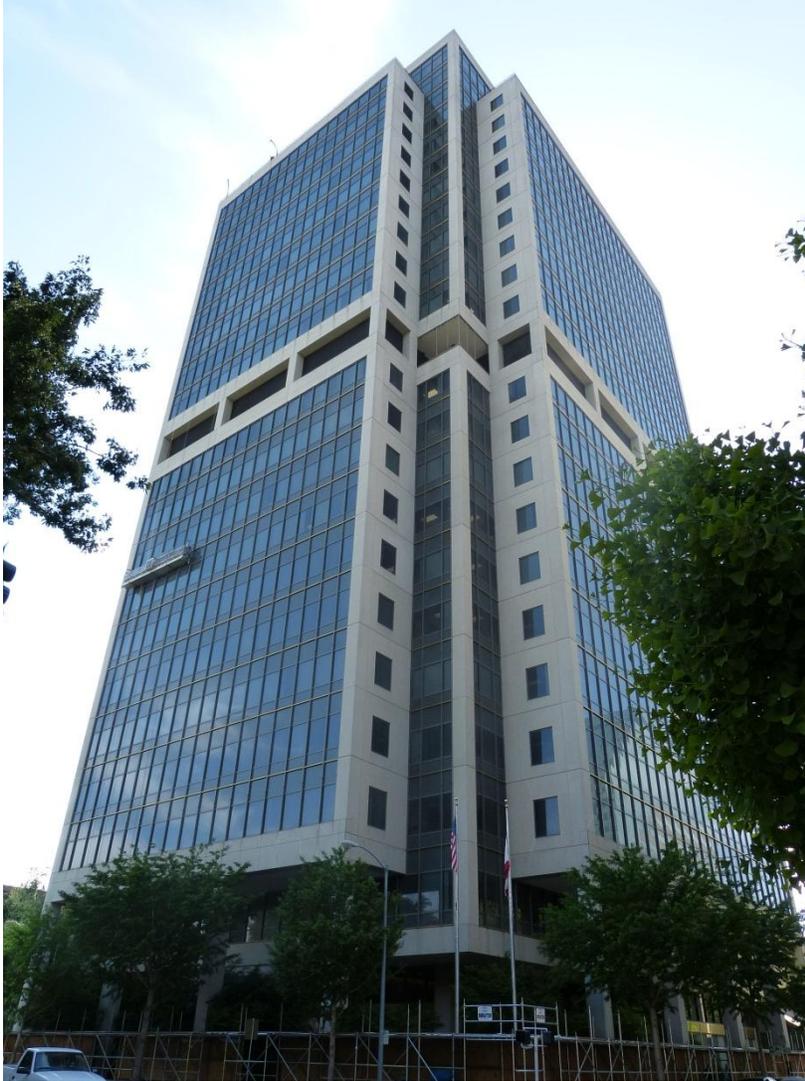
Figure 1. Overall view of building.

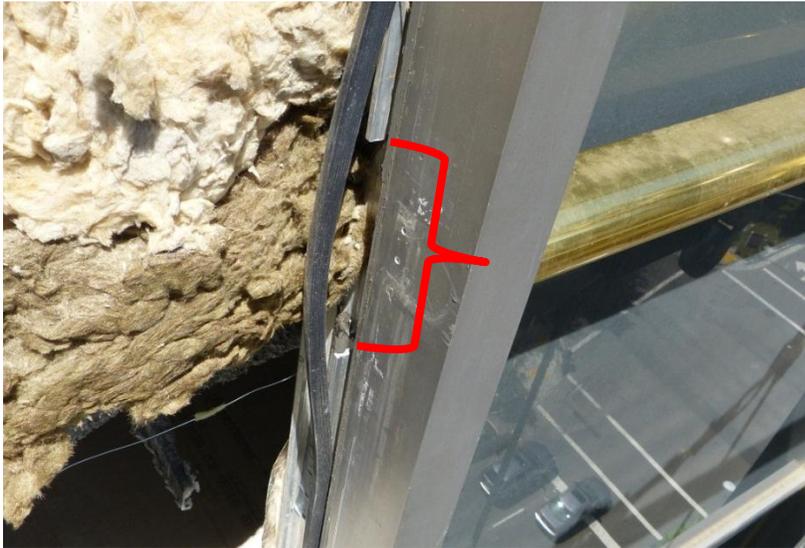
Figure 2. Gasket support profile interrupted at anchor location.

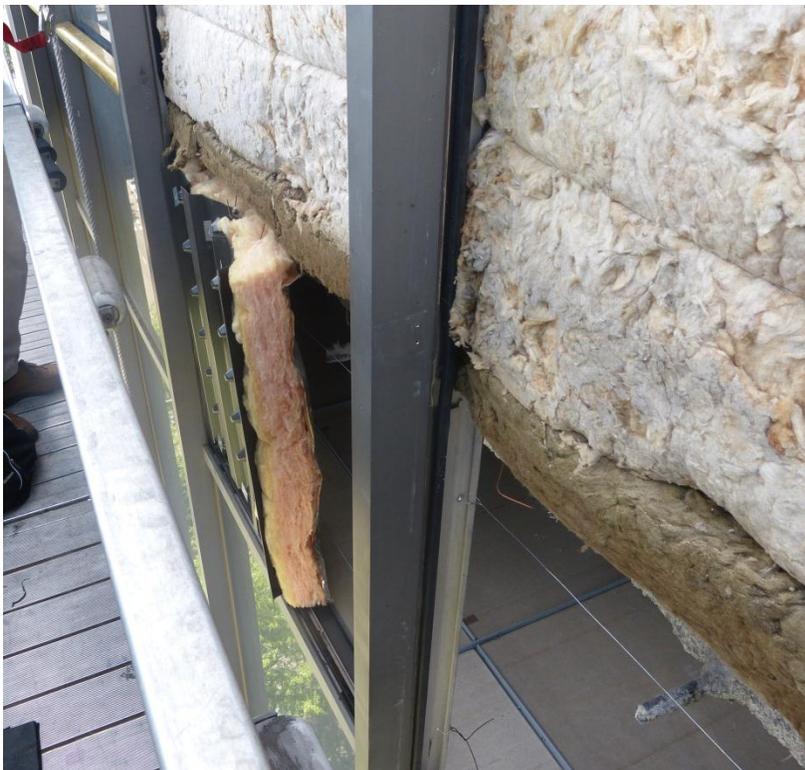
- Glass bite and edge clearance appeared to be adequate to prevent contact of glass with the framing.
- Insulation at the lower half of the lite (below the floor slab) was found to be held off the glass by dimpled foam “egg-crate” material. The fire-safing and insulation above it, on the other hand, were found to be generally in contact with the back of the spandrel glass. (Figure 3)

Figure 3. Spandrel area with glass removed. Fire-safing at floor level and insulation above it are generally in contact with back of glass. Insulation below safing is held back from the glass by the use of dark-colored foam egg-crate material. Some of the insulation below the floor line has been temporarily removed in this photo.

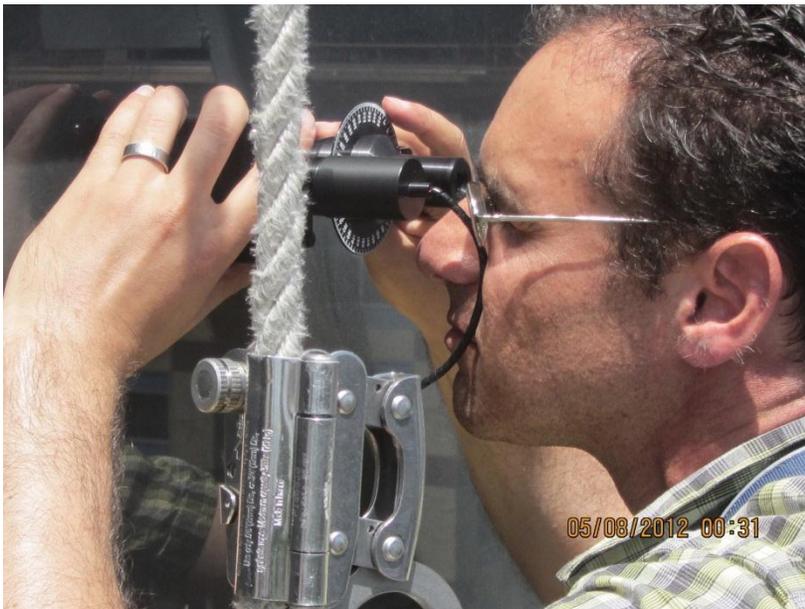
Surface Stress Measurements. WJE took measurements using a grazing angle surface polarimeter (GASP) to determine the RCSS in the spandrel glass (Figure 5). We measured RCSS on fragments of the removed broken lite stored in the maintenance room, and also took in-situ measurements on the lites still on the building immediately to the left and right of the replacement lite. We found that the RCSS on the fragments of the broken lite averaged 7599 psi. Measurements on the lites to the left and right averaged 9226 psi and 8377 psi respectively.

Figure 5. GASP device in use to measure RCSS of spandrel lites.

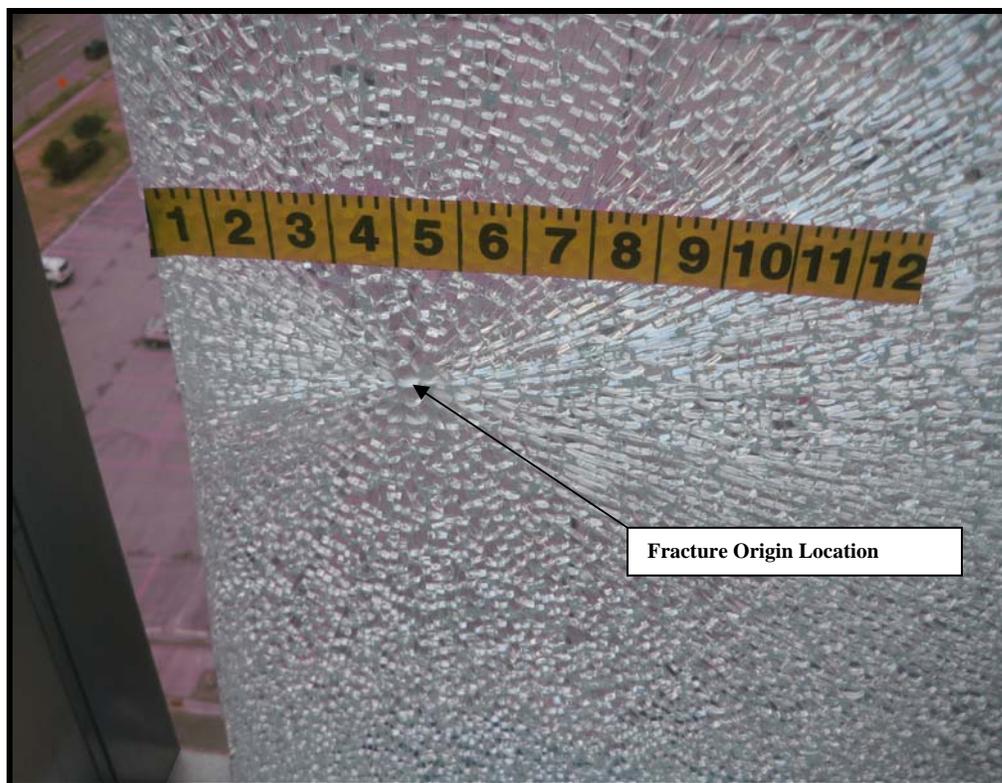
- 1. Locate the initial break area. This is usually identified by a portion of the glass that appears like the center of a spider web. This is illustrated in the photo below.**
